Limited Preservation Plan, Woodstock Town Hall Theatre - DRAFT

November 15, 2022

**WOODSTOCK TOWN HALL THEATRE
LIMITED PRESERVATION PLAN**

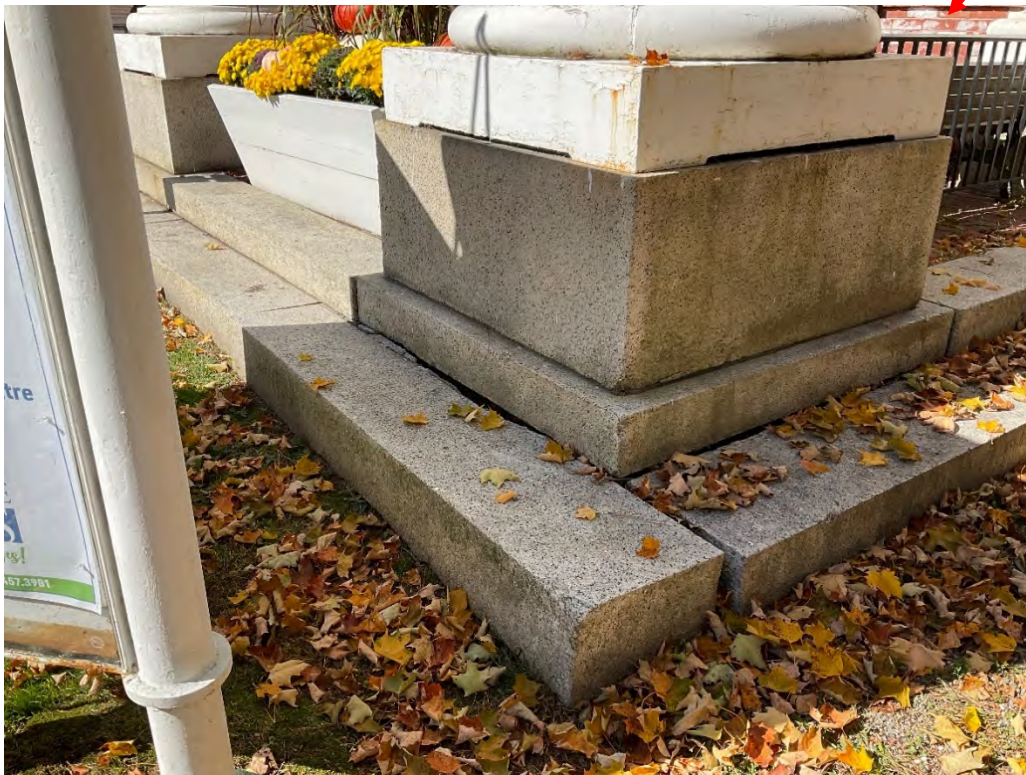
Figure 7. Open joints and displacement of granite steps around portico porch. Note front wall efflorescence in background.

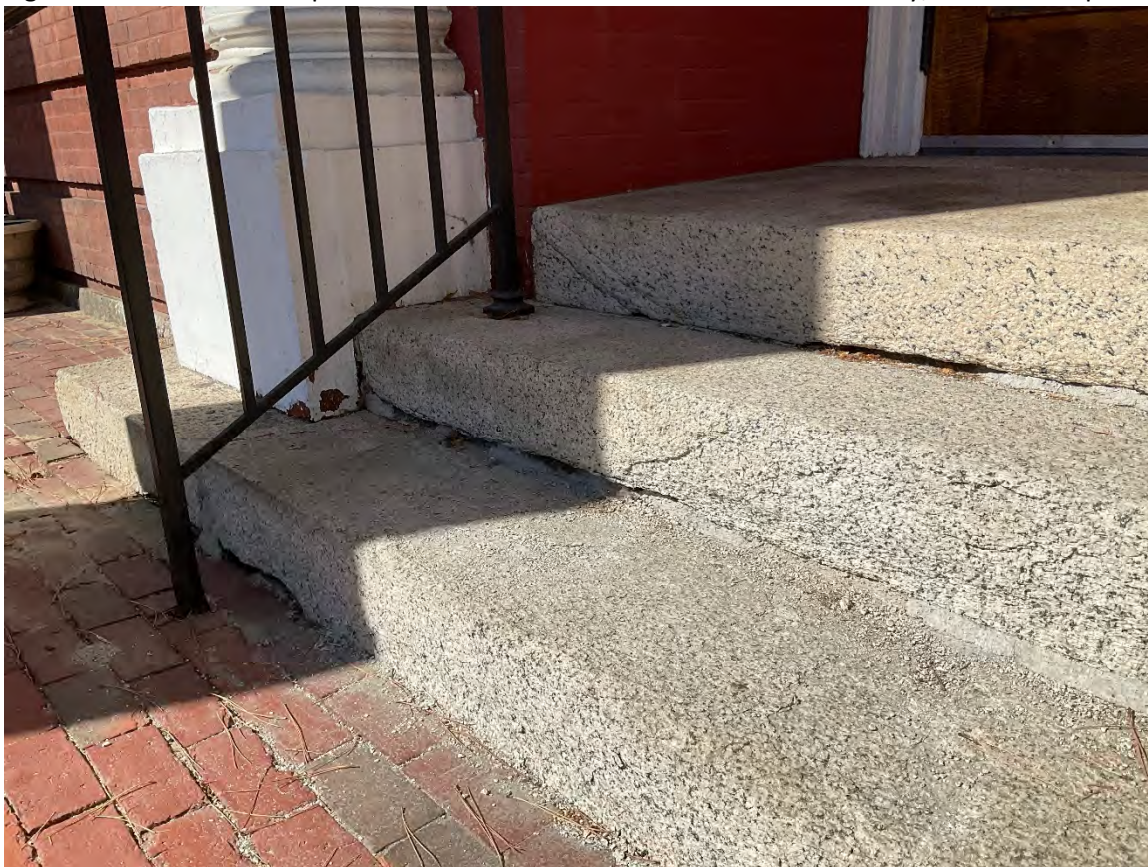
Figure 9. Deteriorated granite steps and open joints.

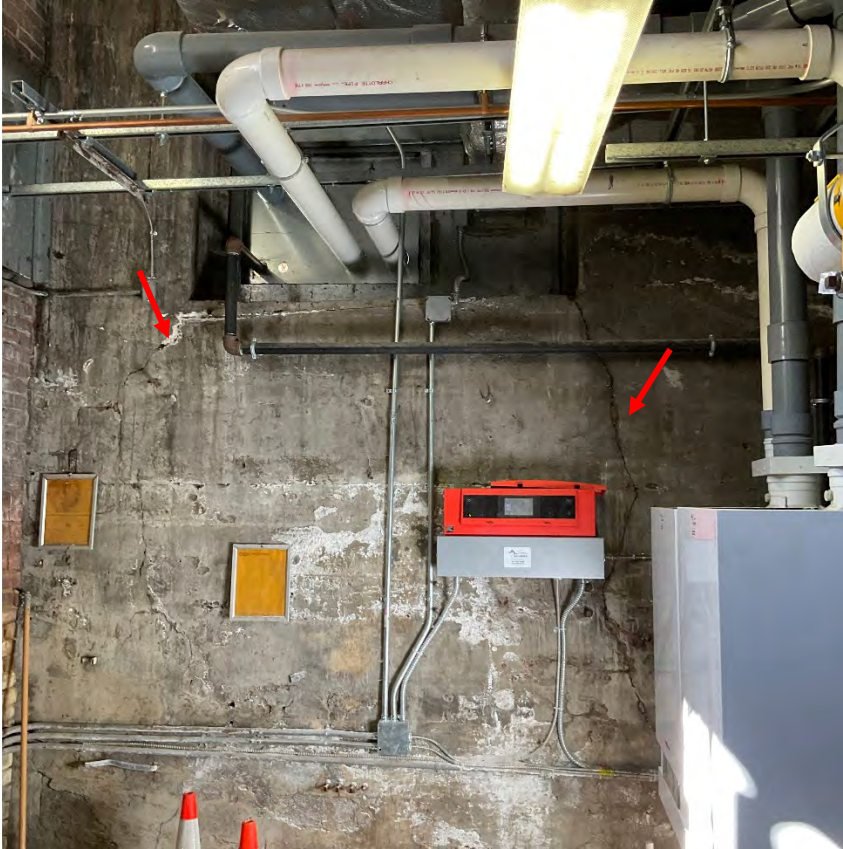
Figure 10. Large cracks at northern foundation wall in the stage addition (boiler room).

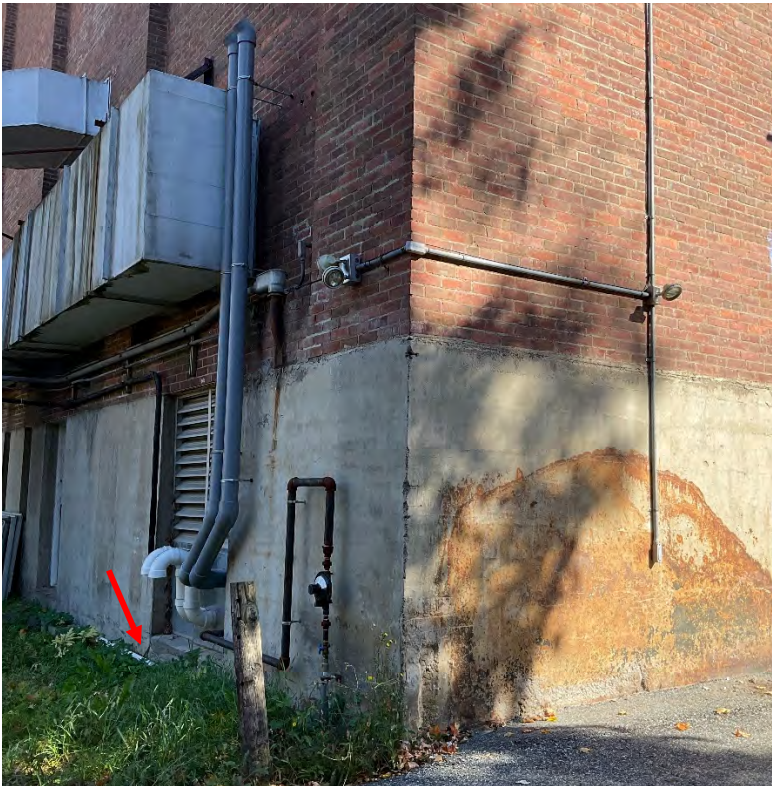
Figure 11. Exterior side of opening with foundation cracks. Note top and corner of concrete wall.

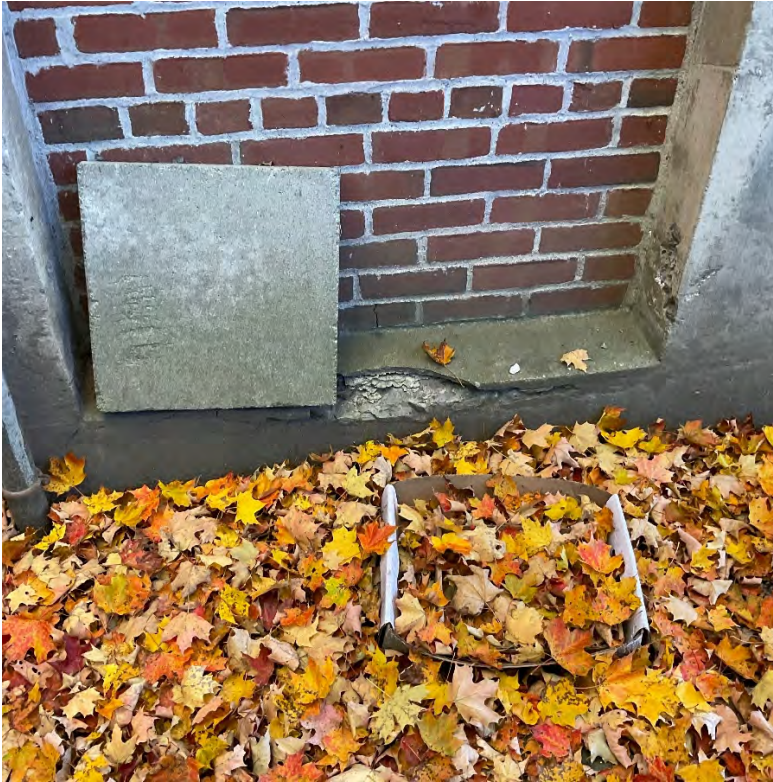
Figure 12. Concrete spill at infilled opening to dressing room.

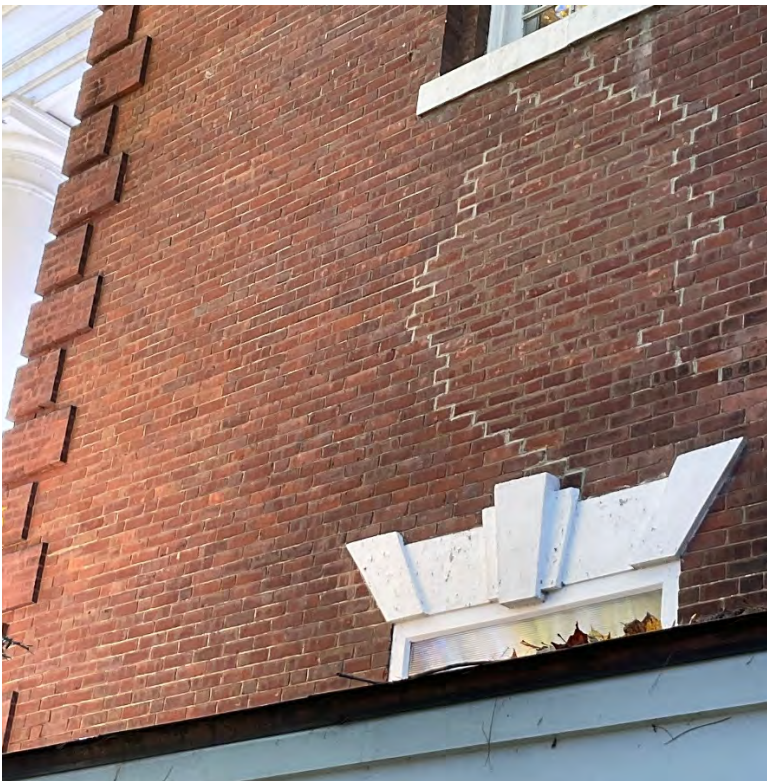
Figure 14. Infill of oval window, completed in 1927. The date of more recent repointing is unknown.

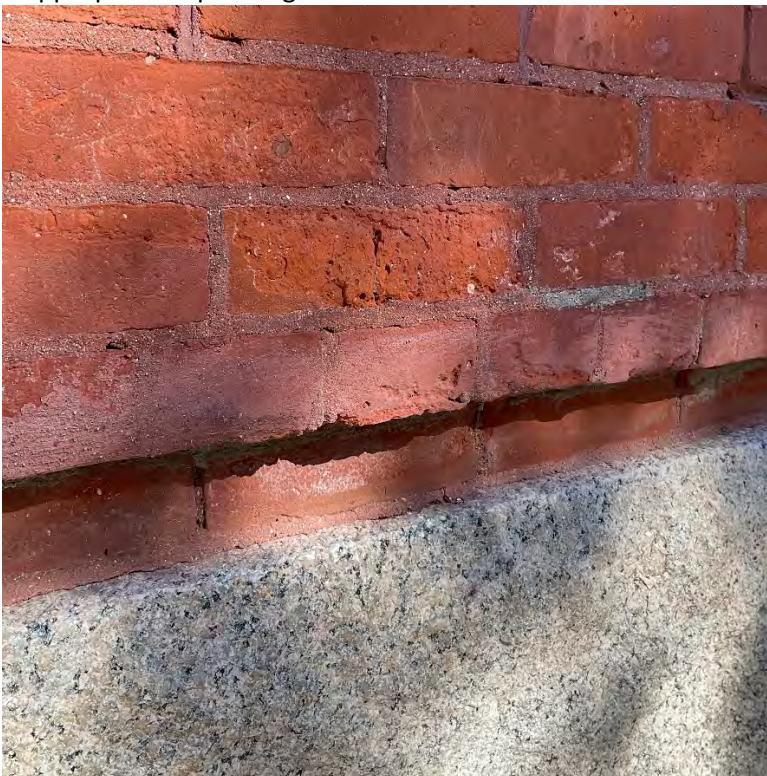
Figure 16. Example of spalled brick face (at center). The second row of brick has received a repair mortar mix at surface.

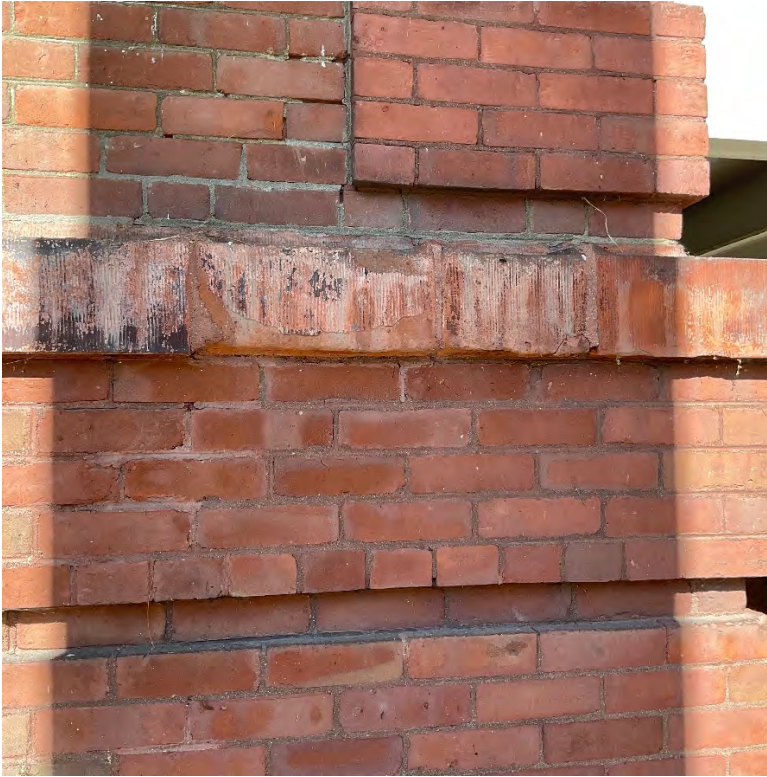
Figure 17. Deteriorated terra cotta water table: tooled face shows water staining and soiling, with outer layer delamination. Once the outer layer delaminates, stone is subject to moisture infiltration.

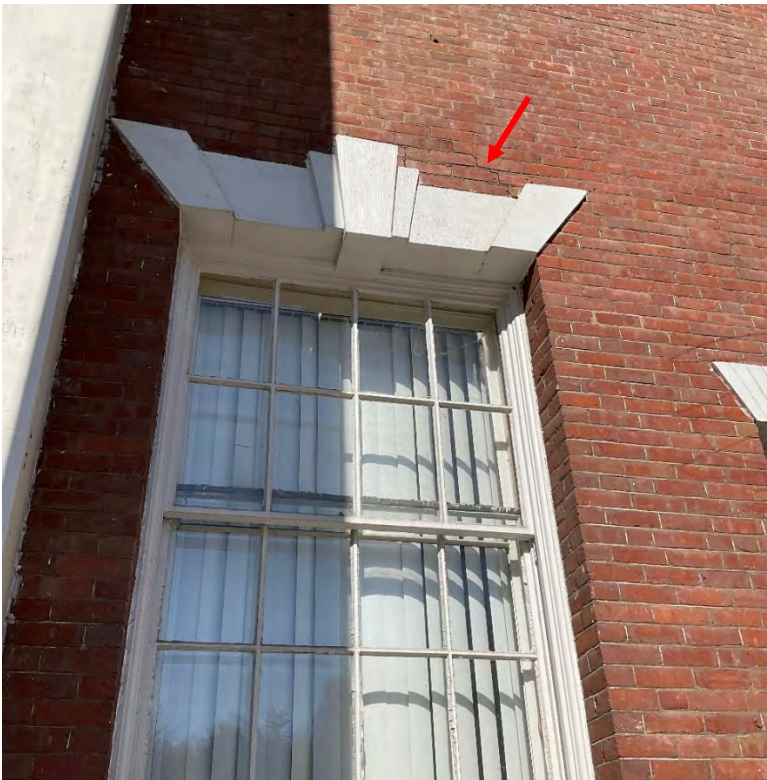
Figure 18. Step crack above 1st floor front window (west of entry) in typical crack arching shape.

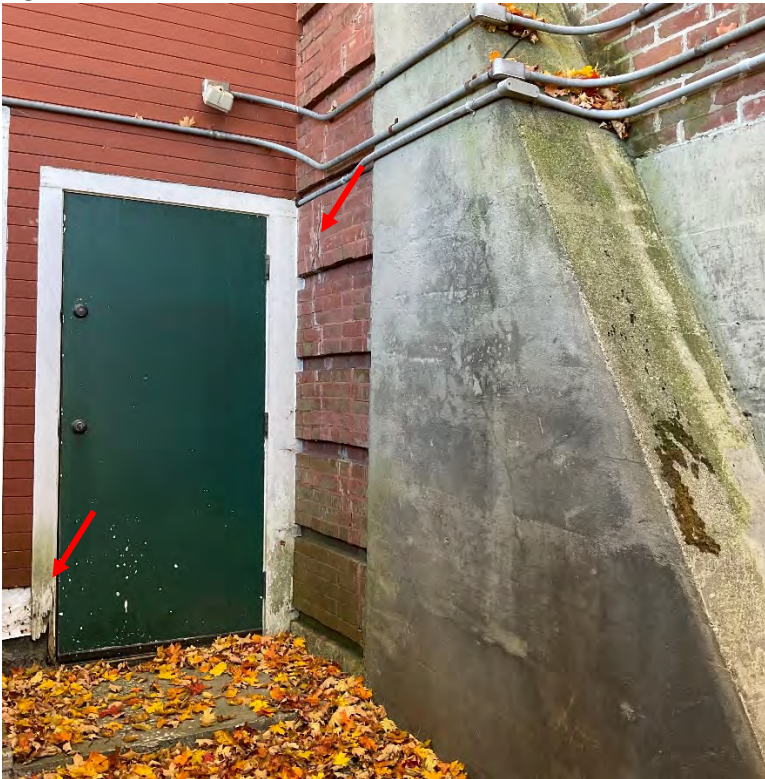
Figure 20. Stair tower and original building intersection. Cracked brick and step crack at south of buttress, though previously repointed, is currently open. This was reported as open between 1/8" and 5/16" by STS in the 2019 report. Also note rotted wood trim elements at addition.

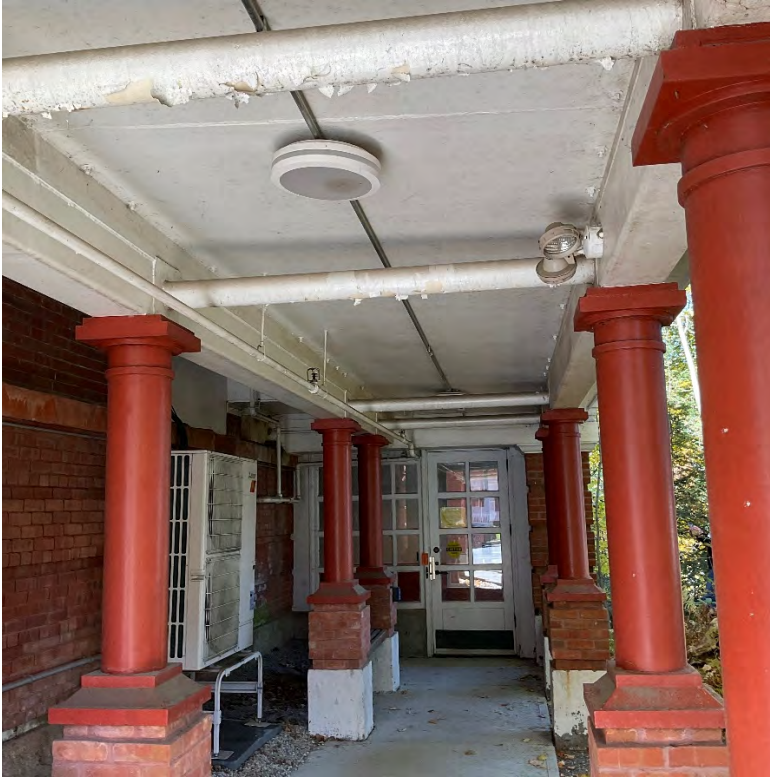
Figure 21. Breezeway approach to accessible entrance from the south. Outside A/C unit and pipes are unsightly; paint loss and soiling detract from appearance.

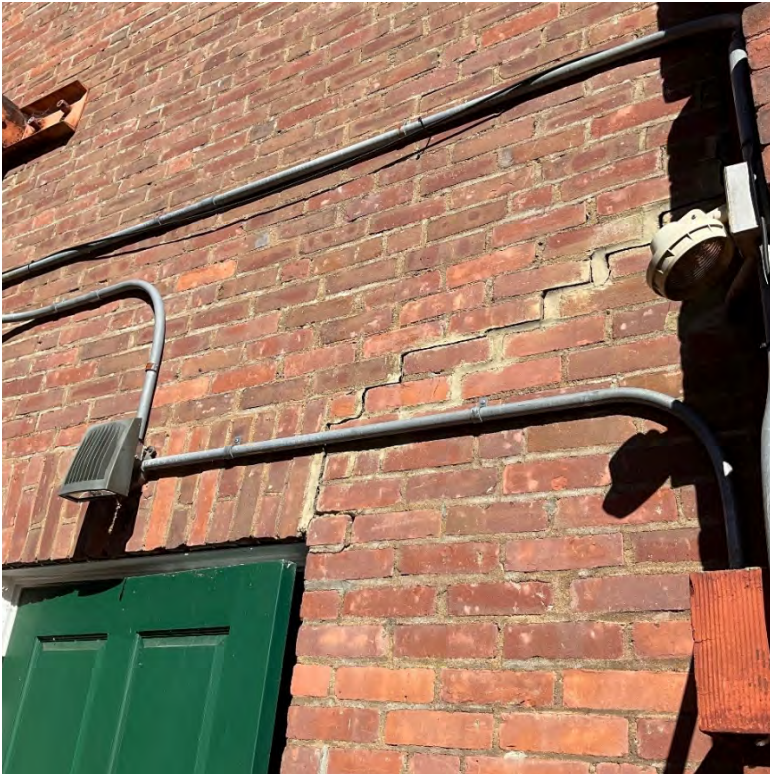
Figure 22. Step crack on west side above stage door.

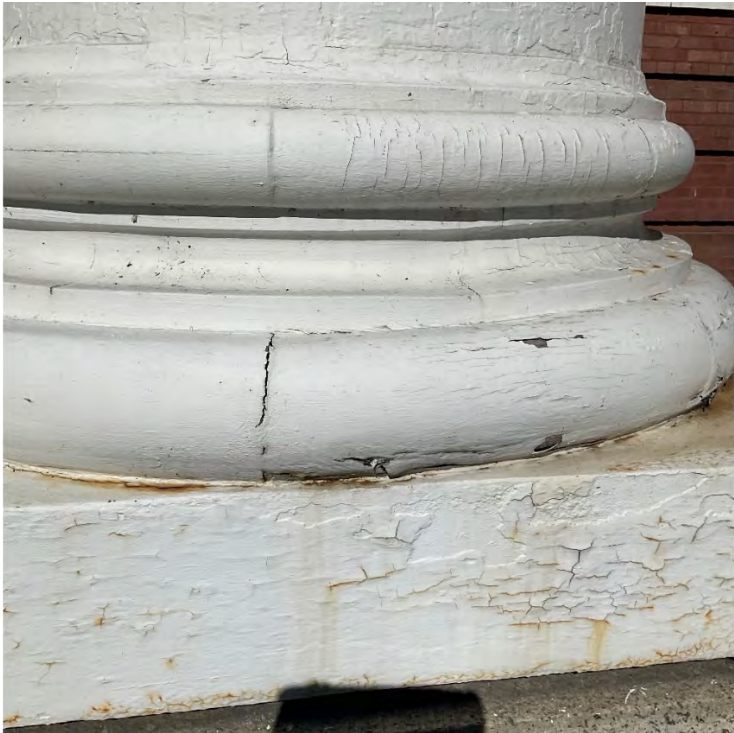
Figure 30. Detail of column base with wood crack and rust staining at metal box base.

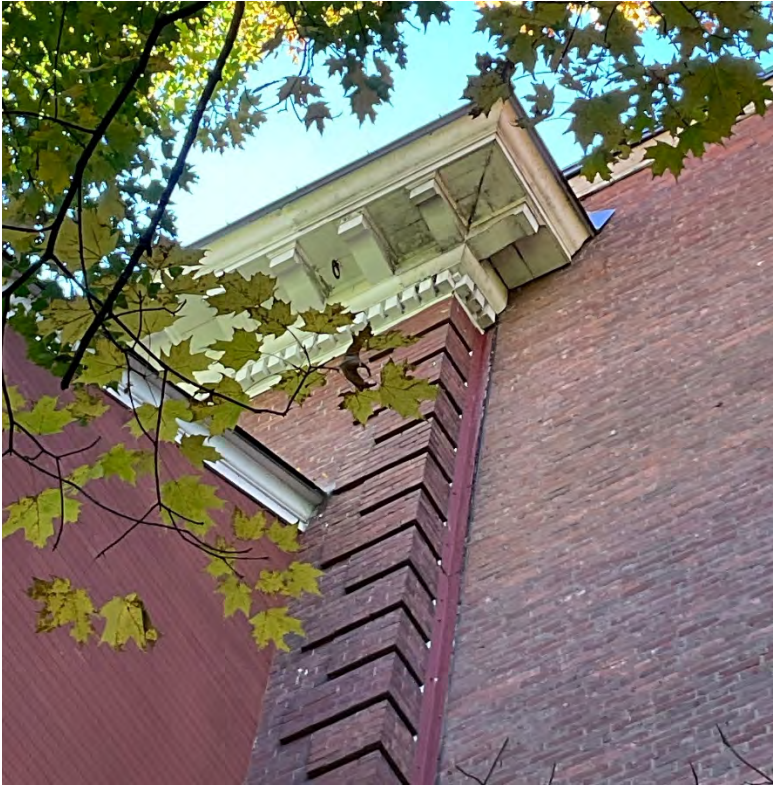
Figure 31. Rotted wood and open joints at underside of cornice, northeast side.

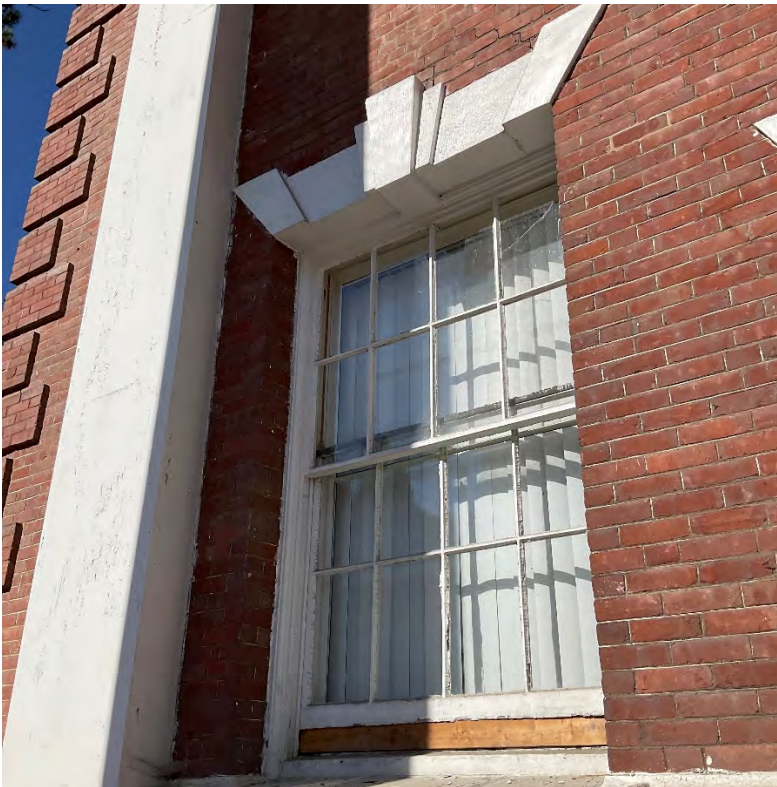
Figure 34. 1st floor window at front elevation with 8-over-8 lites. Glazing putty is cracked and deteriorated; top right pane is broken; bottom sash does not close; storm window at interior.

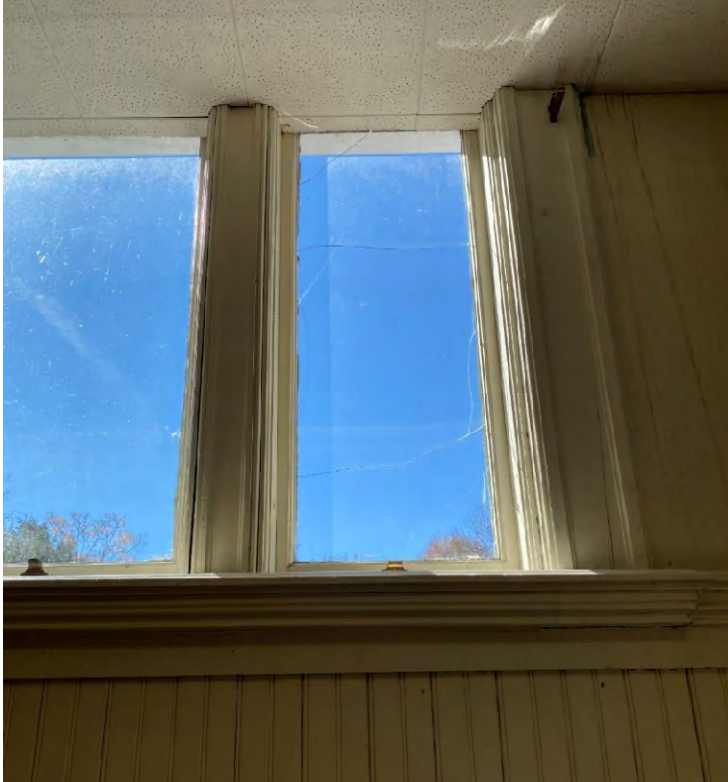
Figure 35. 2nd floor office window with dropped ceiling, cracked glazing. Note: no interior storm.

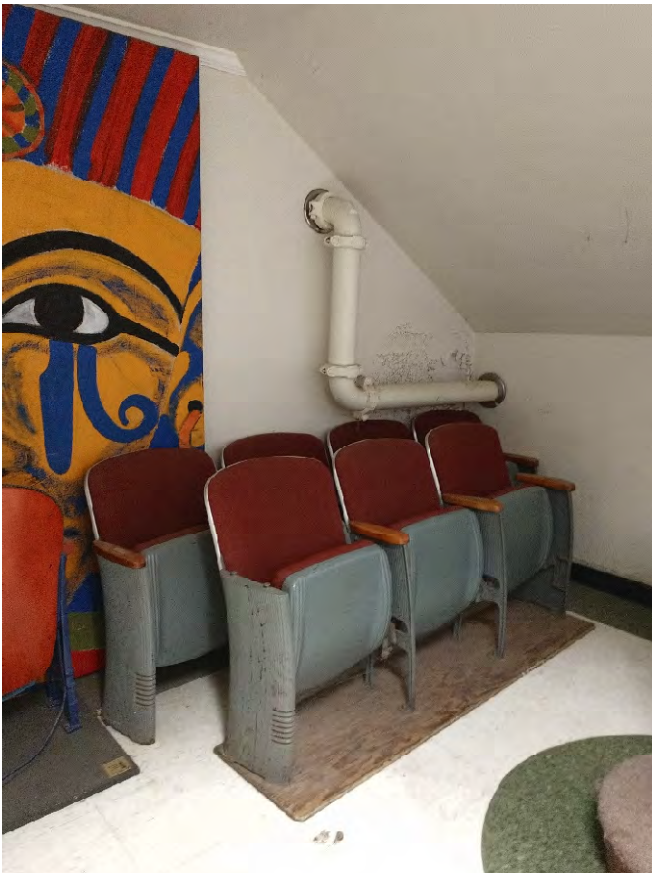
Figure 17. Stairhall at basement level: paint loss/peeling at wall behind pipe. Storage in egress stair area.

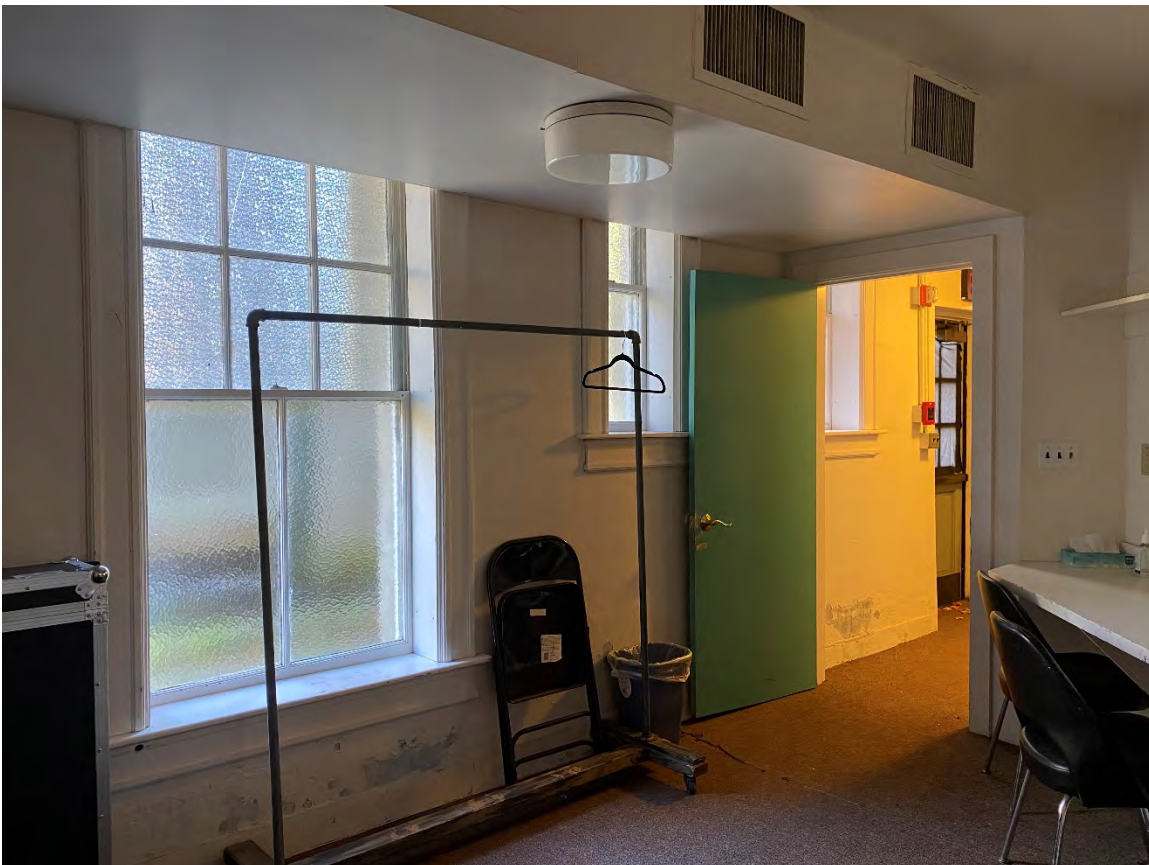
Figure 21. Basement, dressing room: areas of paint loss at base of north wall.

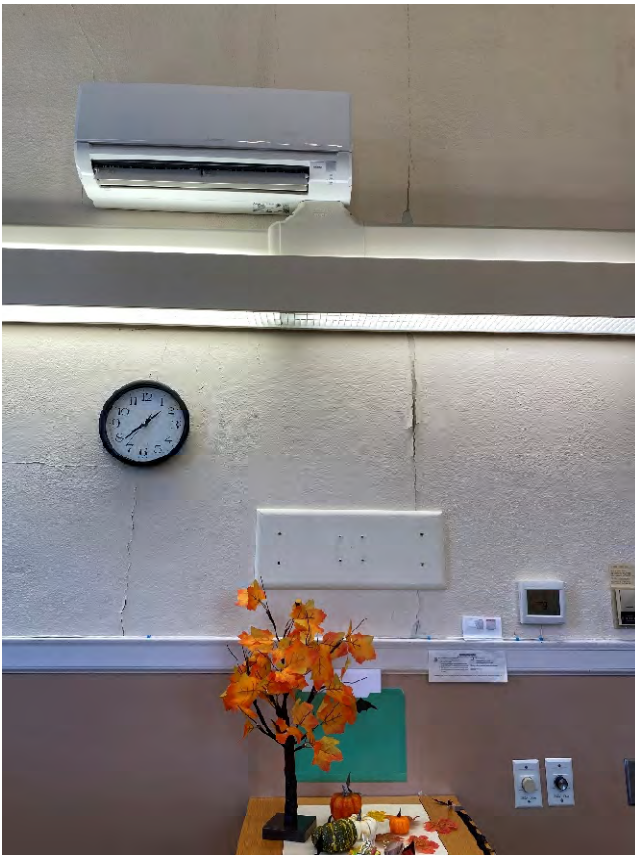
Figure 33. Second floor, south office: large vertical crack in plaster wall.

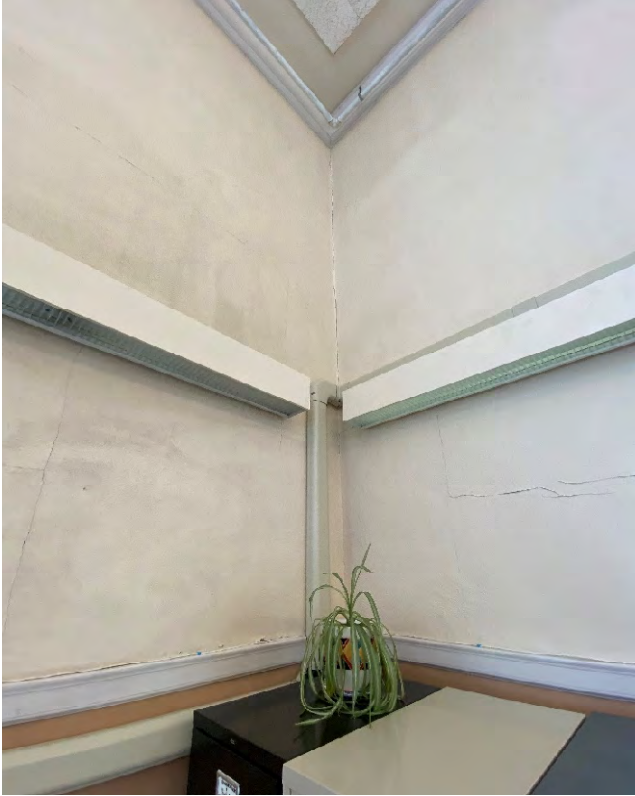
Figure 34. Second floor, south office: cracks in plaster wall at northwest corner.

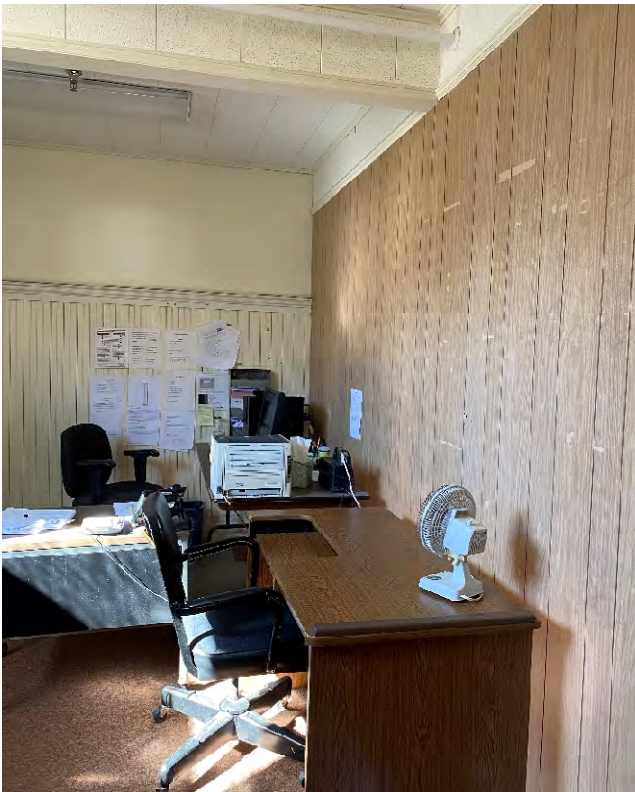
Figure 35. Second floor, northwest office (Listers Office): scrapes on wood paneling.

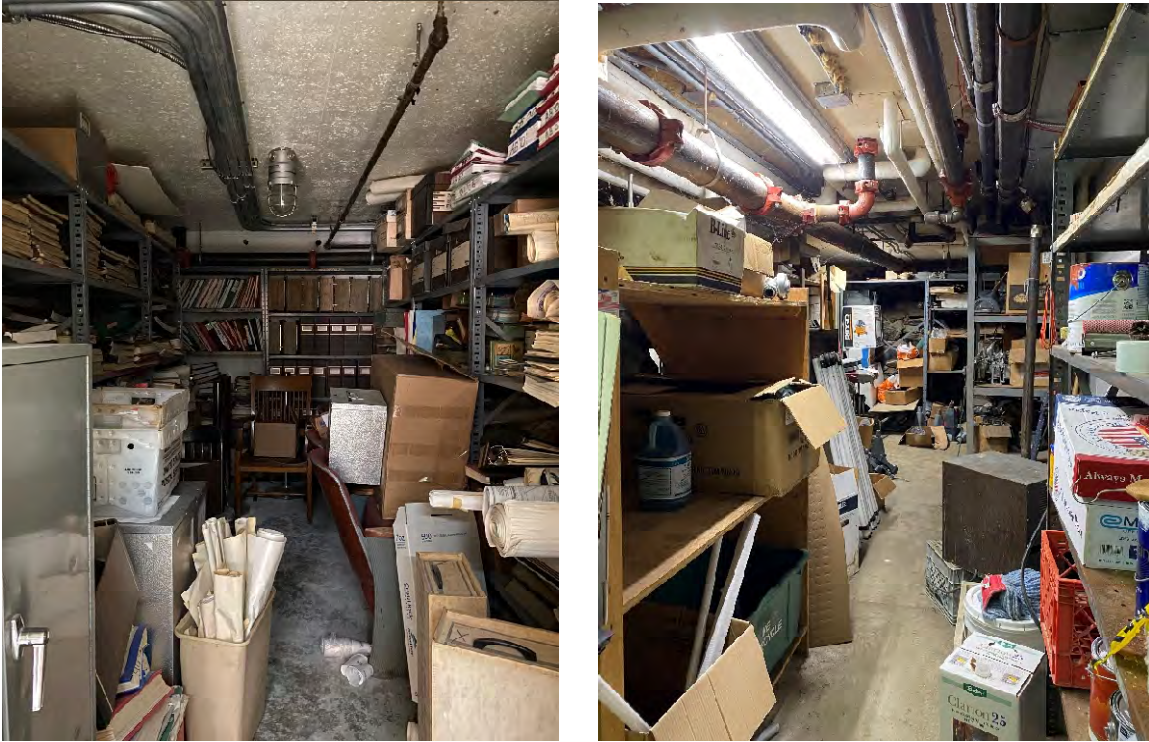
Figure 39. Basement, storage closet: staining in floor from moisture.

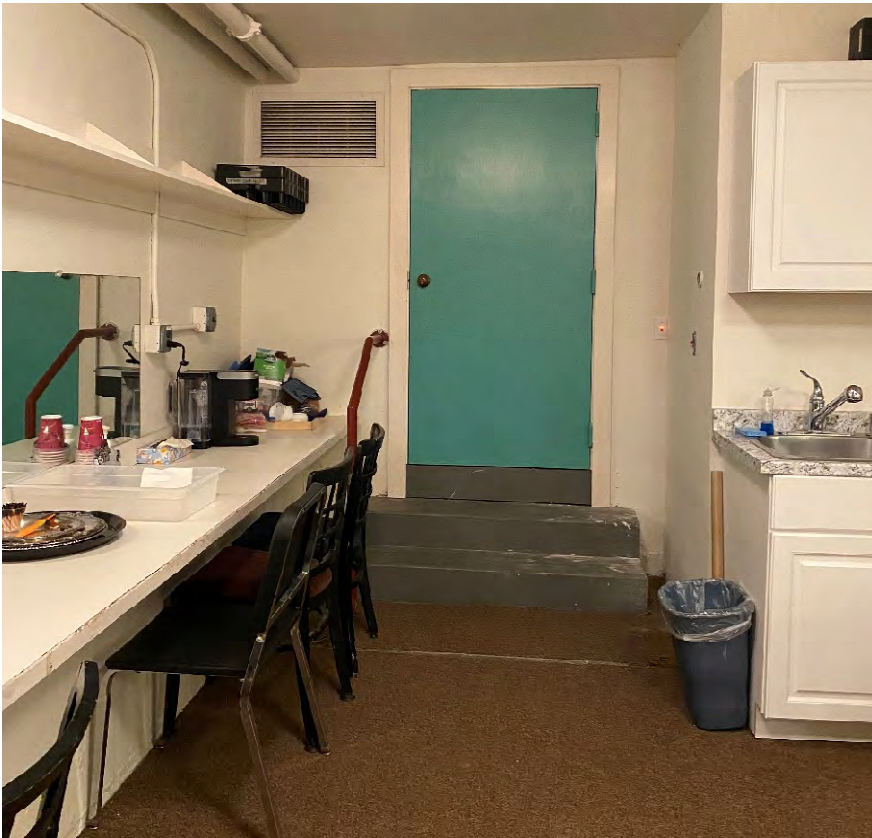
Figure 40. Basement, dressing room: open seam in carpet; stair treads are worn.

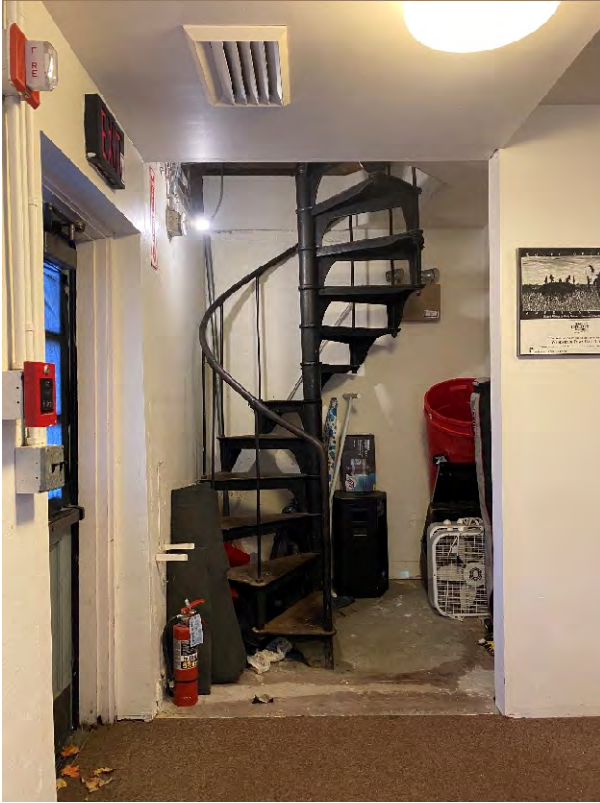
Figure 41. Basement, spiral stair at northeast corner: moisture staining at concrete floor. Storage in egress stair area is a hazard.

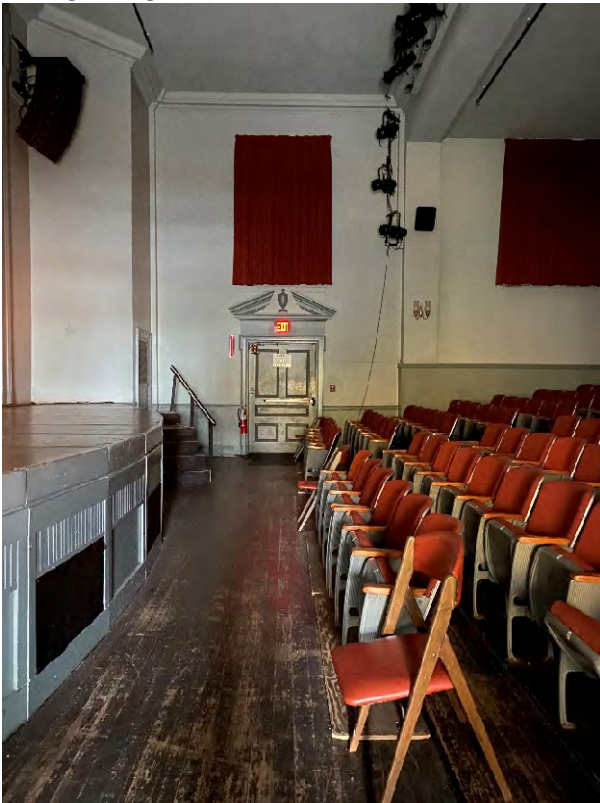
Figure 42. First floor auditorium: original 1927 wood floor is worn.

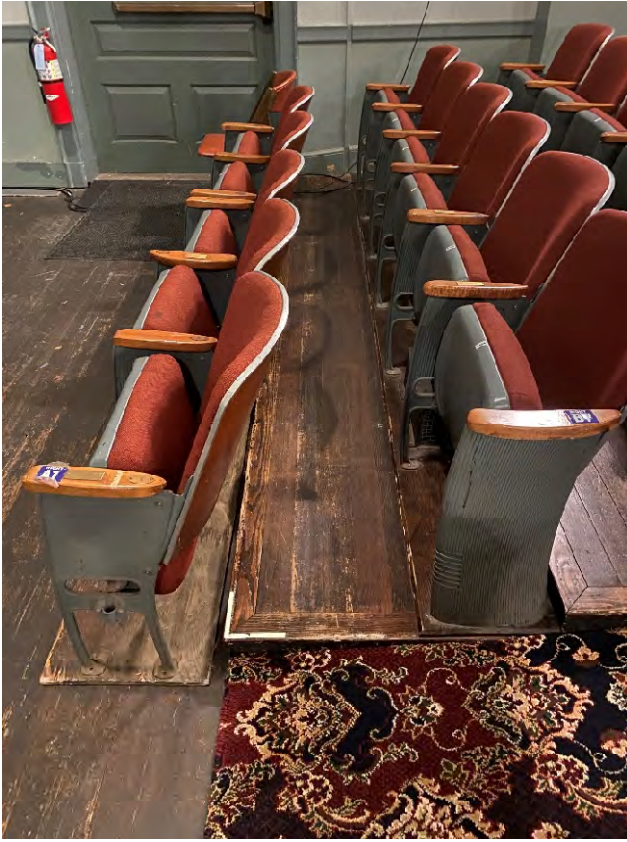
Figure 43. First floor auditorium: floor is worn, seating is outdated.

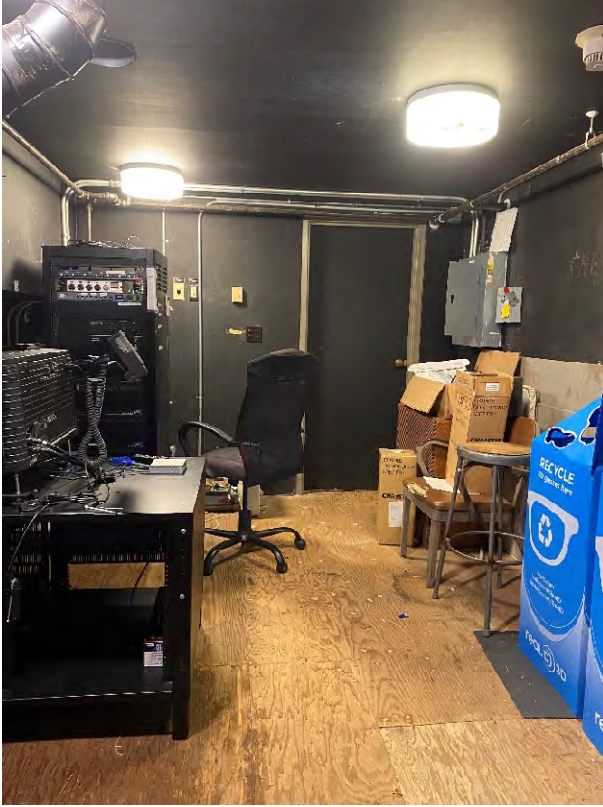
Figure 45. Mezzanine, projection room: patchwork of plywood flooring is worn and showing water staining.

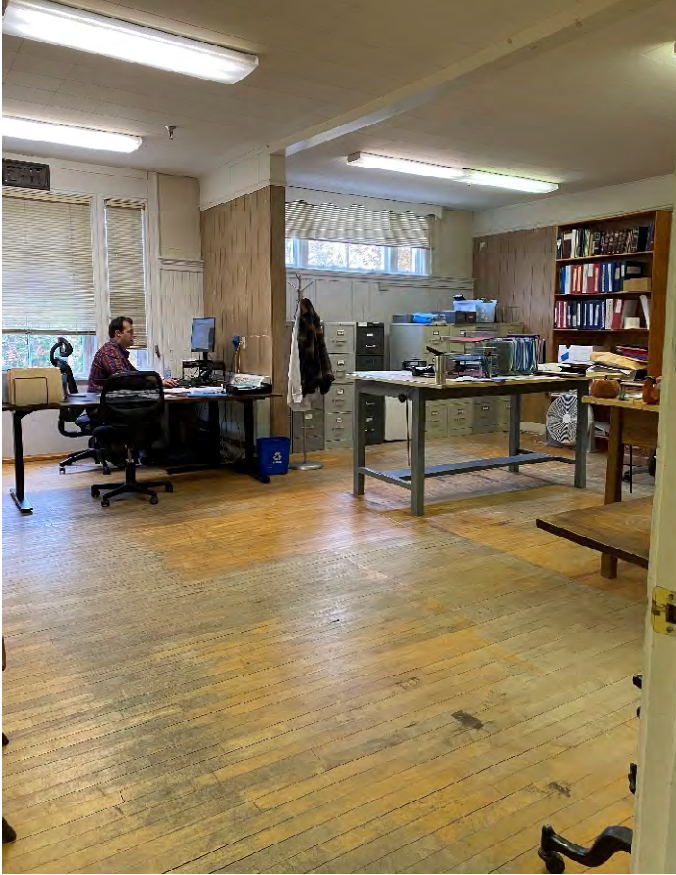
Figure 47. Second floor, offices: wood flooring is worn and stained.

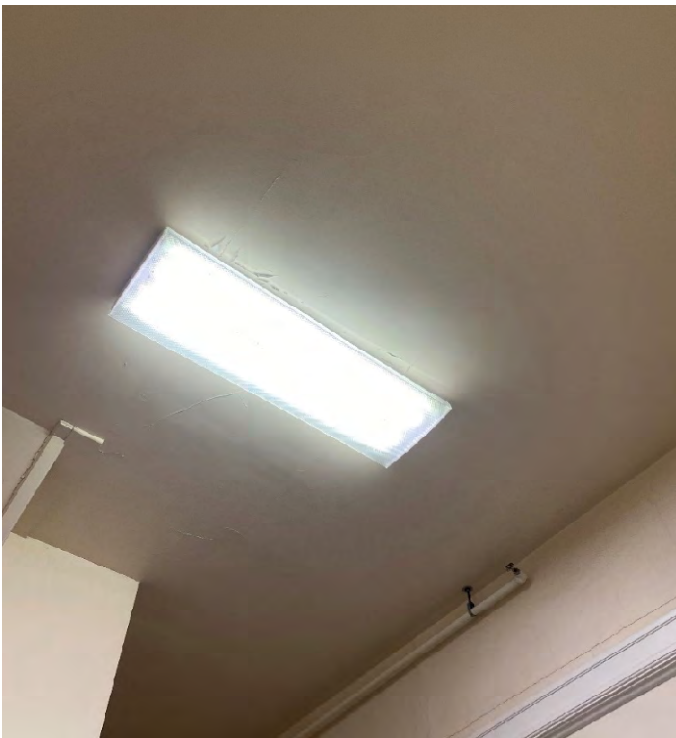
Figure 48. Second floor hallway: minor cracks in ceiling around light.

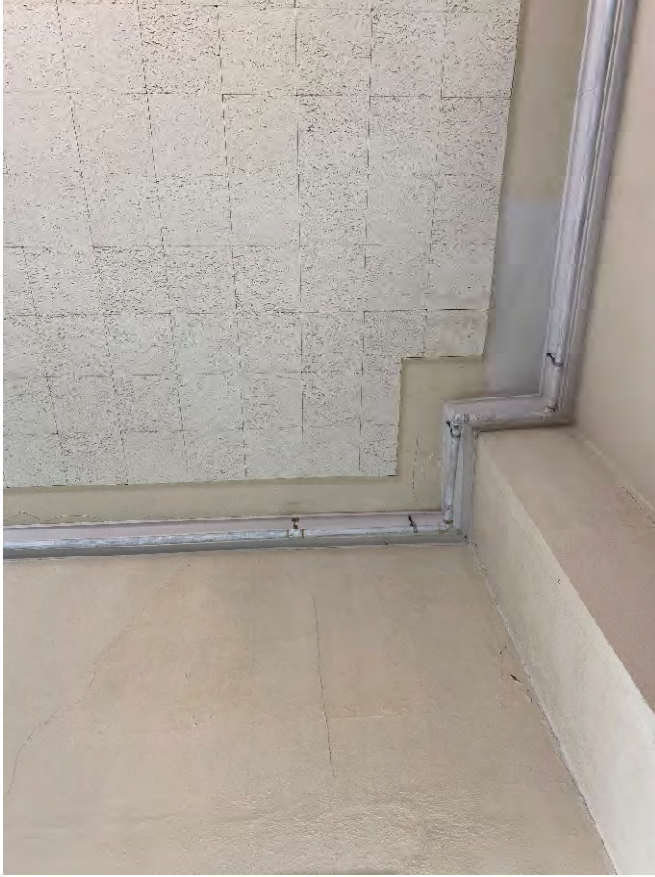
Figure 51. Second floor, south office: water stains in tiled ceiling, cracks in plaster.

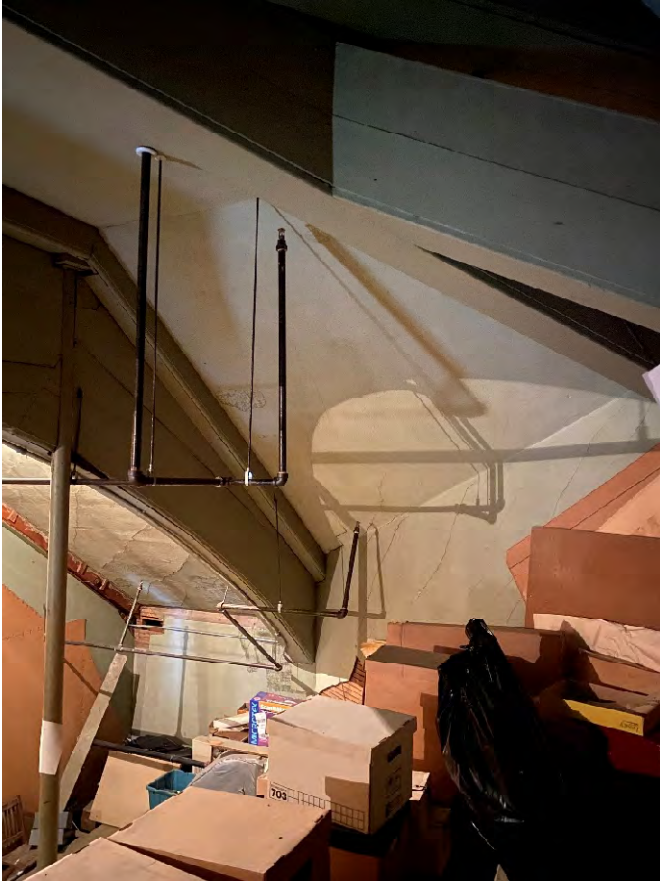
Figure 53. Attic: cracks and water stains in vaulted ceiling.

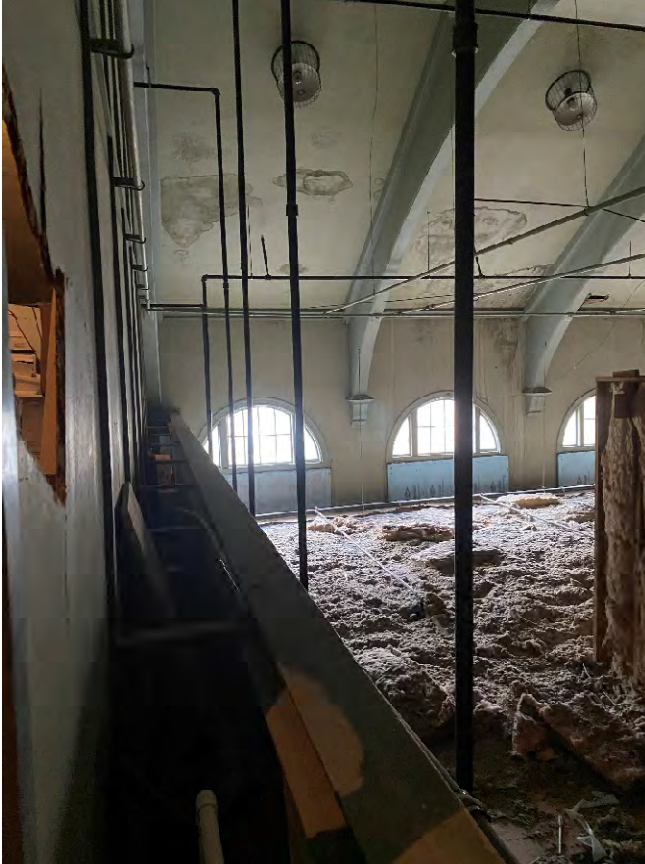
Figure 55. Attic: cracks and large water stains in vaulted ceiling, hole in wall.

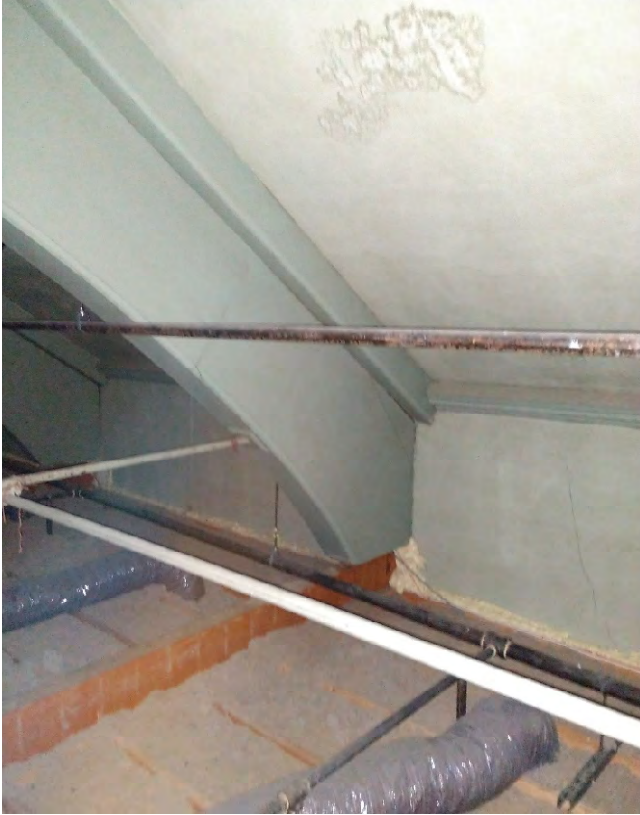
Figure 57. Attic: water stain on plaster ceiling, cracks, deterioration at base.

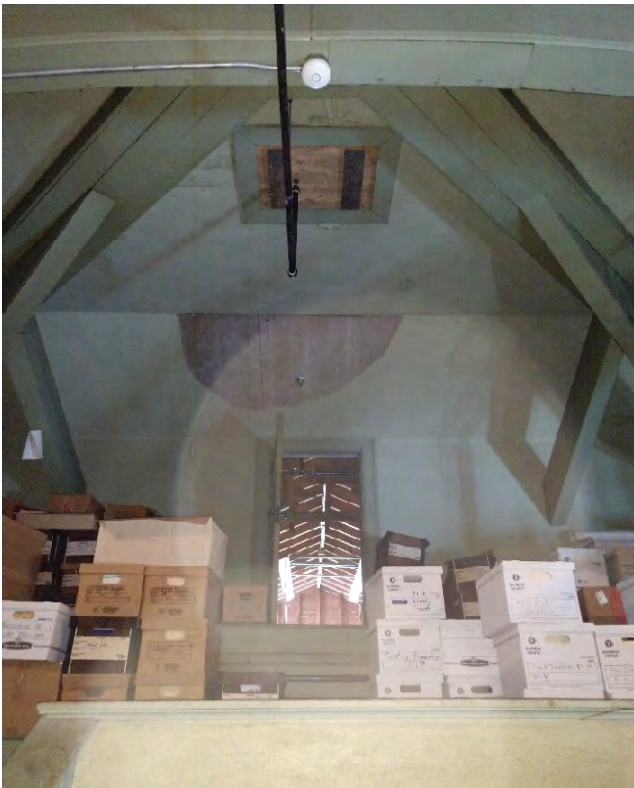
Figure 58. Attic looking south: large area of paint loss in ceiling.

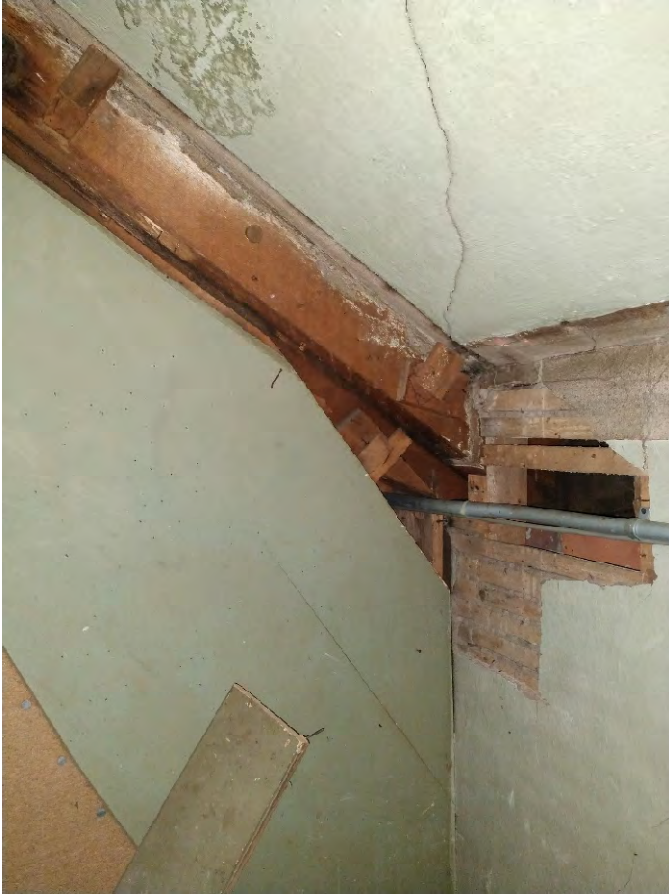
Figure 59. Attic: exposed framing connection, wood deterioration, plaster loss.

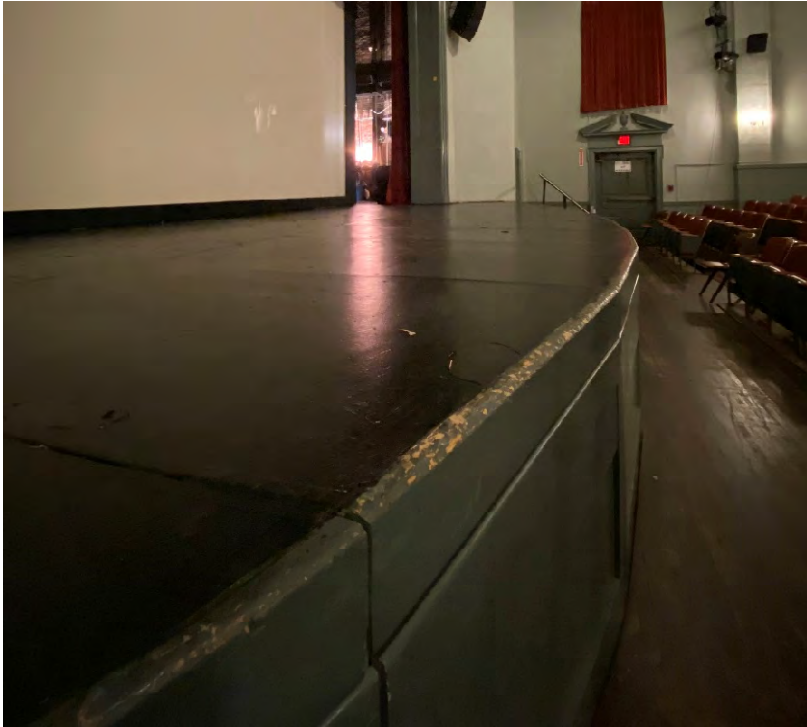
Figure 61. First floor auditorium stage: edge trim has nicks and paint loss.
