Limited Preservation Plan, Woodstock Town Hall Theatre - DRAFT

November 15, 2022

**WOODSTOCK TOWN HALL THEATRE
LIMITED PRESERVATION PLAN**

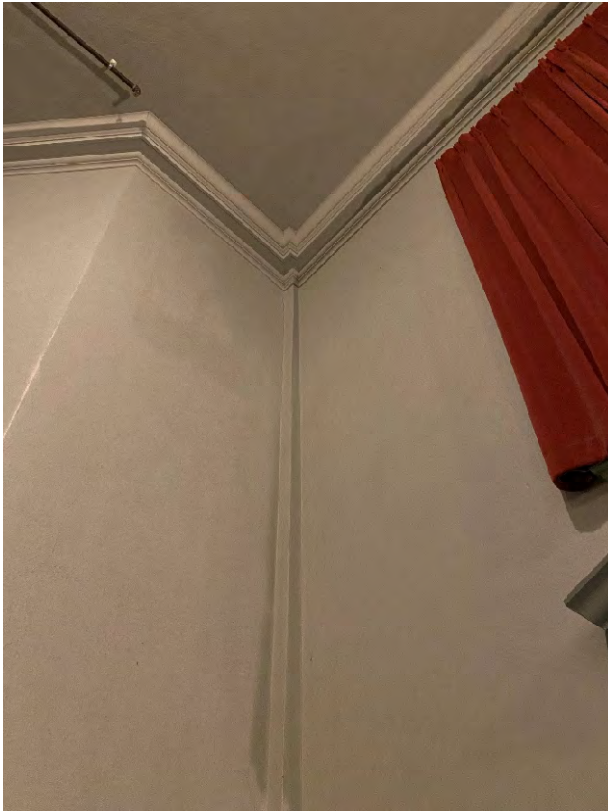
Figure 64. First floor auditorium northeast corner: cornice has water staining.

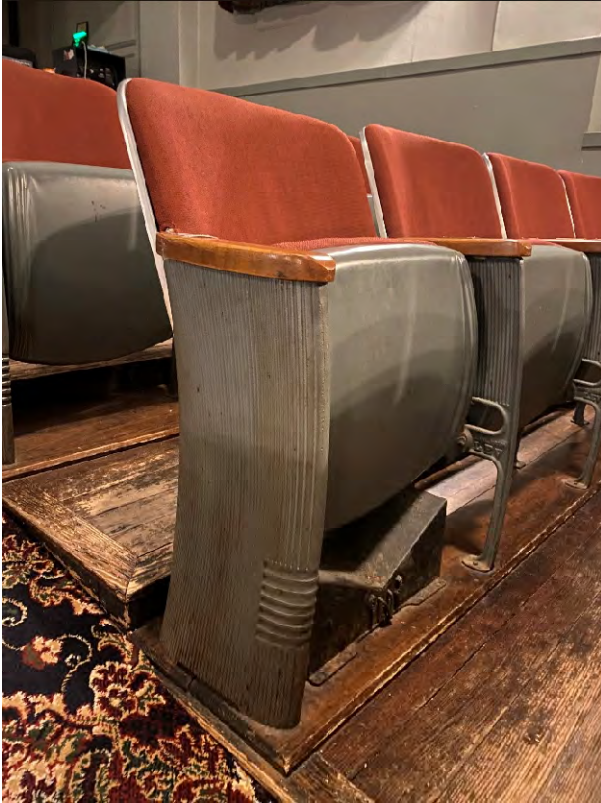
Figure 65. First floor auditorium seating: metal chair assembly shows rust, cushions show staining.

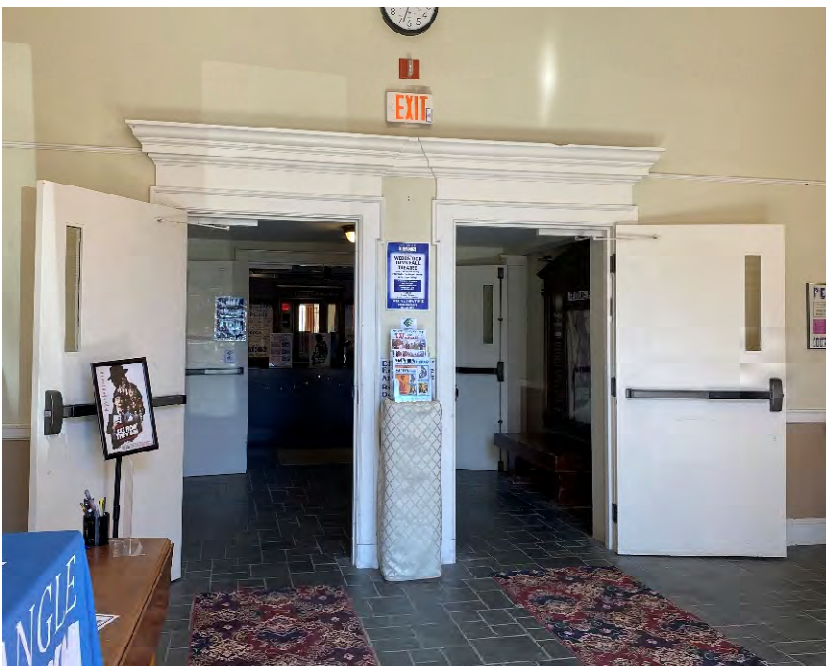
Figure 66. First floor main lobby, north doorways: nick in cornice above east door.

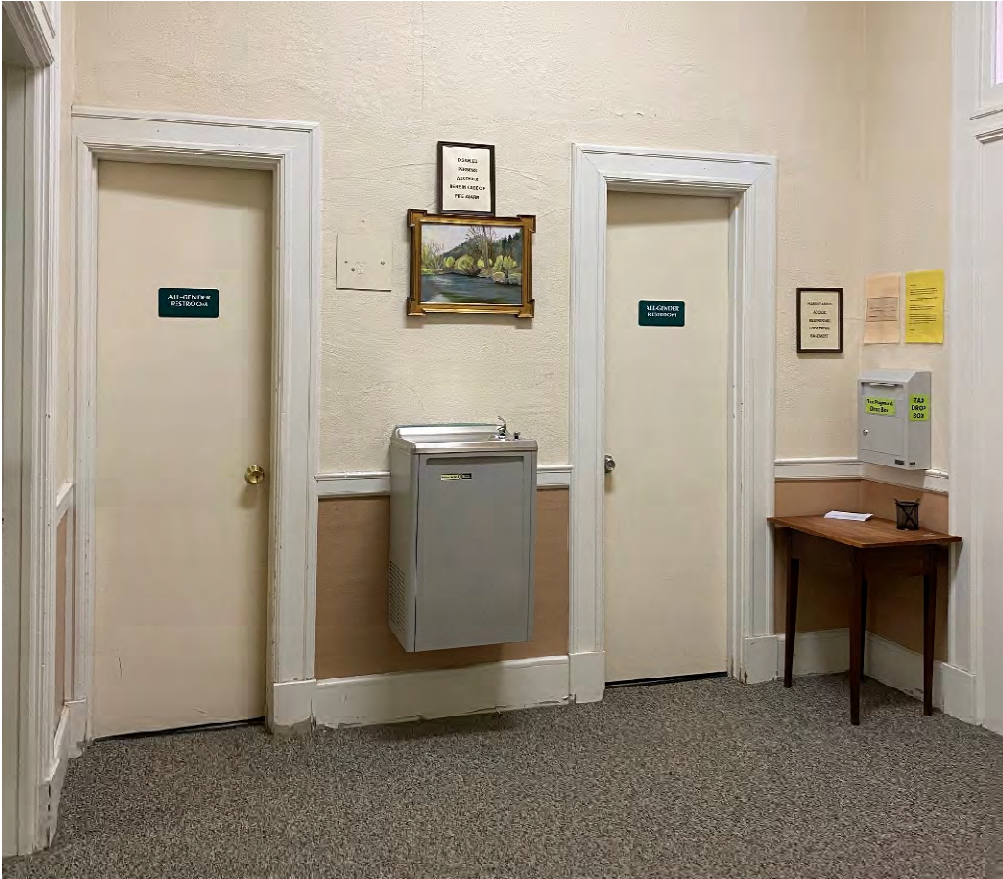
Figure 69. Second floor stairhall looking east to toilet rooms: paint loss and wood deterioration at baseboards.

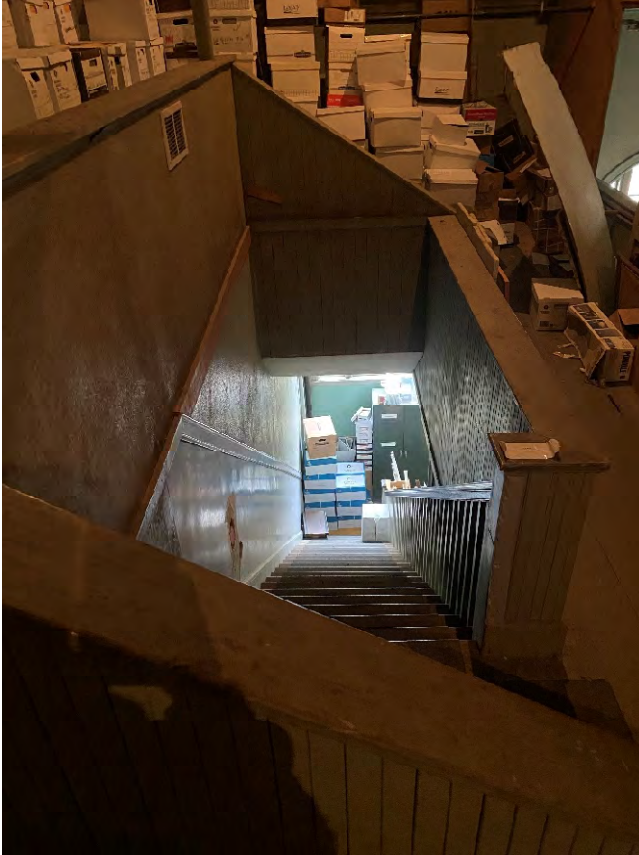
Figure 71. Attic stair: stain on wainscoting, minor wood deterioration and paint loss. Use of this space as a storage area should be reconsidered.

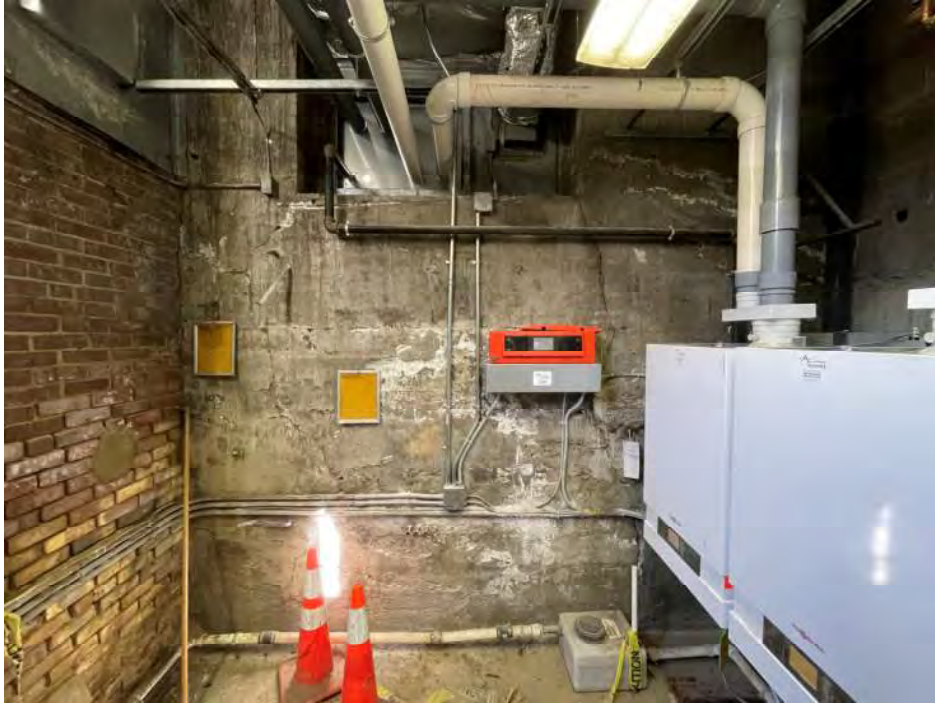
Photo 5: Interior face of north mechanical room foundation wall spalling.

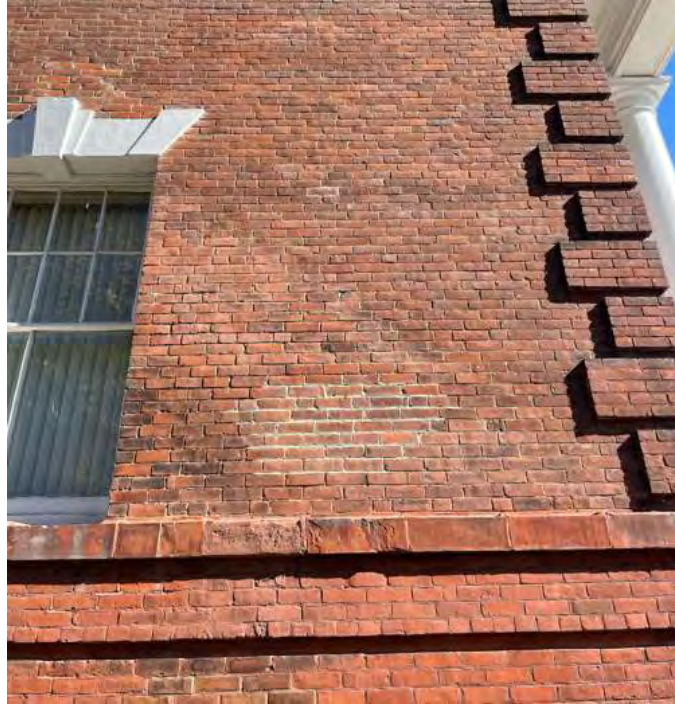
Photo 8: Southwest corner- example of mismatched mortar repair

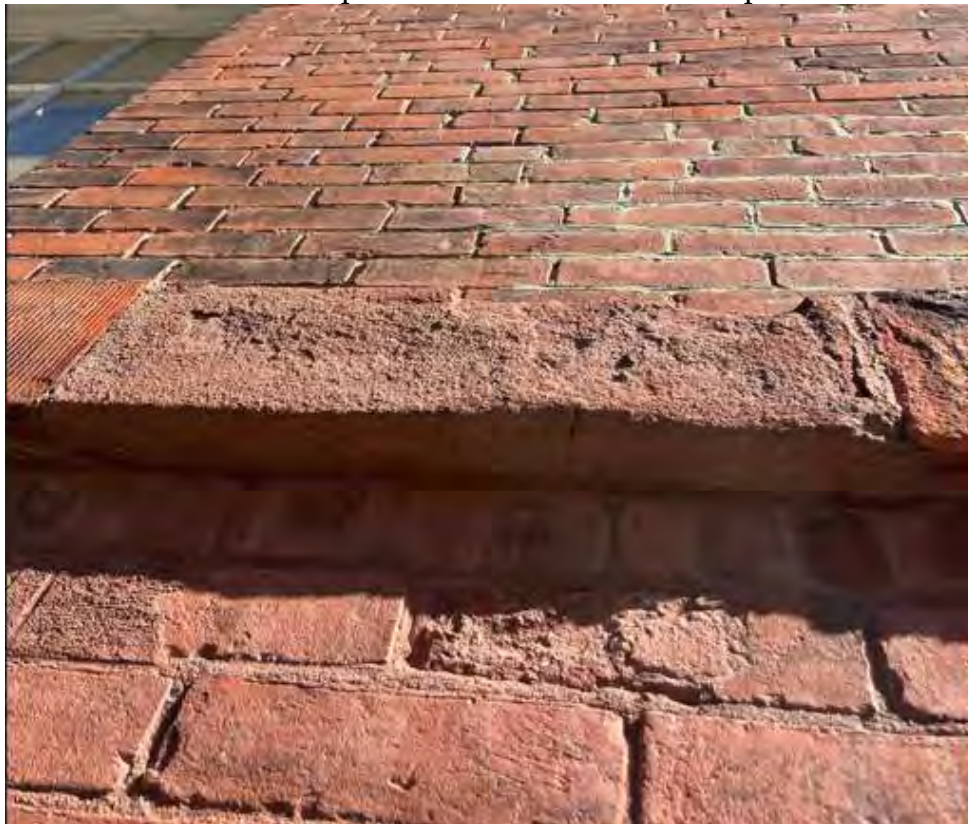
Photo 9: Patched terra-cotta water table

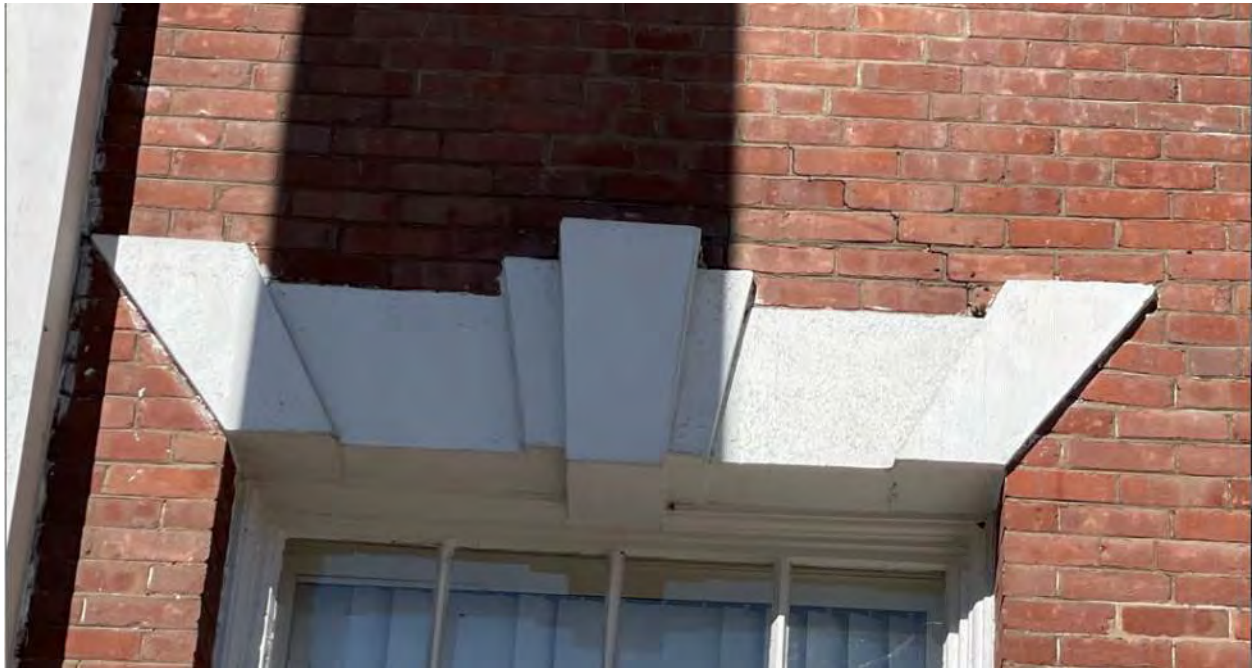
Photo 10: Migrating cracking at mortar joint above window at front elevation

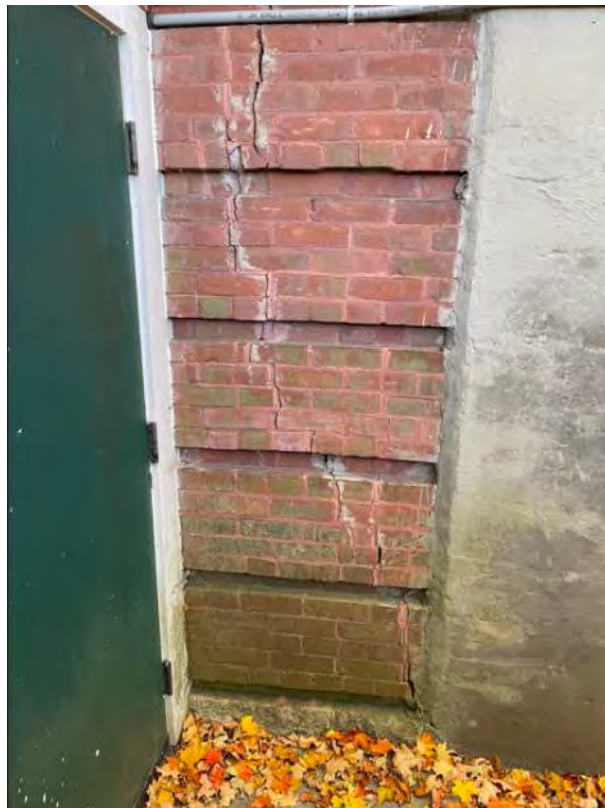
Photo 11: Crack at the northeast corner

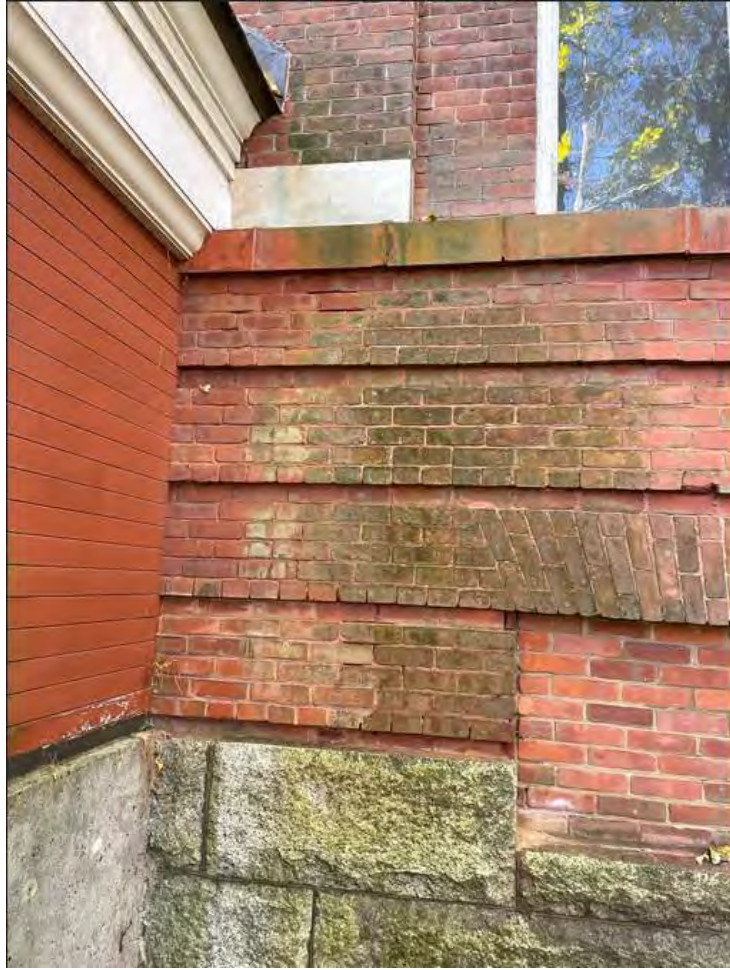
Photo 14: Organic growth on brick surface

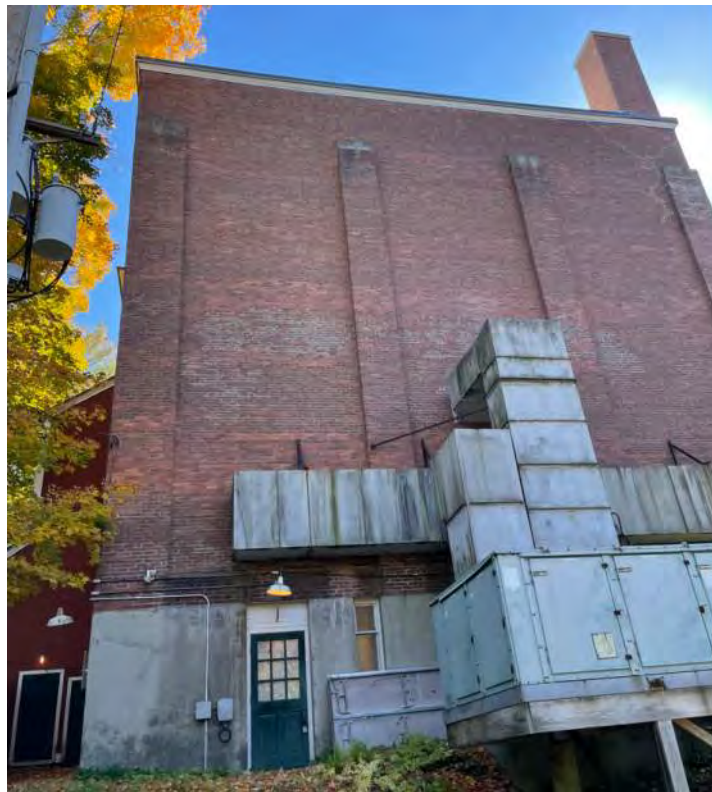
Photo 16: Environmental staining on pilaster caps and brick

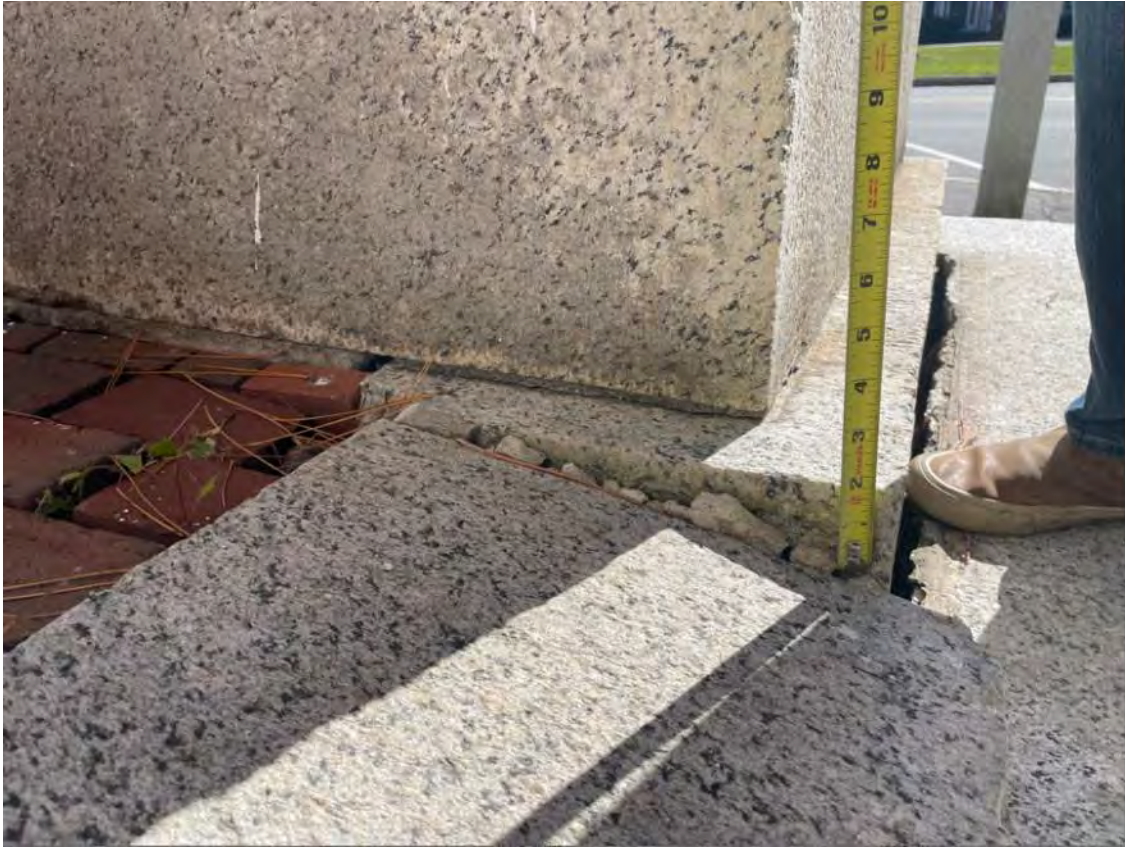
Photo 17: Settled or heaved granite steps and brick pavers at portico entrance

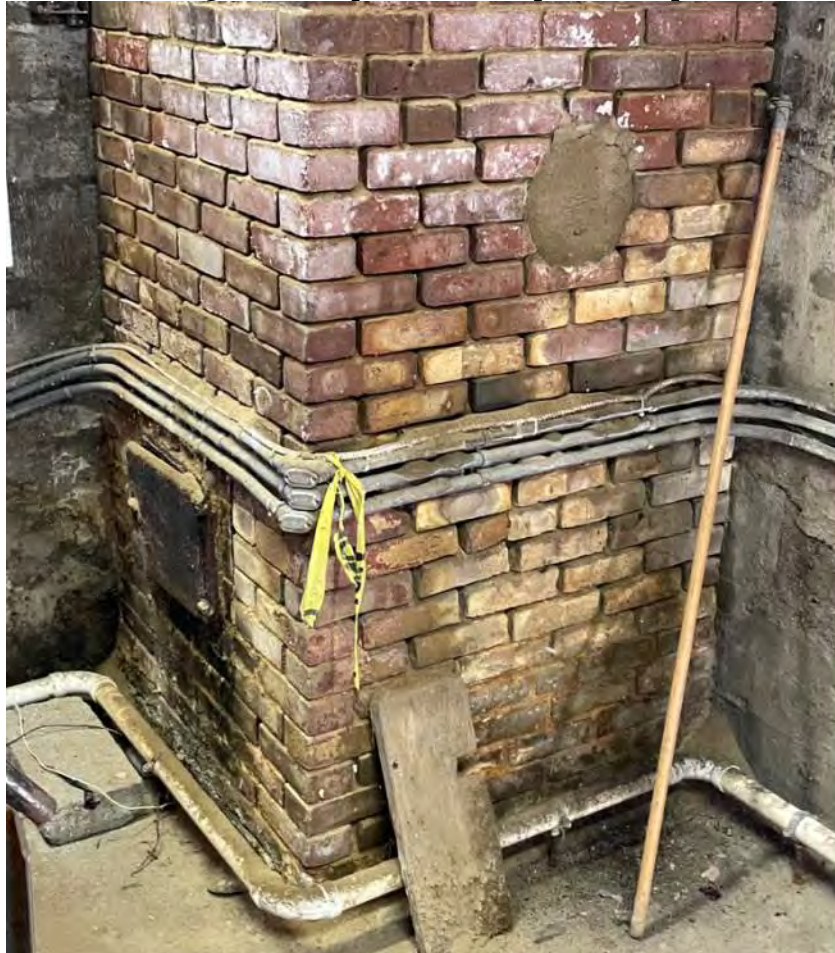
Photo 19: Deteriorated mortar joint at boiler room chimney

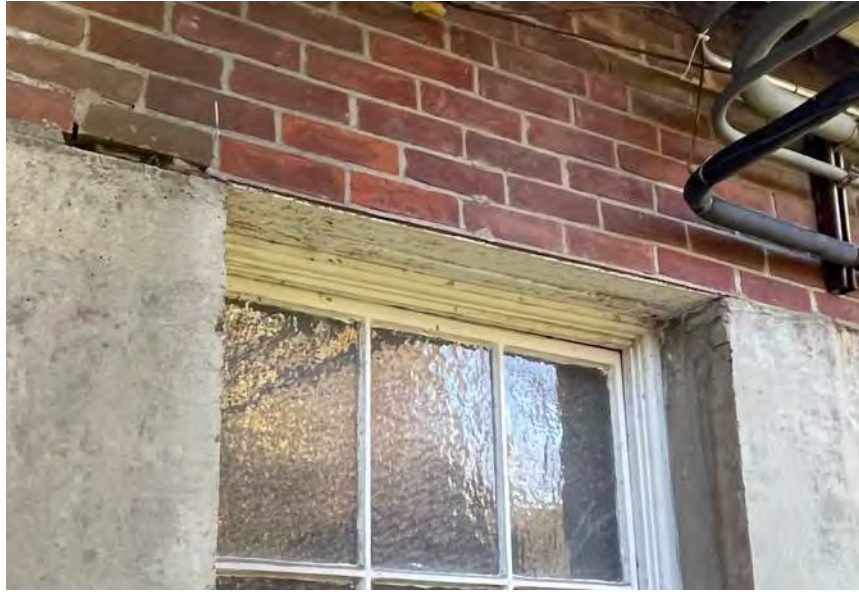
Photo 20: Rusty steel lintels along the rear elevation

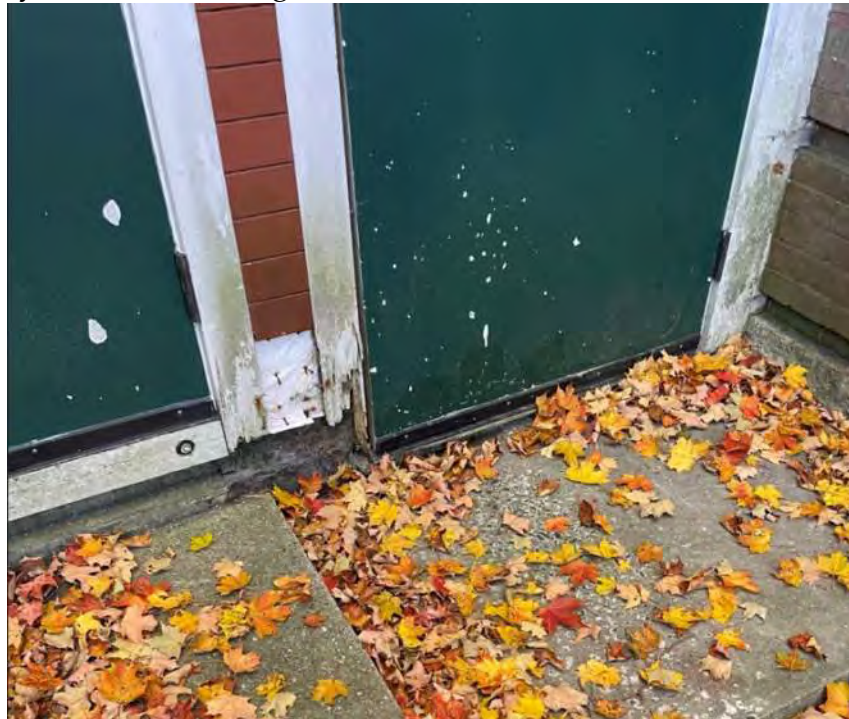
Photo 21: Rotted wood trim at the east stairway structure
