Limited Preservation Plan, Woodstock Town Hall Theatre - DRAFT

November 15, 2022

**WOODSTOCK TOWN HALL THEATRE
LIMITED PRESERVATION PLAN**

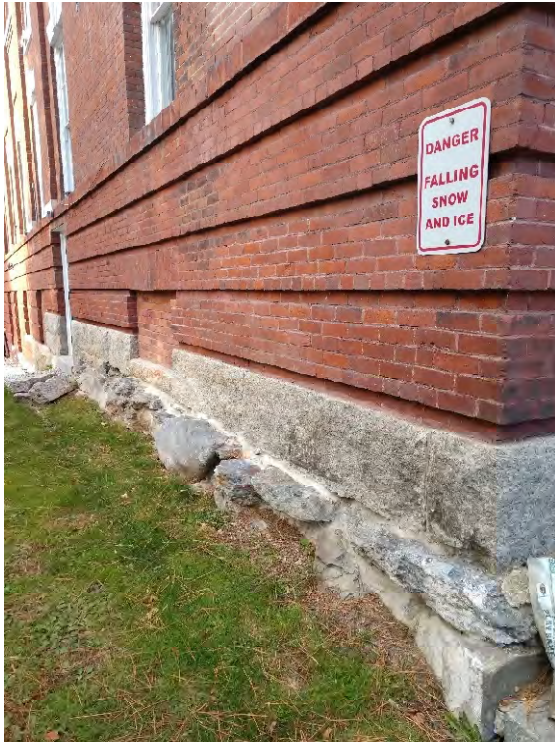
Figure 5. (Left) Southwest corner: rubble stone above grade has not been encased in concrete. Figure 6. (Right) The foundation of the rear wall of original building has been stabilized with concrete, as seen in the boiler room.

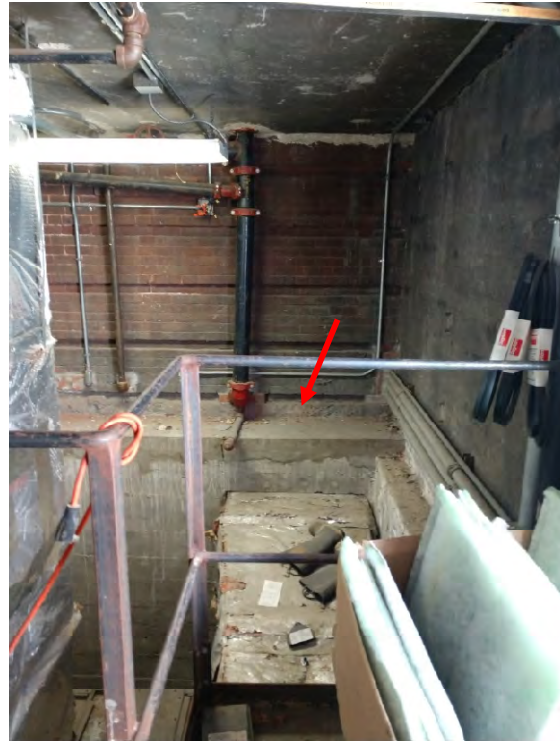
The interior northern wall of the 1927 addition has significant cracking and spalls in the concrete at both sides of a low opening used for mechanical penetrations. Snow buildup and moisture penetrate the grille and are causing long term deterioration of the foundation wall, though this does not pose an immediate risk.

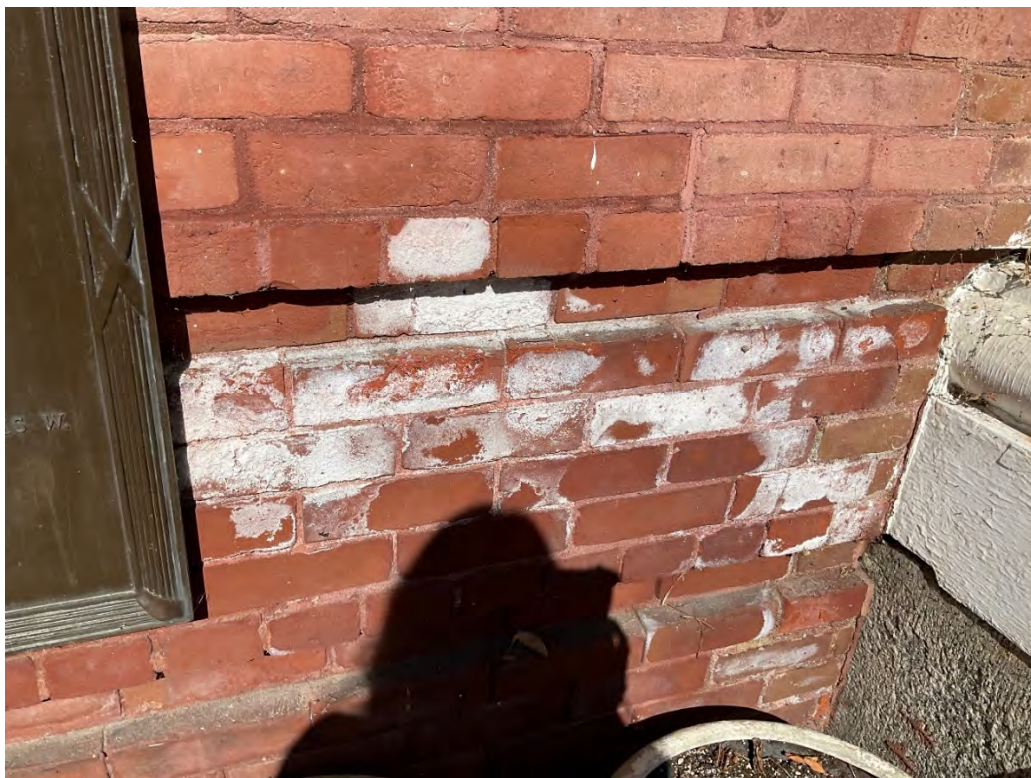
Figure 8. Efflorescence at porch can also be seen at east wall near breezeway; west wall at path.

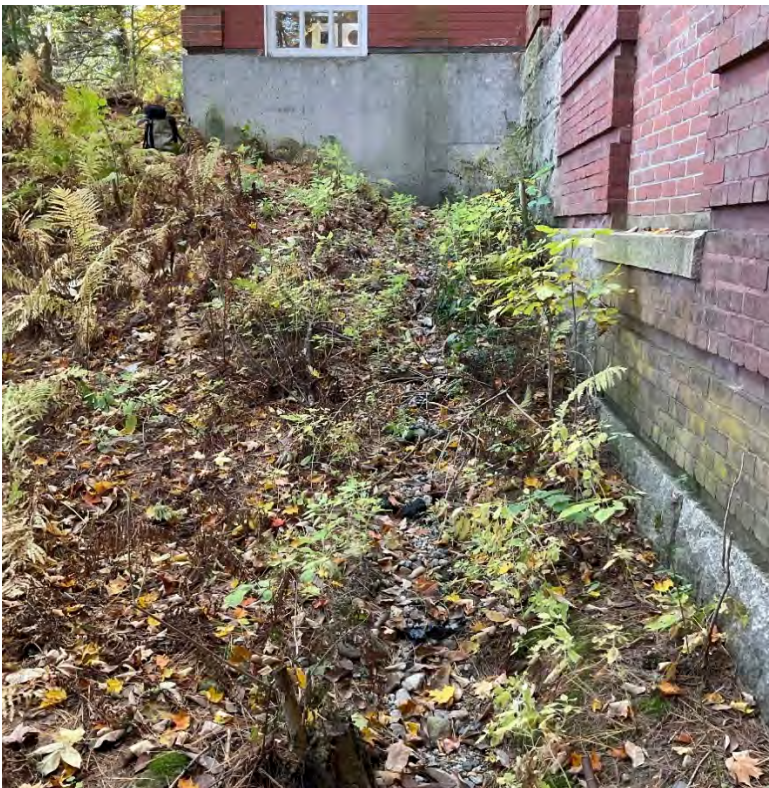
Organic growth on the stone, brick, and concrete also causes long term deterioration. The east side of the building exhibits the most biological growth and requires regular maintenance of ground plants and leaves from the trees.

Figure 13. Looking south at the accessible entrance addition. Note organic growth at the east wall and grade slopes towards the building (a small gully helps drain to the north).

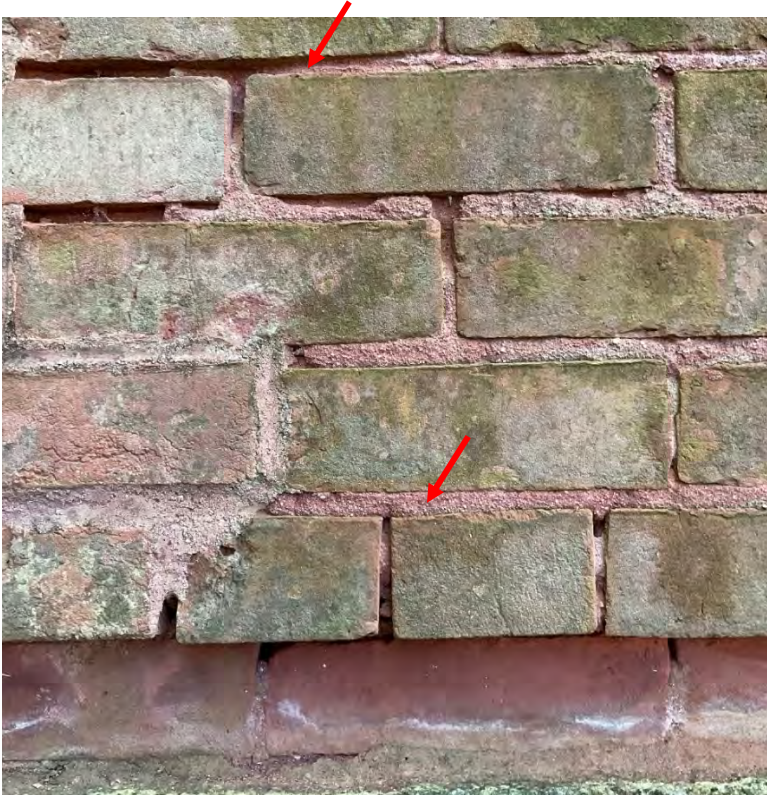
Figure 15. Reddish mortar color at east side believed to be historic. Mortar at left is an inappropriate repointing mix.

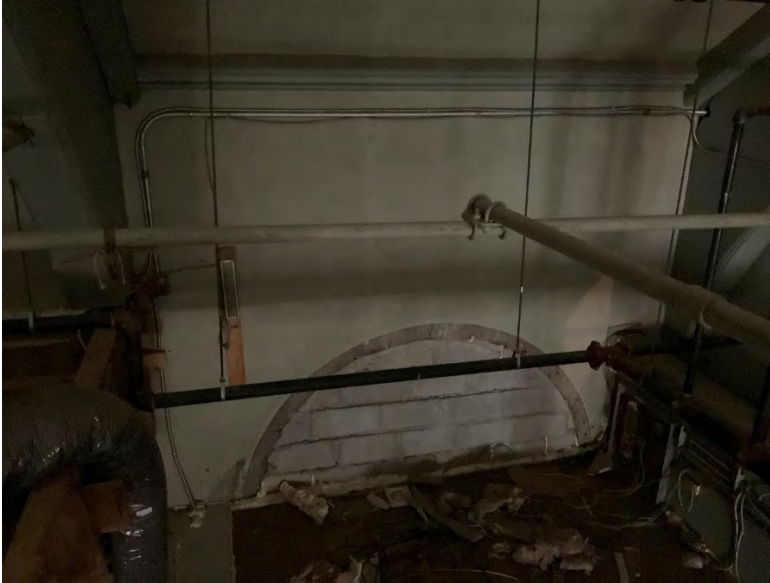
Figure 23. CMU infill with elevator shaft ceiling below.

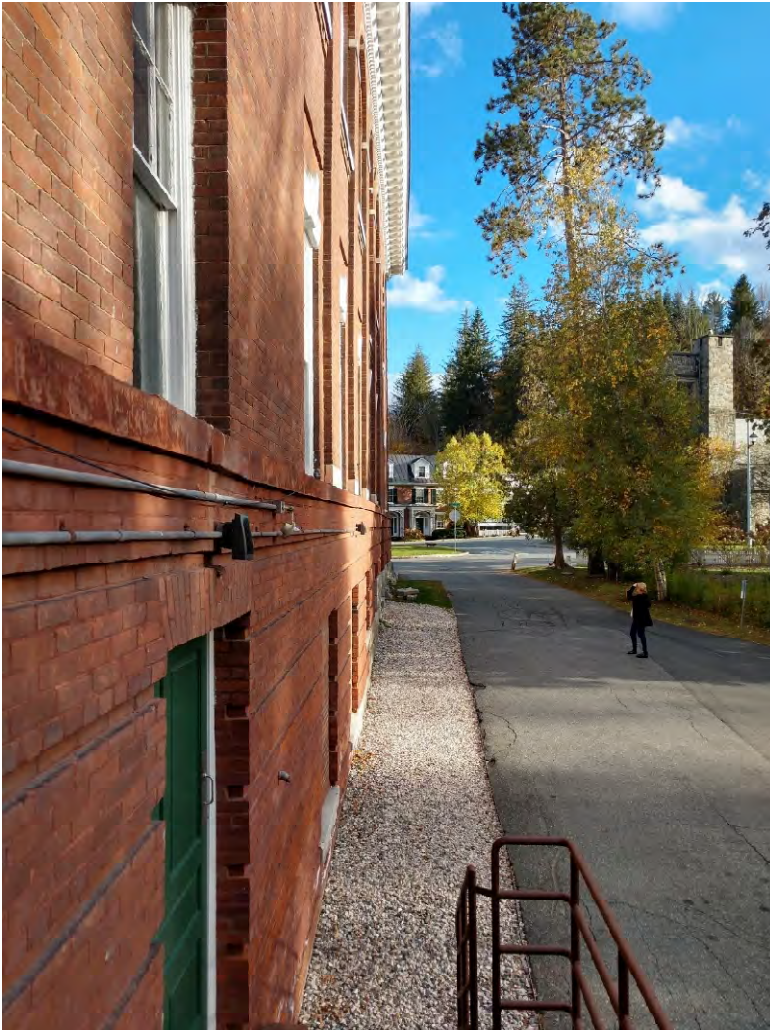
Figure 24. View of the west side looking south. The cornice bows outward slightly in the area corresponding to the interior stair.

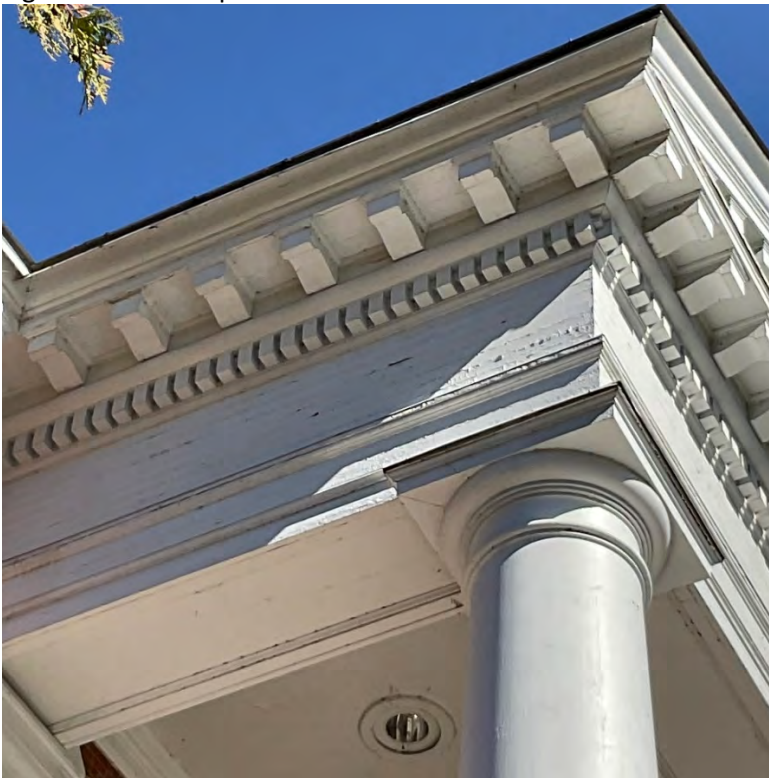
The entablature and pediment were only observed from the ground so a full assessment was not possible. The modillions, dentils, and underside of the soffit appear sound, however an assessment by high reach lift would enable one to test the wood for rot or softness with an awl. The underside of the soffit has a large patch to the west side of the center grille from a recent repair. It is unclear how moisture penetrated the wood; the interior of the pediment space did not smell musty. At the fascia, wood boards have open joints, some are cupped or warped, and paint is peeling.

Figure 26. Portico entablature at west side: open joints and peeling paint are typical.

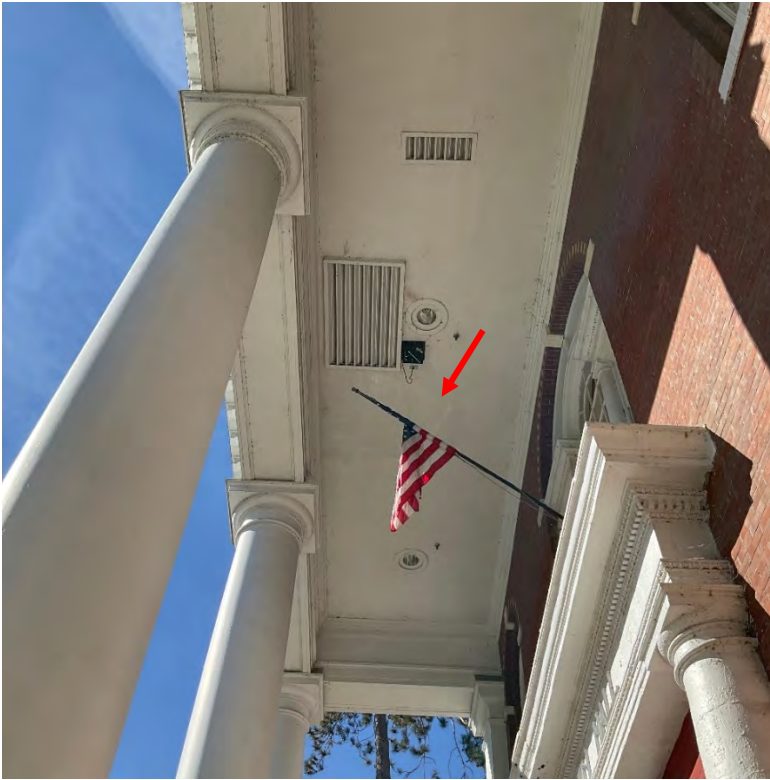
Figure 27. Underside of soffit with patched area denoted by arrow.

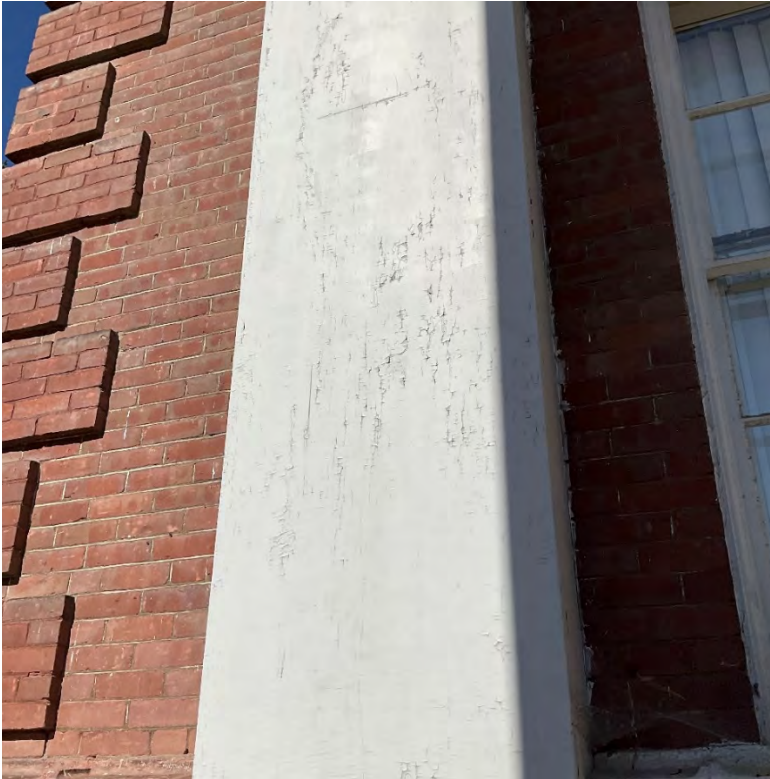
Figure 28. Peeling paint and crazing at portico pilaster.

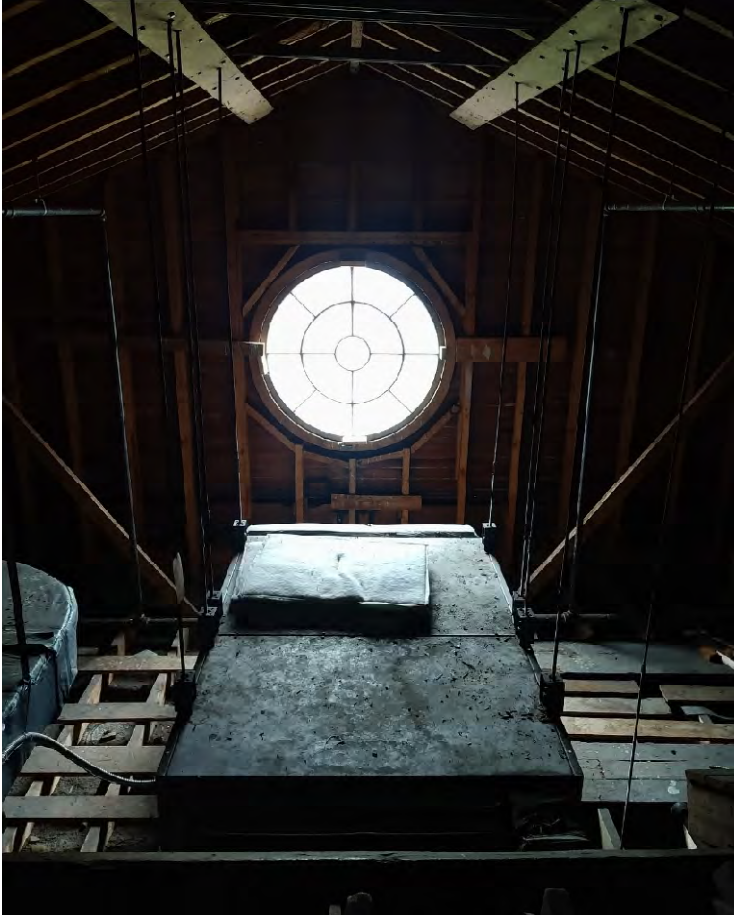
Figure 29. Looking south inside the pediment structure. Note debris, equipment, and ductwork.

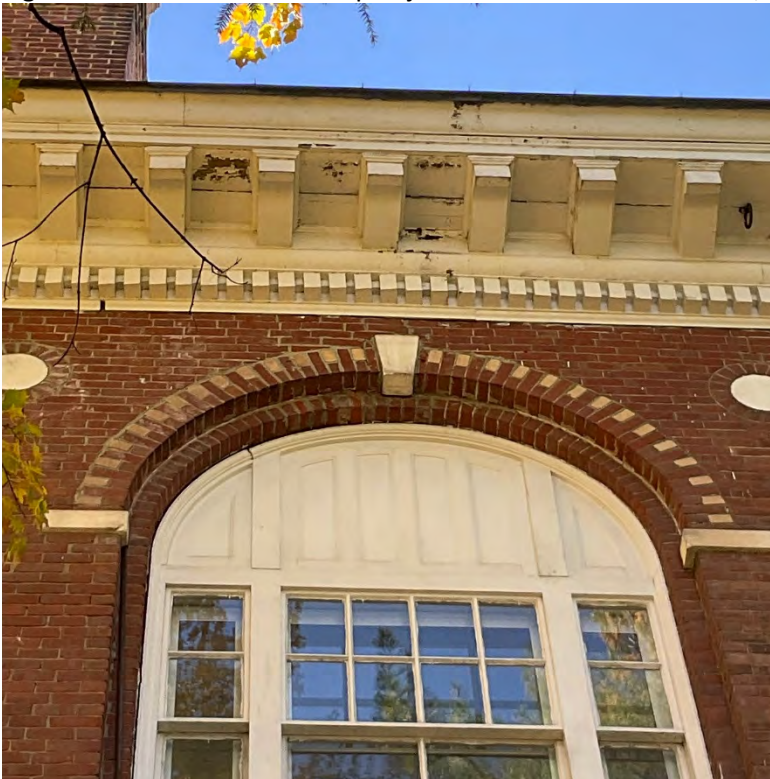
The large wood cornice was also only observed from the ground, though it appears to be in fair condition, largely due to the center open joint at the underside in many locations. Paint loss and rotted wood are seen primarily on the east side and the northeast corner. An internal gutter would not be uncommon in a large cornice such as this one, however we were unable to determine if one exists.

Figure 32. Rotted wood, paint loss, and open joint in center of underside of cornice. The ring is attached at the center underside in the far right of photo.

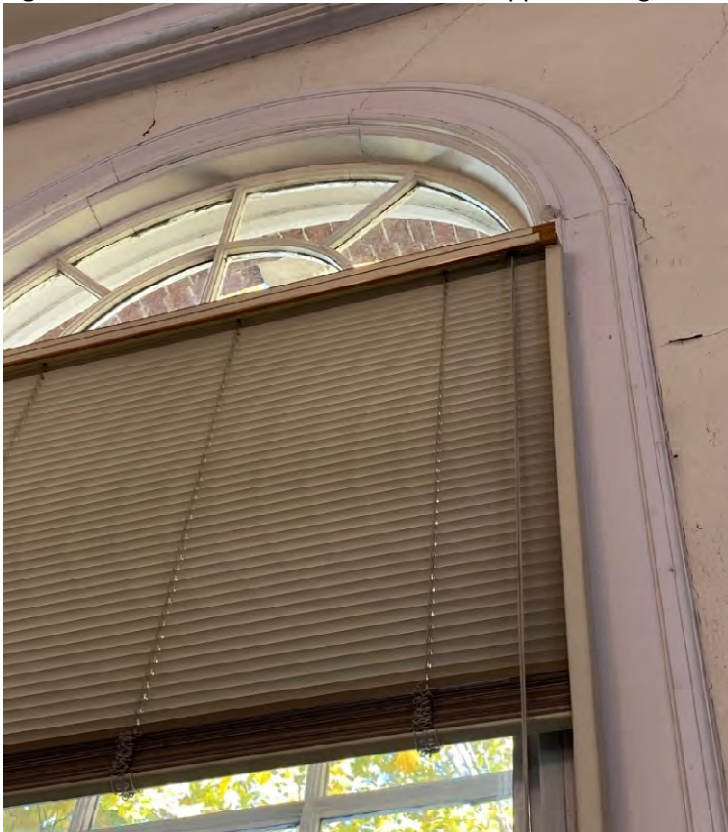
Figure 36. 2nd floor front window, with interior storm at double-hung portion (not at fanlight).

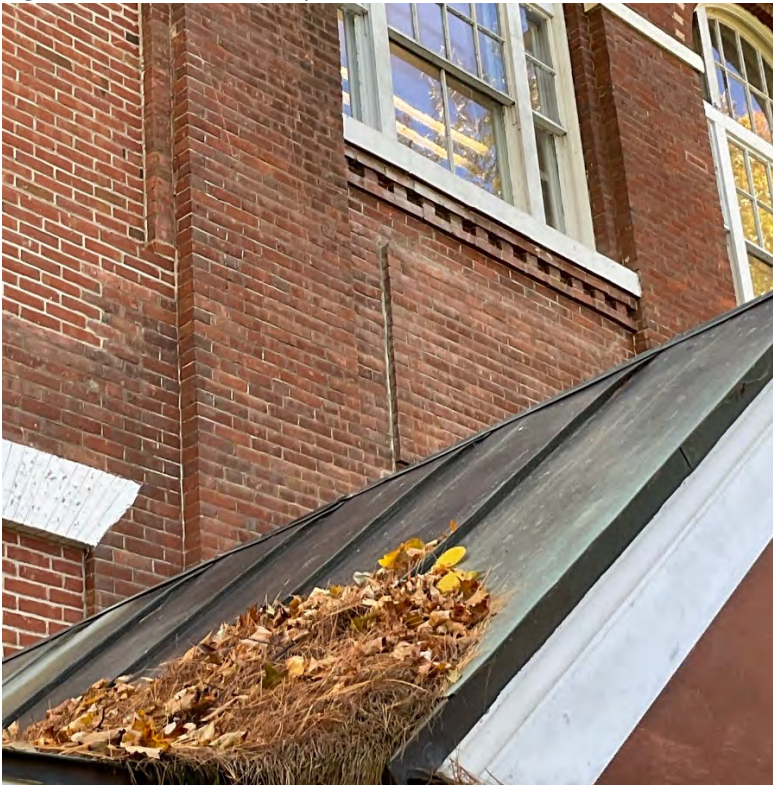
Figure 38. Roof above gable portion of accessible entrance (breezeway) addition.

The east wall near the elevator also prompts investigation at the truss/roof/gutter connection. It is recommended that a thorough roofing inspection for all roofs be completed.

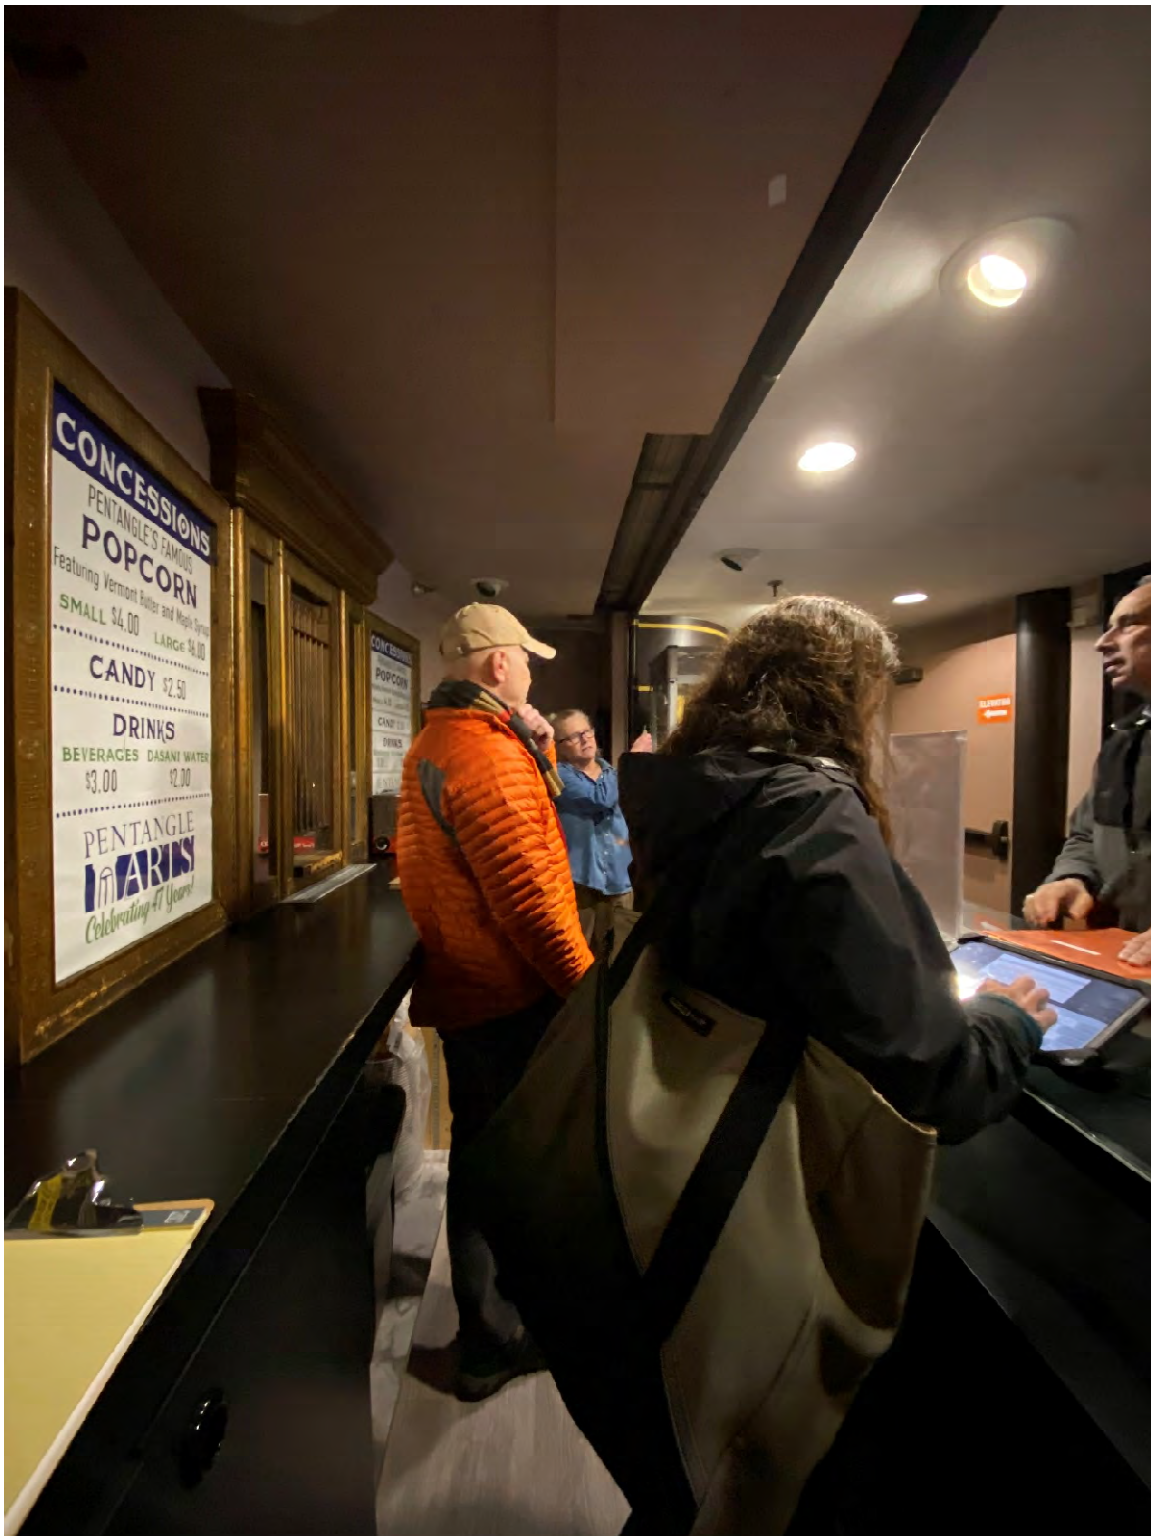
Figure 2. View of concessions looking east. The space is narrow and is not accessible and appears to have reached its current configuration during the late 1980s renovations.

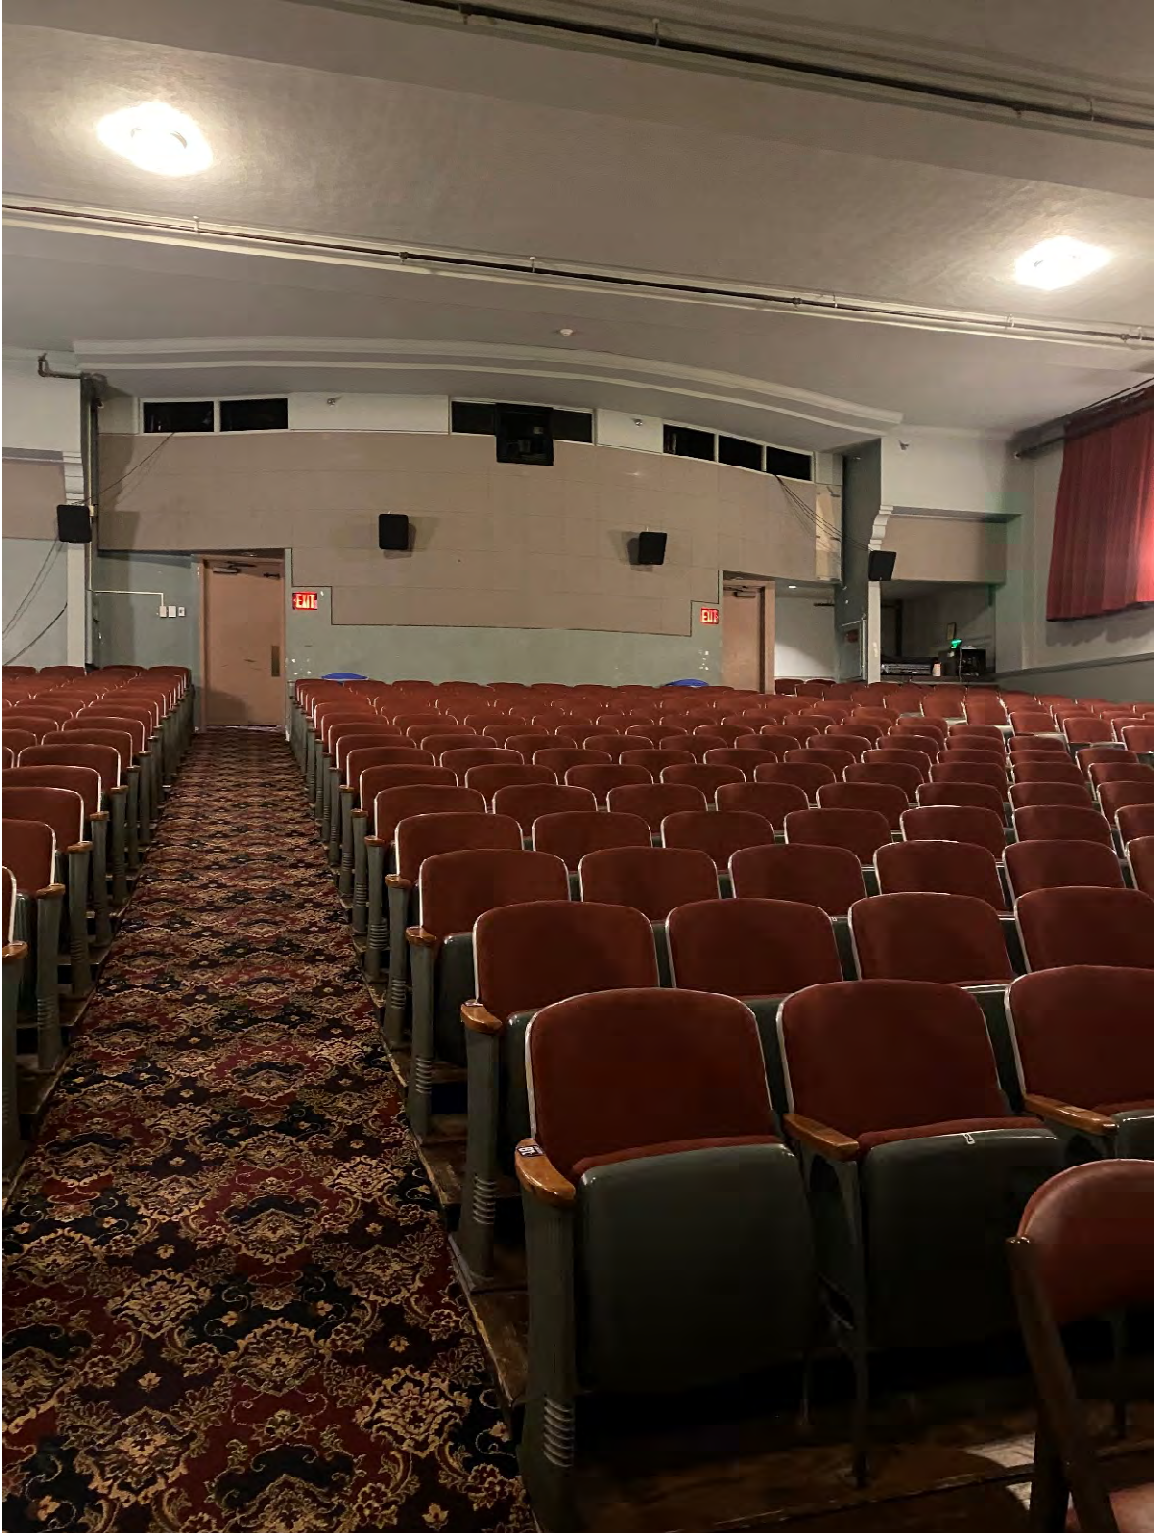
Figure 3. View of theatre looking north toward stage. The auditorium retains its essential 1927 appearance.

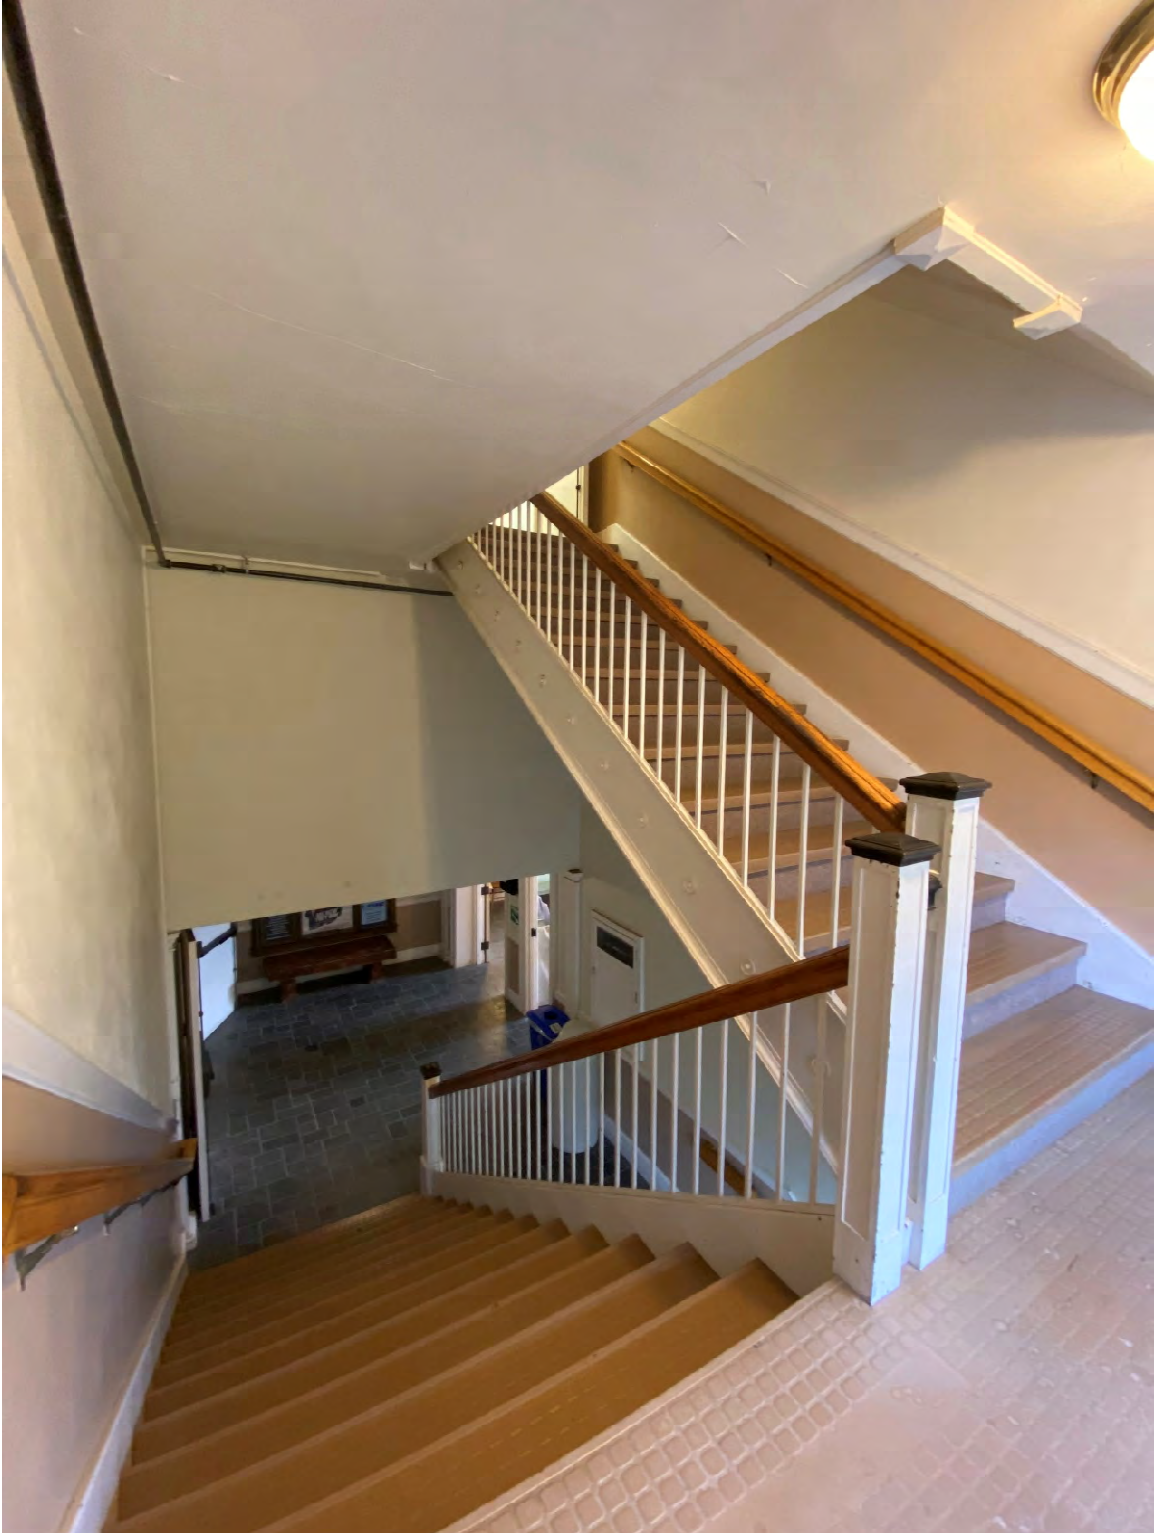
Figure 5. View of backstage / stage house (1927) looking west. Original stage flooring was yellow pine; it was replaced with Marmoleum in the mid-1990s.

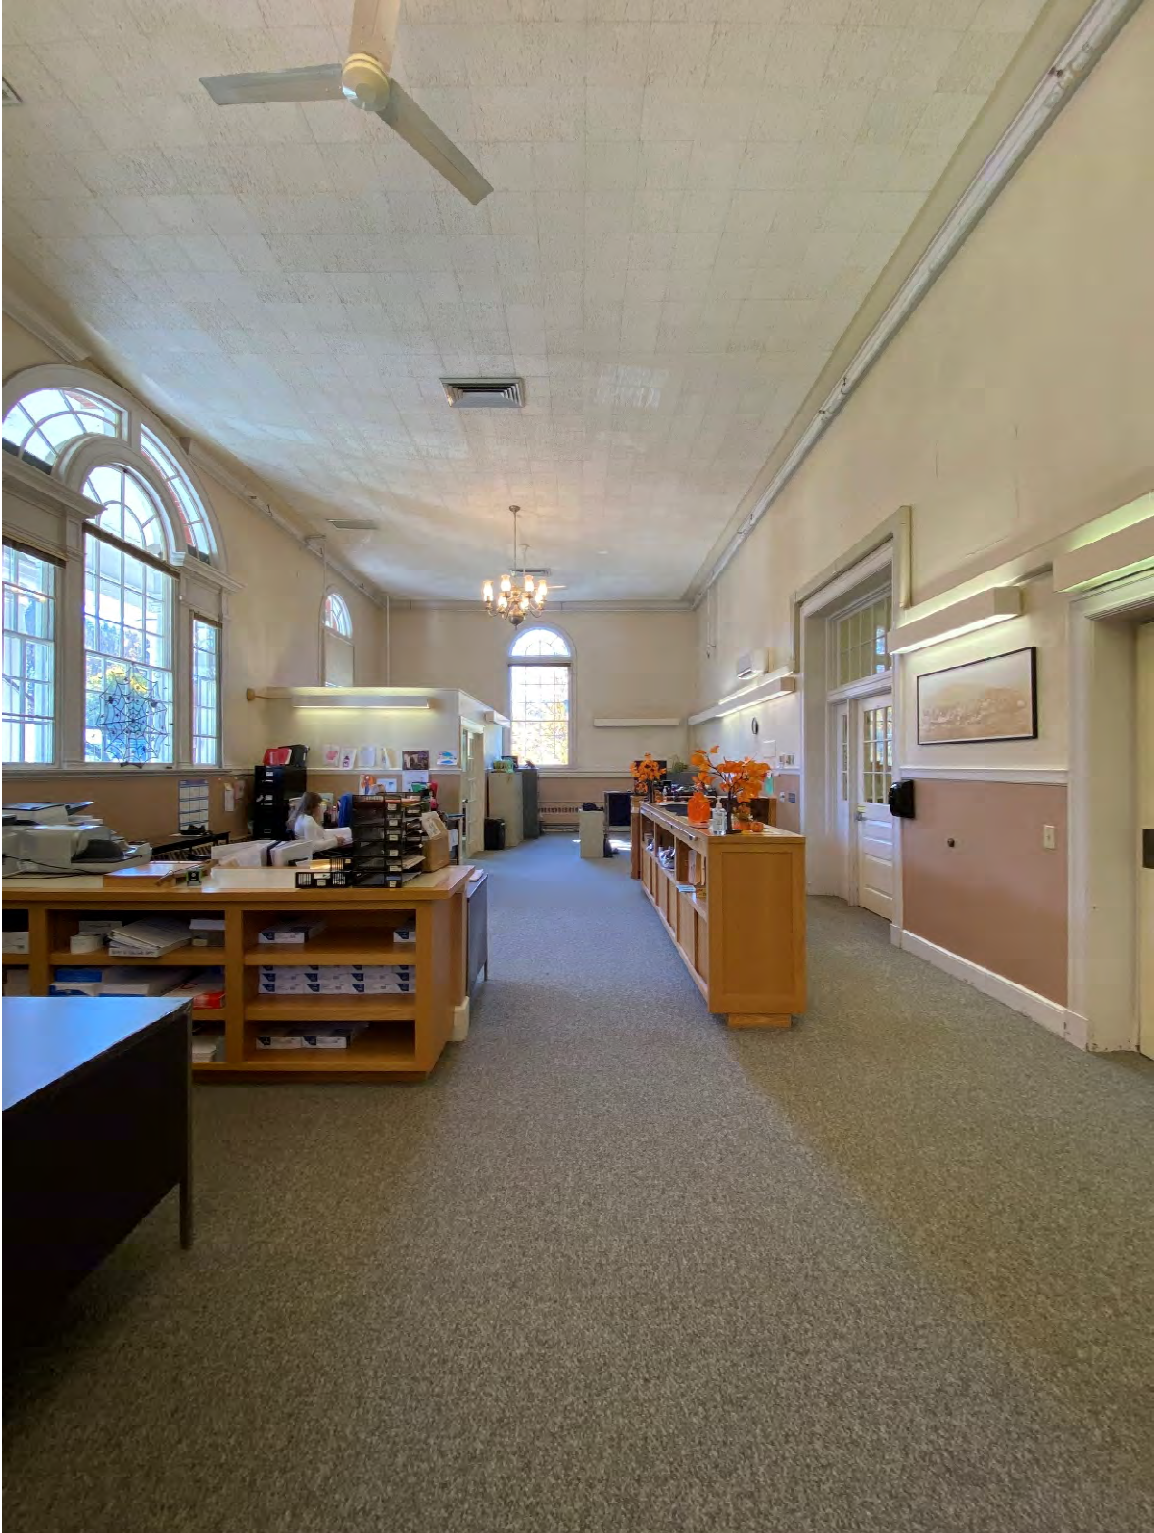
Figure 6. View of main staircase between first and second floors looking down to first floor lobby; the current configuration dates to the 1927 renovation although some of the finishes have been modernized over time (flooring, paint).

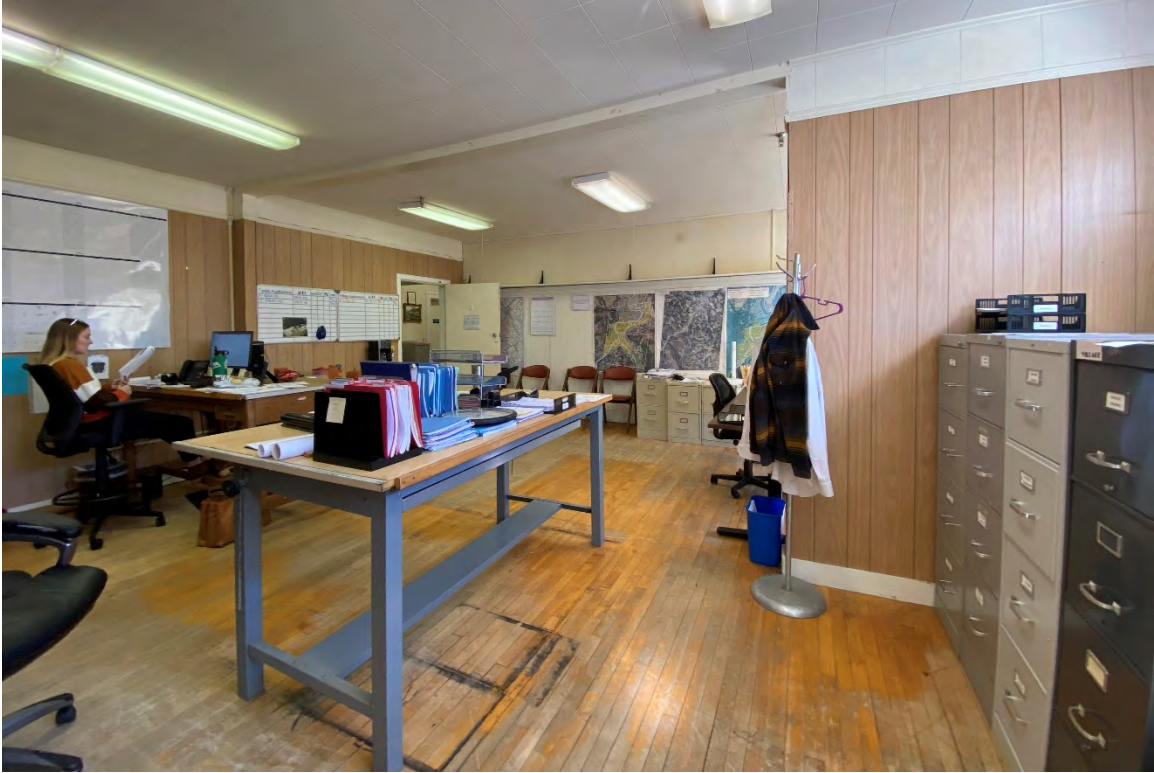
Figure 7. View of second floor open offices (Municipal Manager); these offices still largely reflect renovation work completed in 1985.

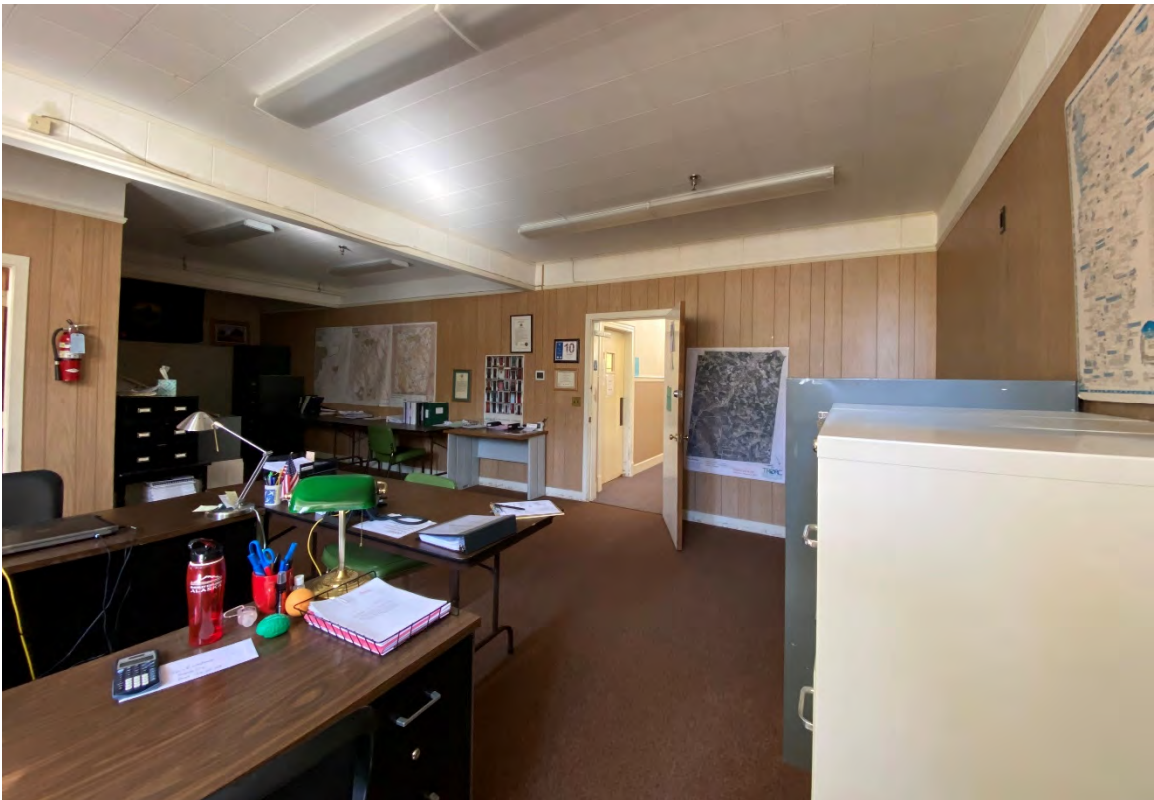
Figure 8. View of second floor open offices; note the 1927 wood flooring remains although is in fair condition.

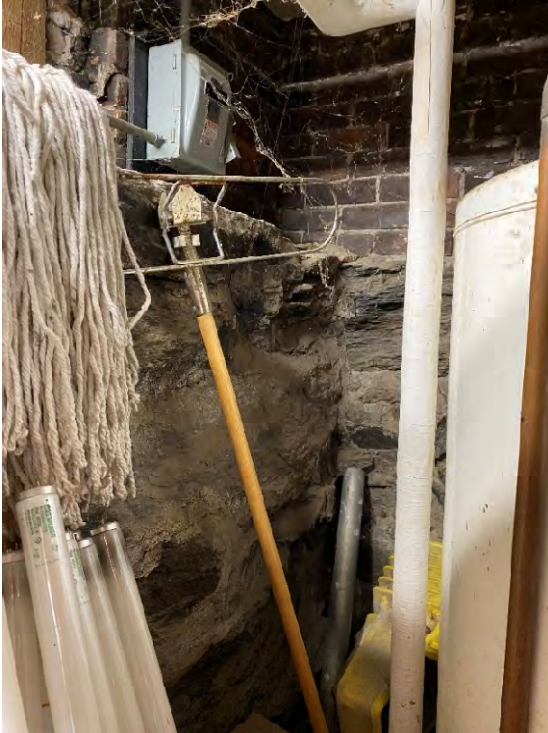
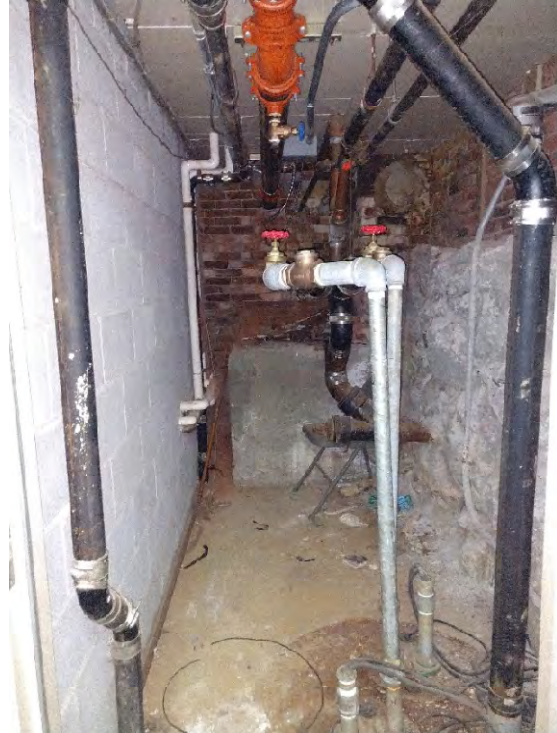
In the basement, walls exhibit some parging loss and stone delamination at the foundations.

Figure 12. Basement, storage/utility room: parging loss and stone delamination in foundation wall.

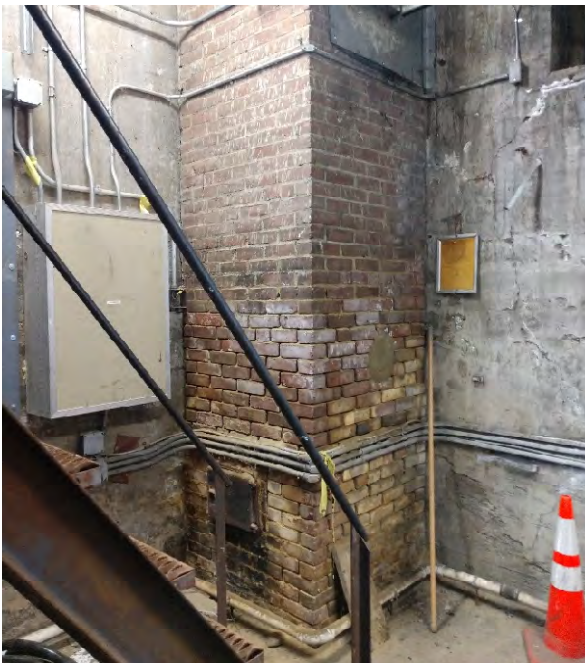
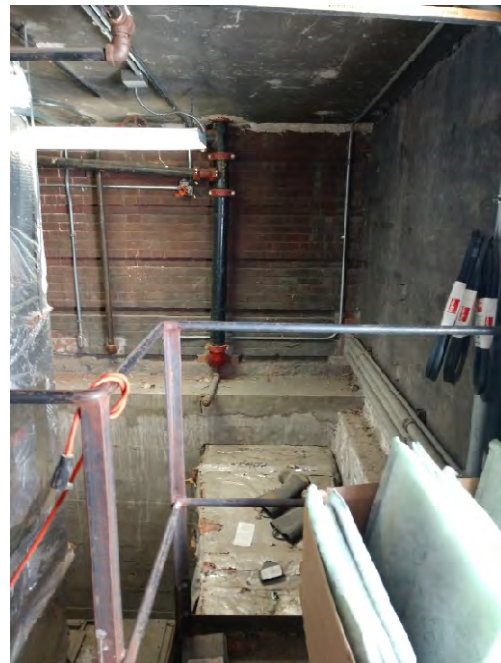
Figure 13. Basement, masonry foundation: efflorescence in brick, mortar loss/open joints in bottom portion of brick, cracks in parging, minor parging loss, water staining.

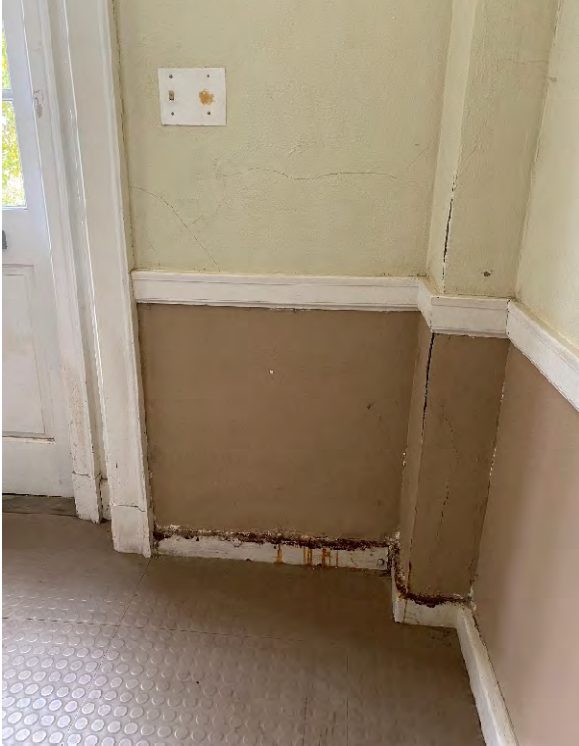
Figure 14. Basement stairway landing at side door: cracks in wall, large cracks at projecting corner, paint loss at corners and around wood trim. rust staining and wood deterioration at top of baseboard.

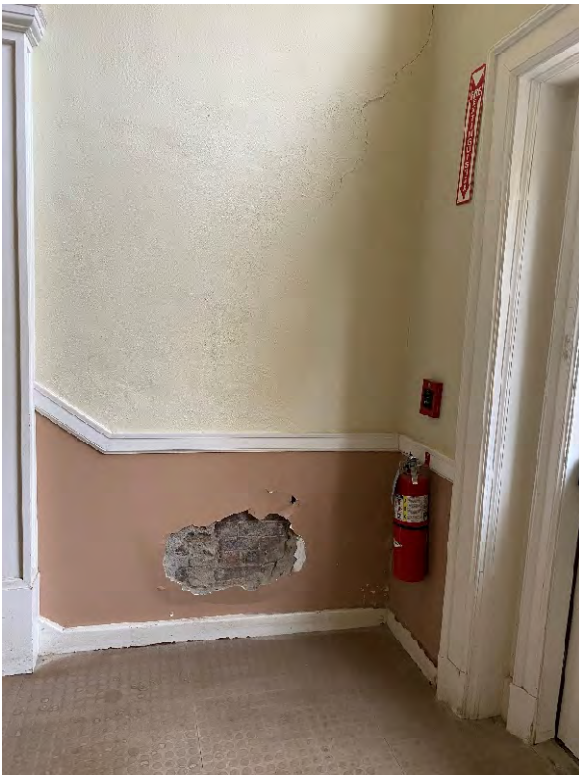
Figure 15. Basement stairway landing at side door: cracks in wall, rust staining at base and top of baseboard. Large area of material loss in wall finish revealing masonry beyond.

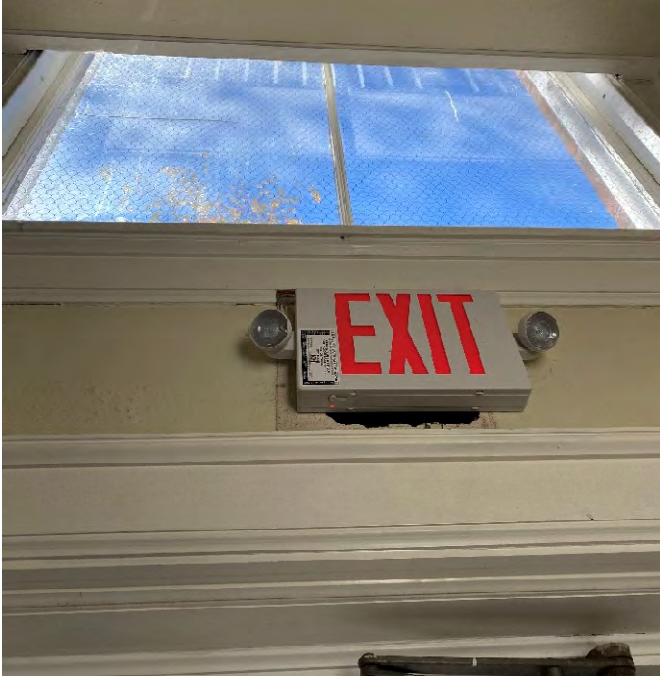
Figure 16. Basement stairway landing: at side door wall deterioration behind exit sign.

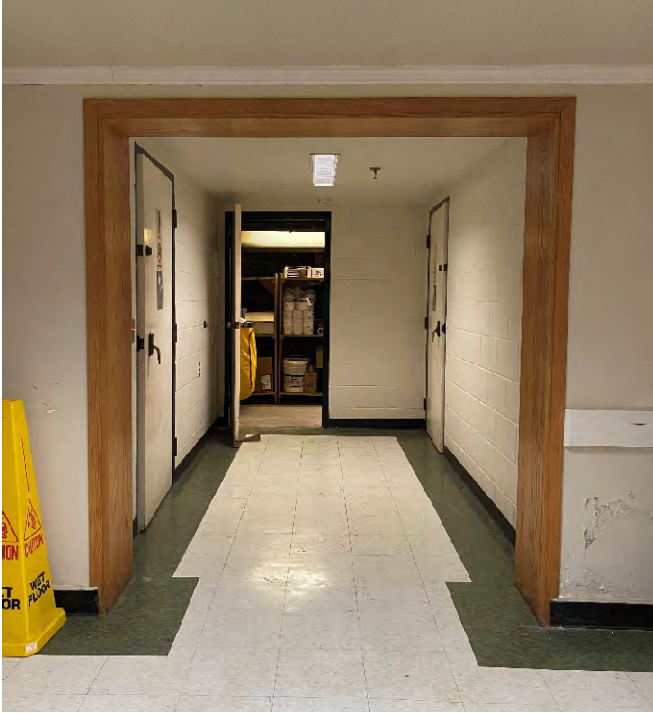
Figure 18. Basement, hallway: paint loss at wall right of opening below the chair rail.

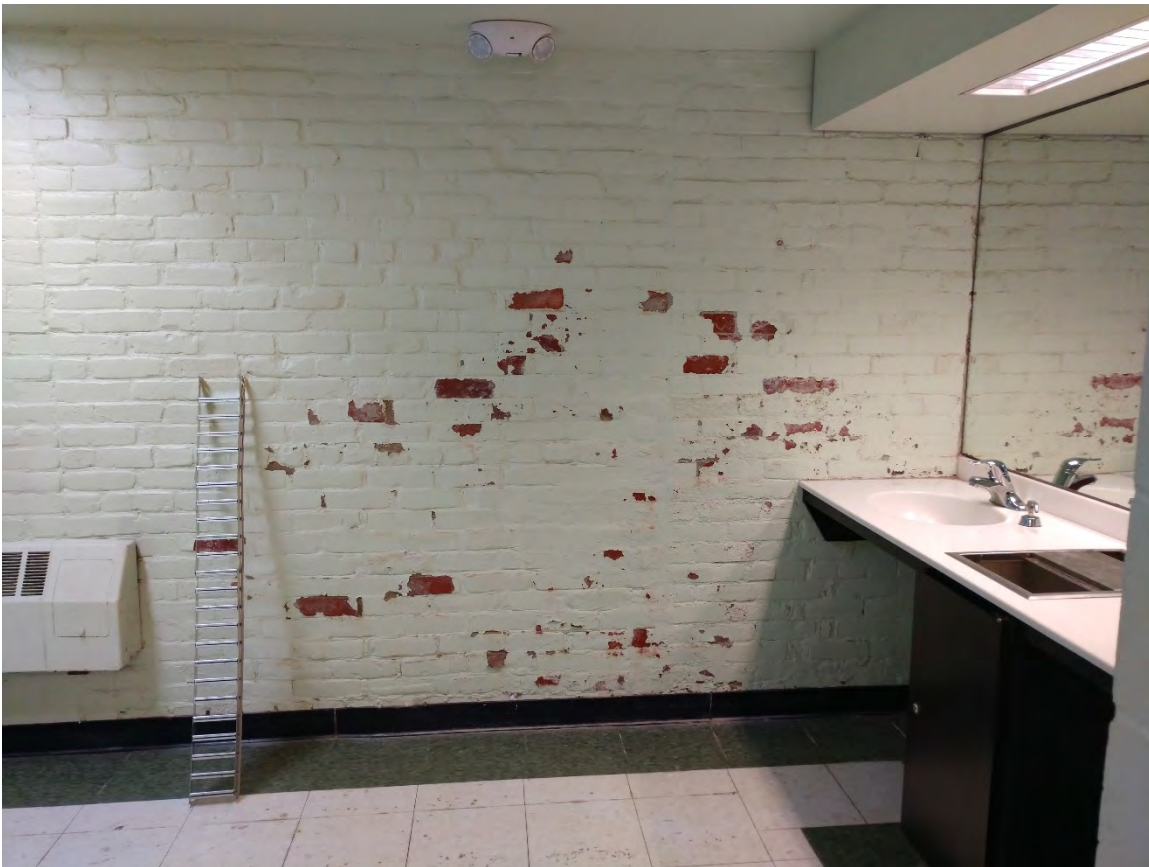
Figure 19. Basement, Men's restroom: paint loss at base of brick wall.
