Limited Preservation Plan, Woodstock Town Hall Theatre - DRAFT

November 15, 2022

**WOODSTOCK TOWN HALL THEATRE
LIMITED PRESERVATION PLAN**

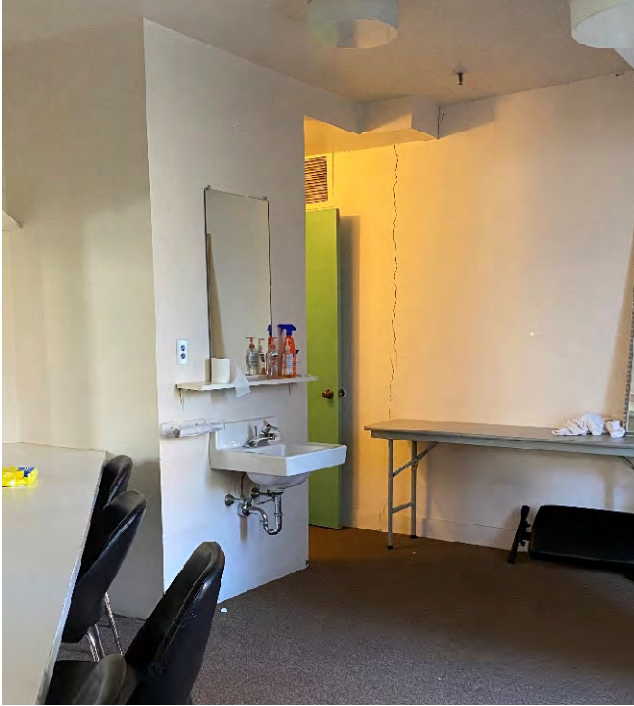
Figure 20. Basement, dressing room: large floor to ceiling crack at bathroom threshold.

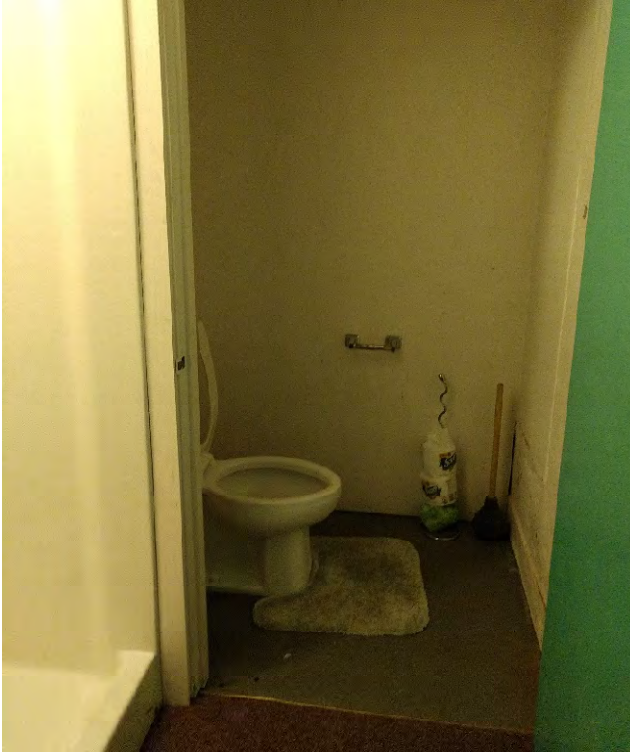
Figure 22. Basement, bathroom: paint loss at base of right wall.

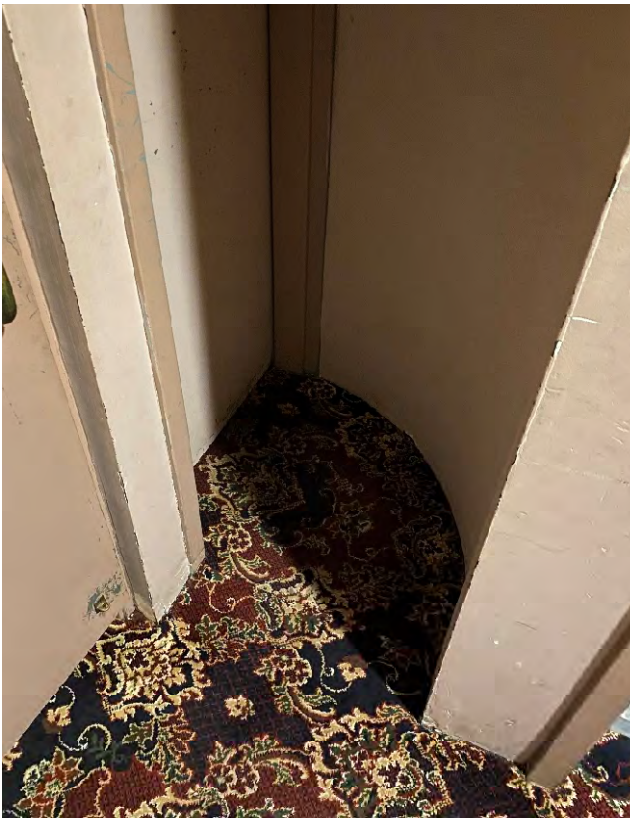
Figure 23. First floor concession area: small nicks in wall.

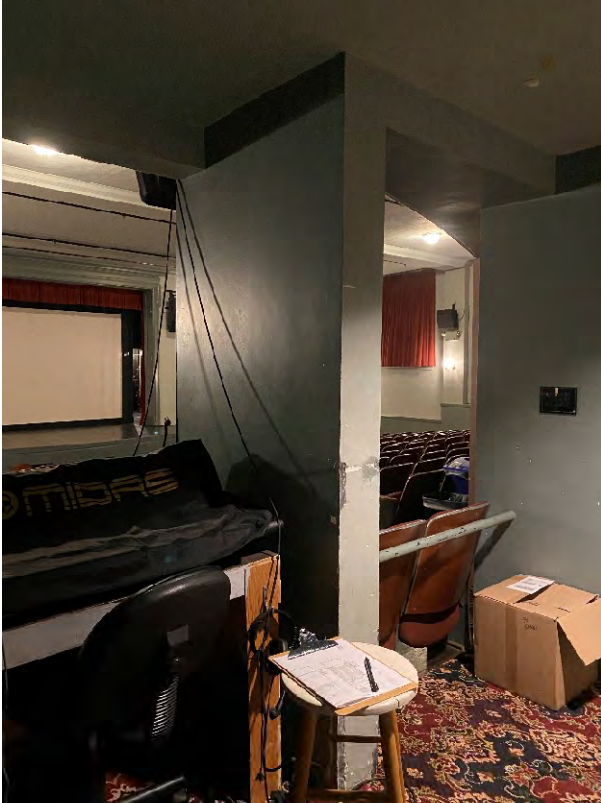
Figure 24. First floor auditorium, rear: nicks in wall.

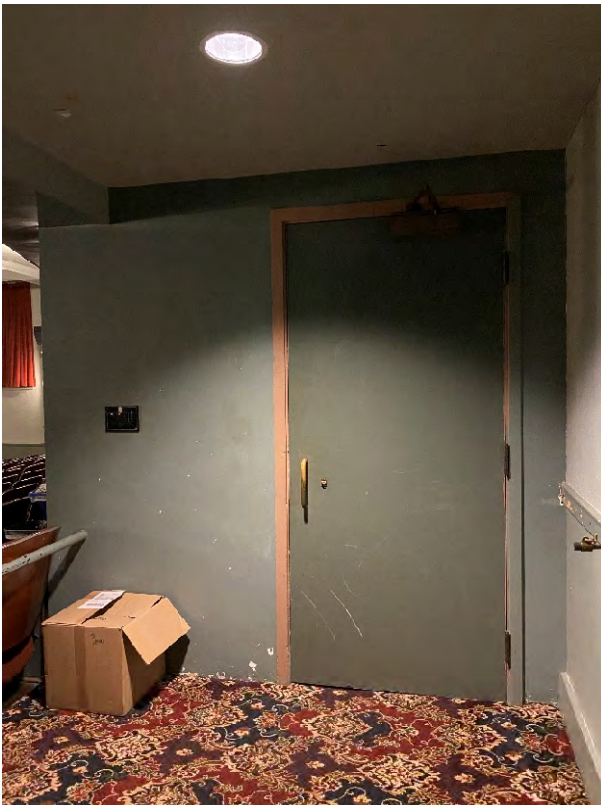
Figure 25. First floor auditorium: nicks in wall and chair rail.

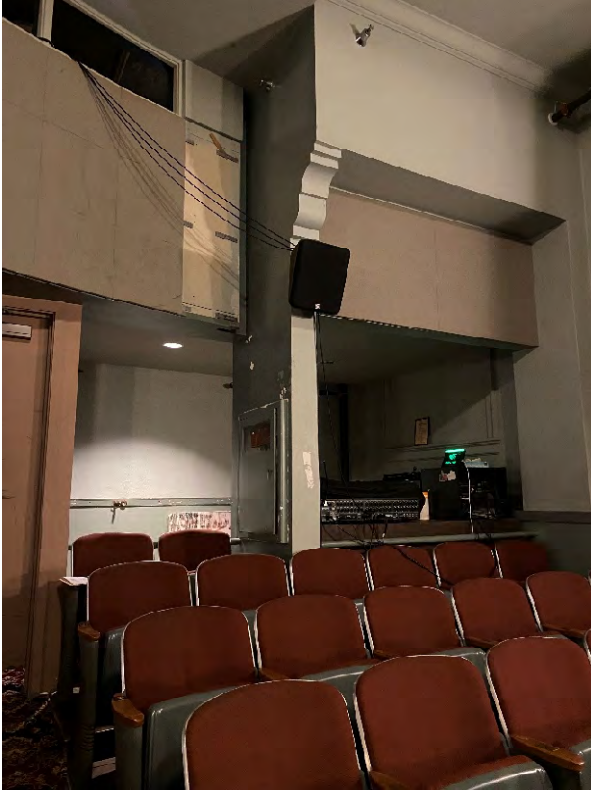
Figure 26. First floor auditorium, southwest corner: nicks in walls, acoustic tiles missing from mezzanine level.

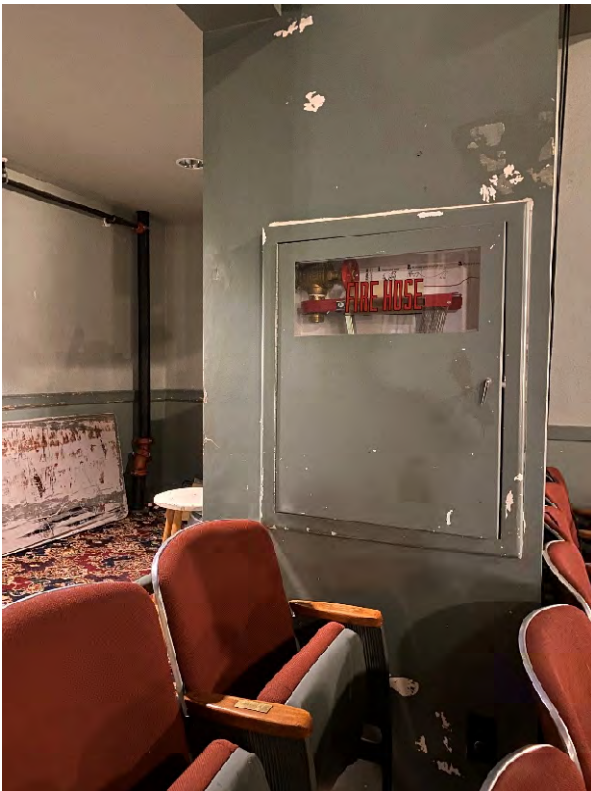
Figure 27. First floor auditorium, southwest corner: nicks and paint loss in wall.

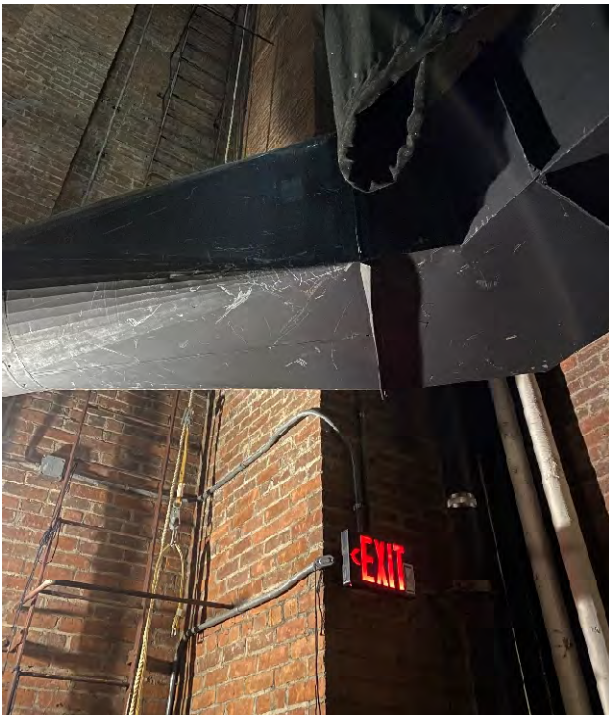
Figure 29. First floor backstage: interior brick chimney.

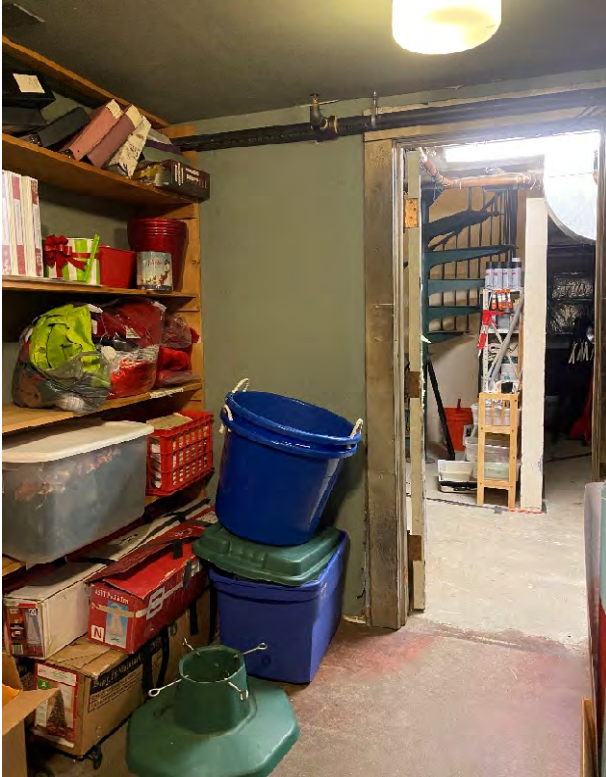
Figure 30. Mezzanine, middle storage room: paint loss and deterioration of wall at base along door frame.

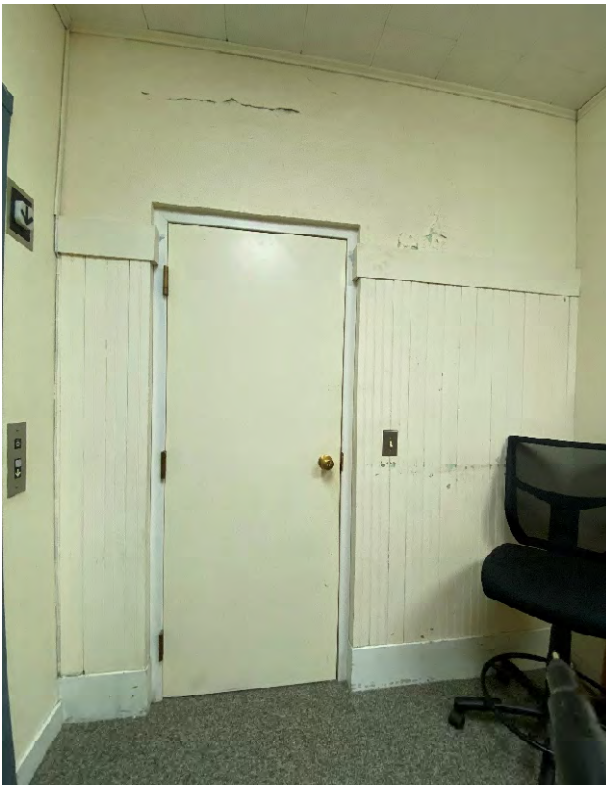
Figure 31. Second floor, elevator lobby: horizontal crack in wall above door, paint loss/crazing.

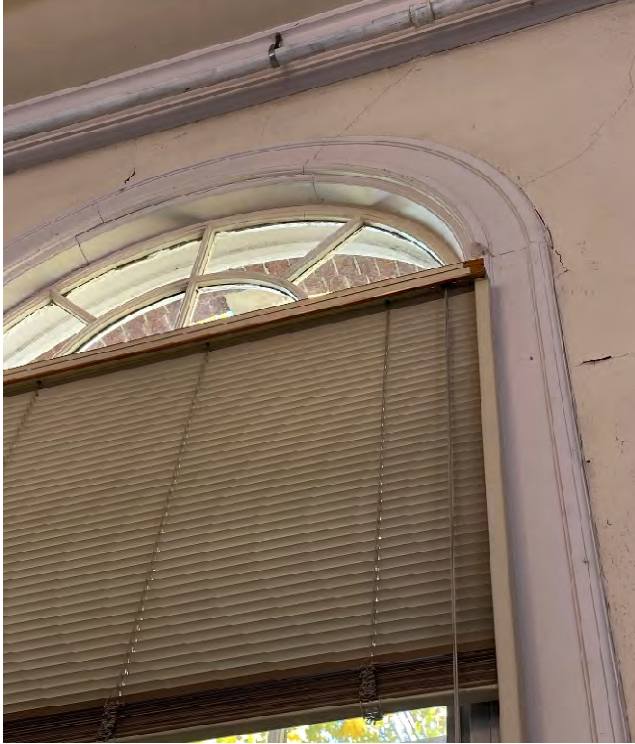
Figure 32. Second floor, south office (Municipal Manager): cracks in plaster wall around window.

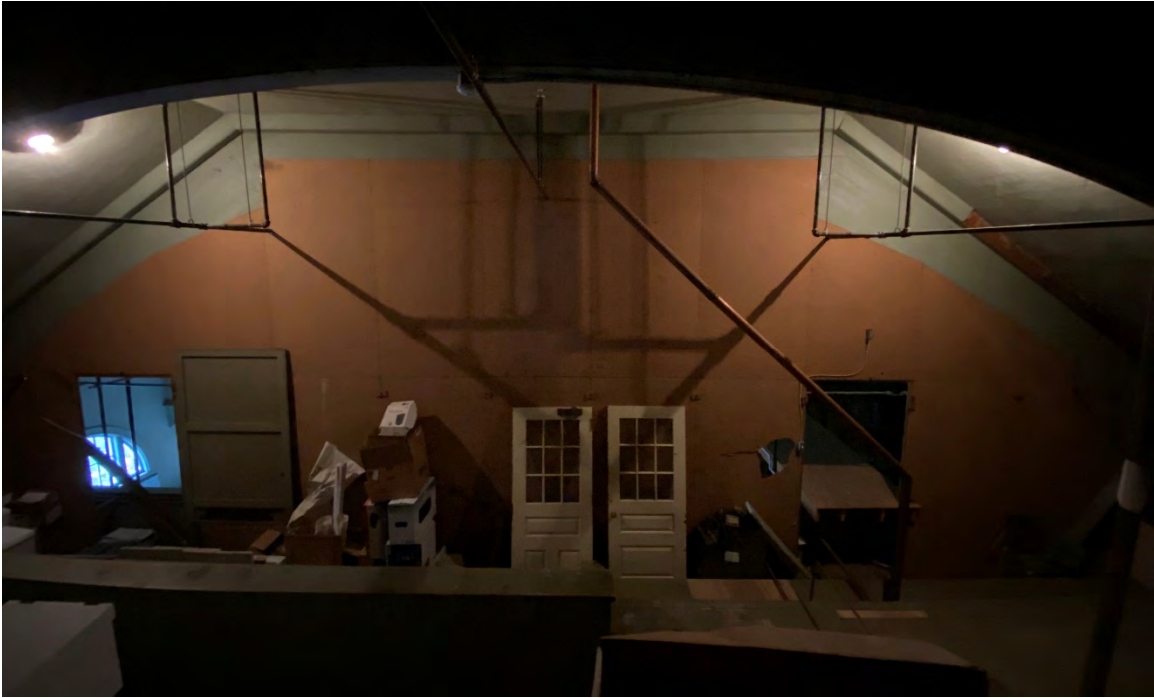
Figure 36. Attic: hole in wall next to door provides access to walkable ceiling.

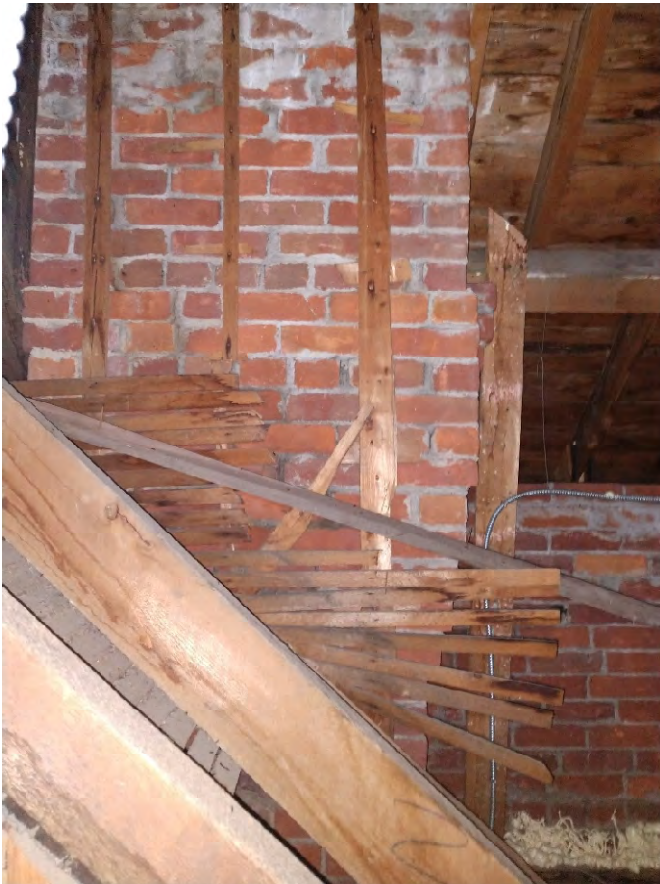
Figure 37. Attic: brick wall and chimney.

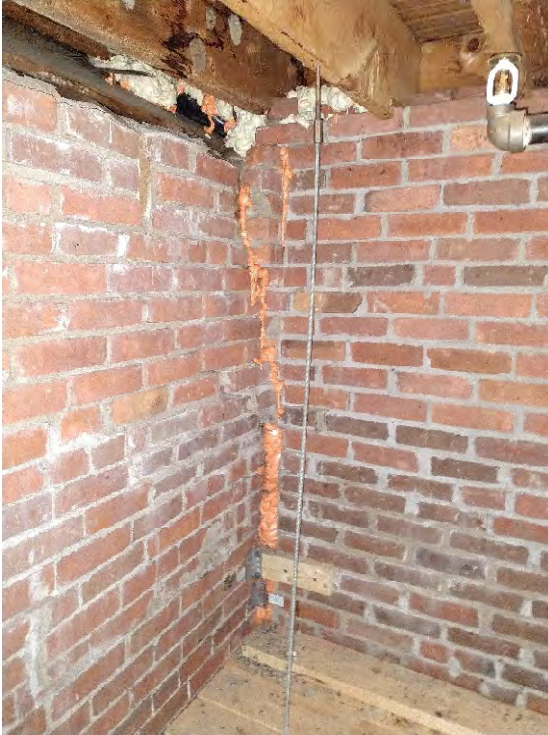
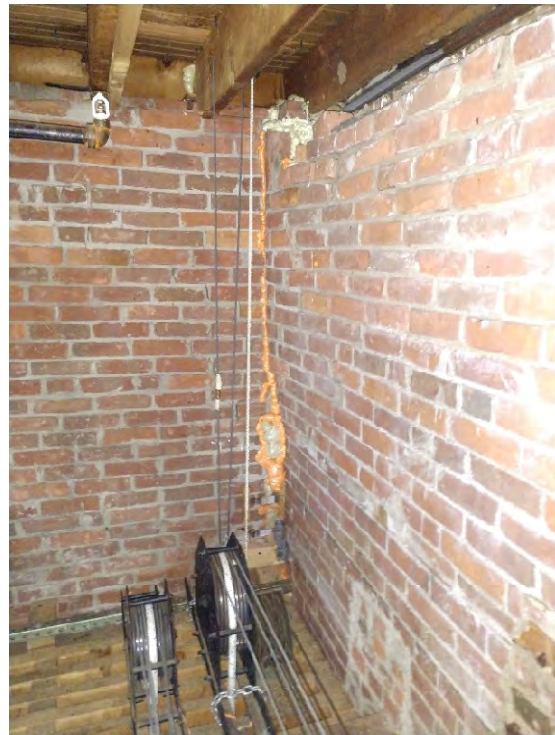
At the Stage House Fly Loft, the brick wall has large separation at the corners that have been injected with foam insulation.

Figure 38. Backstage / Stage House at Fly Loft: brick wall with large separation at corners injected with foam insulation. Wall delamination / leaning is visible. Wood joist deterioration at corner.

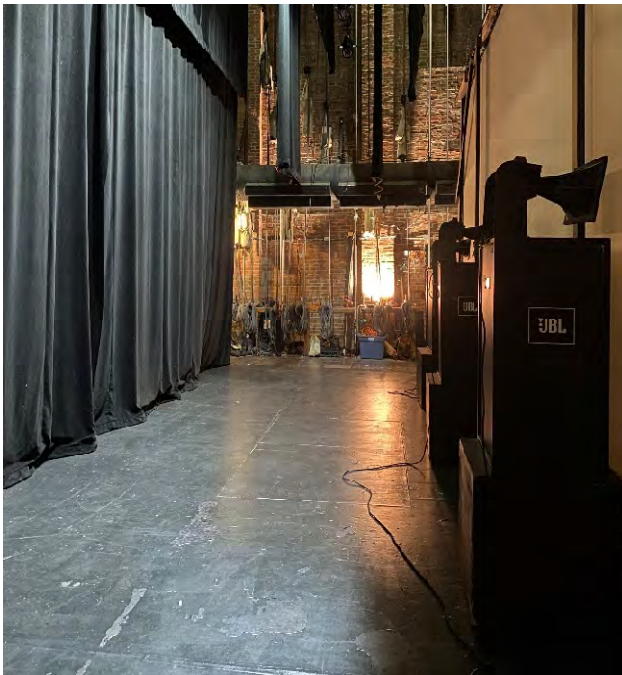
Figure 44. First floor stage house: staining at floor. Original pine floor was replaced with Marmoleum in the mid-1990s.

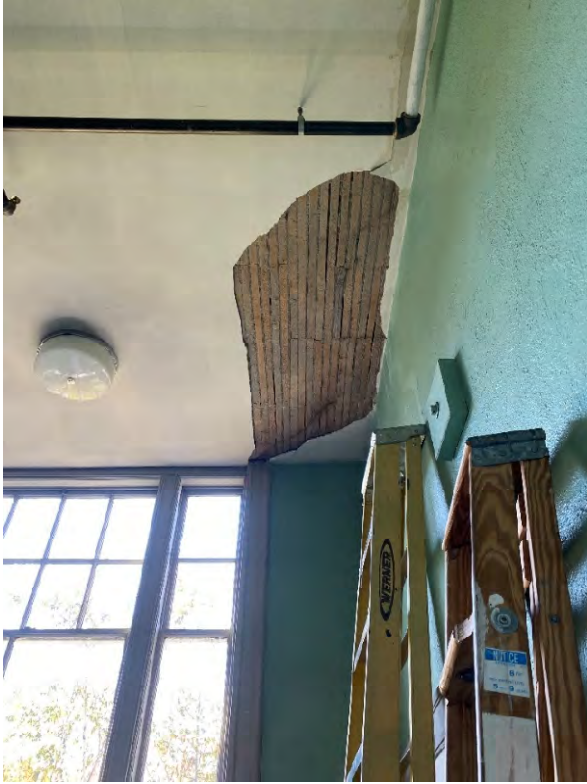
There are many areas of moisture staining on the second floor and attic ceilings. There are a few areas of ceiling collapse that were observed, most likely due to moisture: at the second floor stair landing plaster ceiling and at attic plaster ceiling, revealing lath and wood deterioration underneath.

Figure 49. Second floor stair landing: plaster collapse in ceiling, revealing lath with wood deterioration.

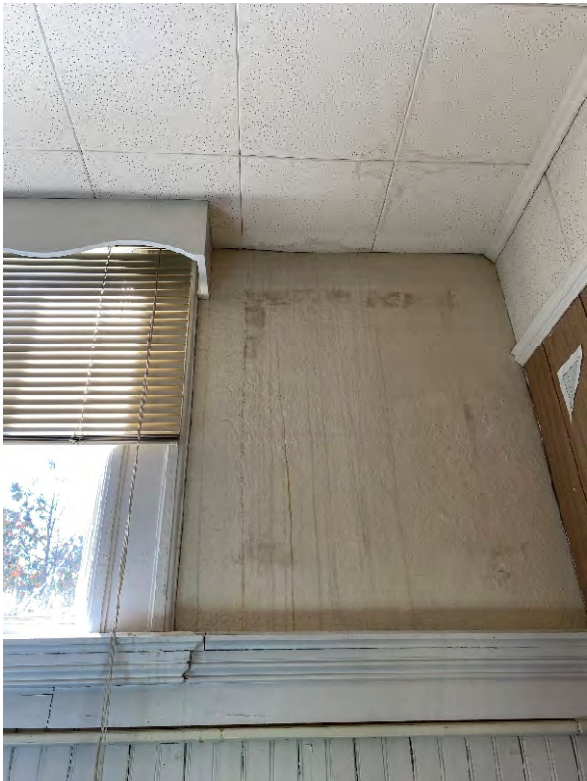
Figure 50. Second floor, west office: water stains in tiled ceiling, stains on wall finish and chair rail.

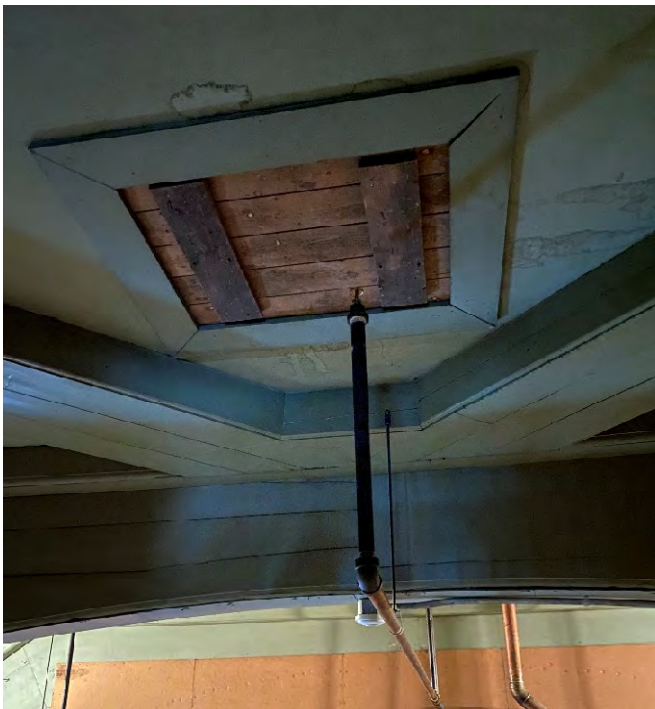
Figure 52. Attic, view of attic hatch: water stains in plaster ceiling hatch.

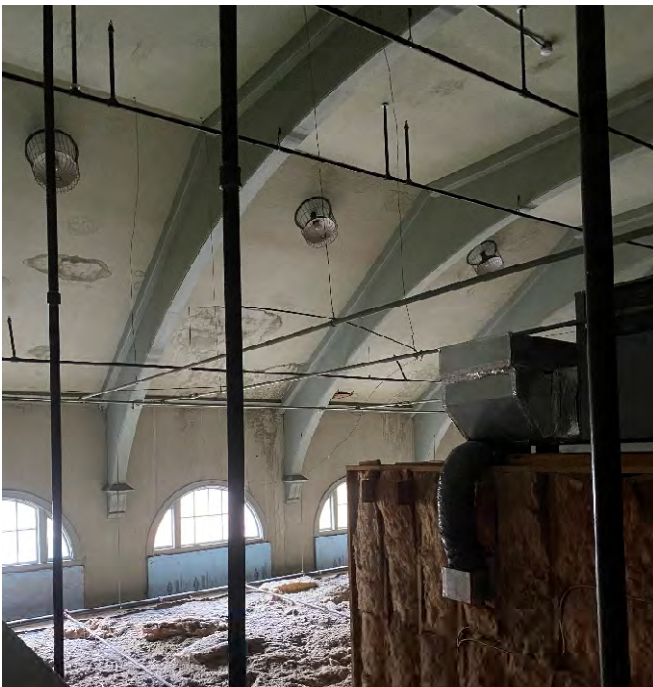
Figure 54. Attic: cracks and large water stains in vaulted ceiling.

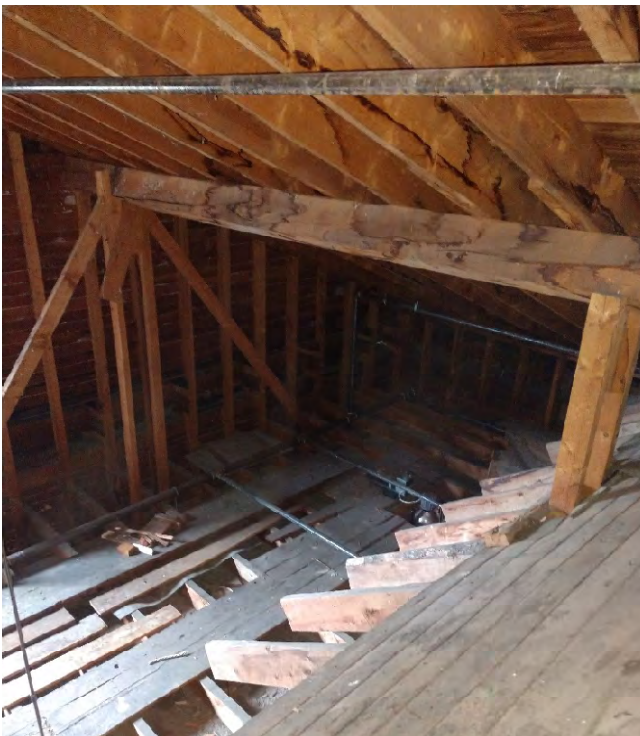
Figure 56. Attic: timber framing members over portico.

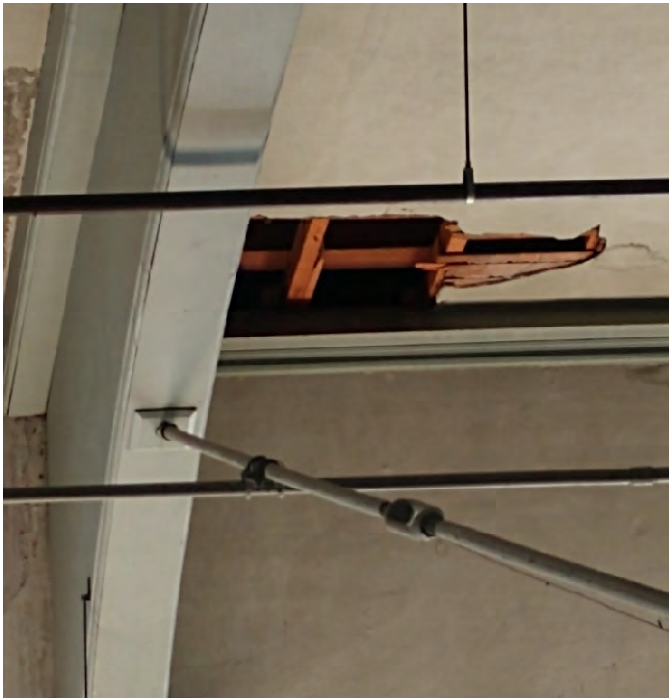
Figure 60. Attic: plaster loss in ceiling, revealing wood rafters.

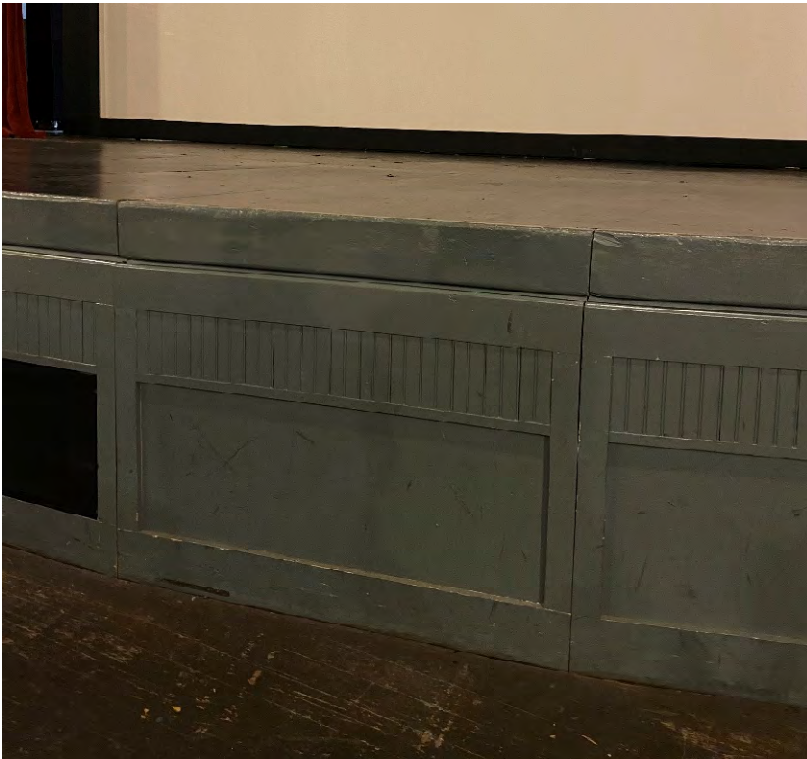
Figure 62. First floor auditorium stage: wainscoting has nicks and minor paint loss.

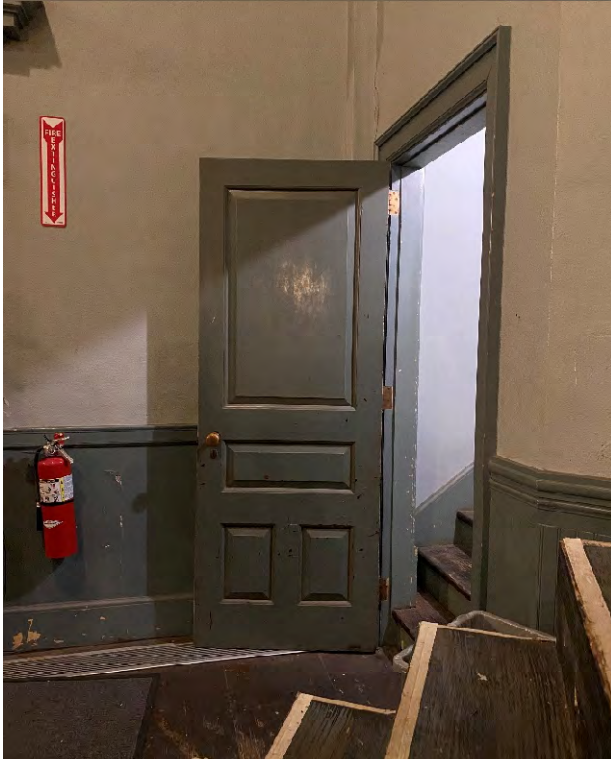
Figure 63. First floor auditorium, northwest corner: nicks and minor paint loss in wainscoting, baseboard, and door.

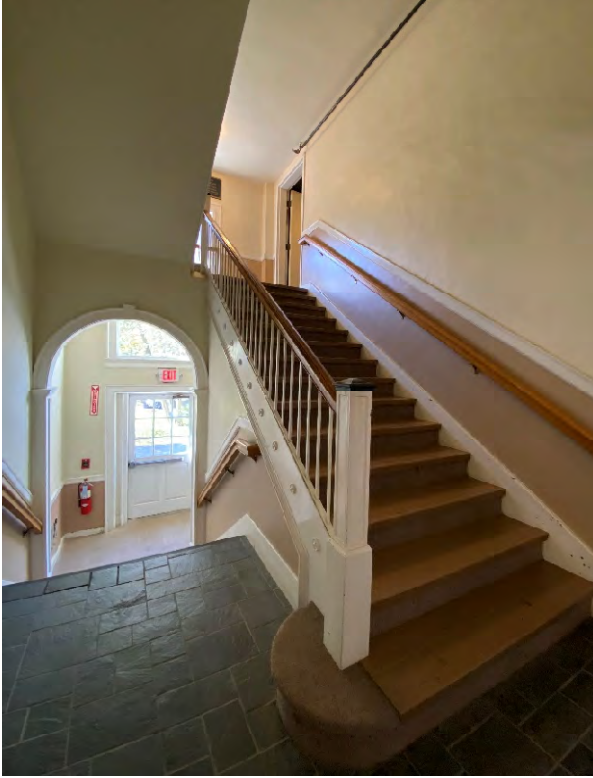
Figure 67. First floor stairhall looking up to second floor and down to landing.

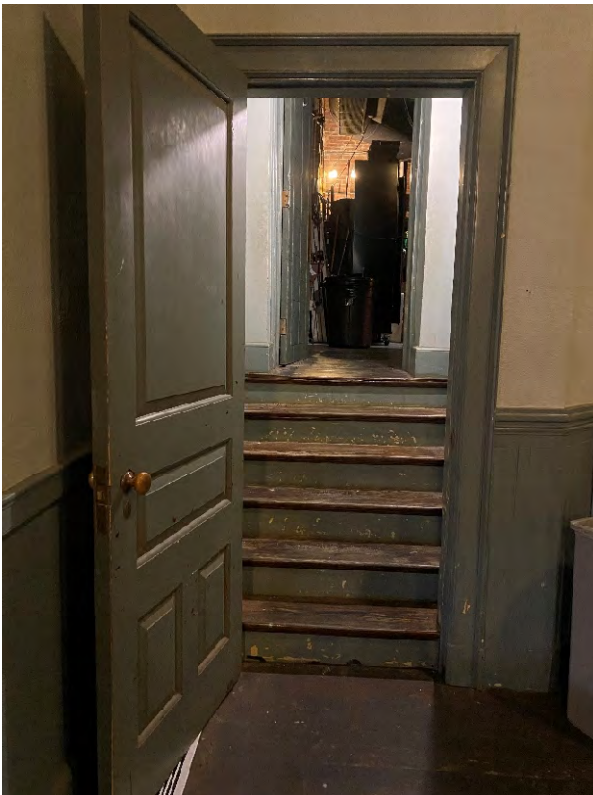
Figure 68. First floor auditorium looking to backstage: nicks and paint loss in risers, areas of deterioration at bottom step, treads worn; no accessibility.

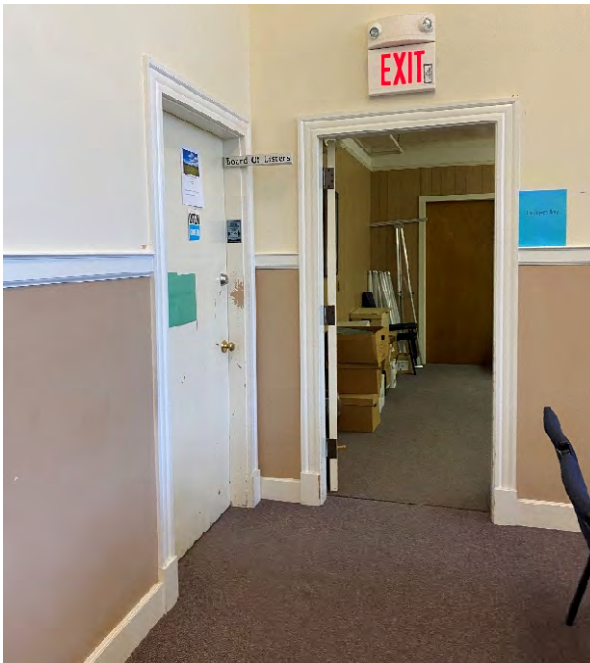
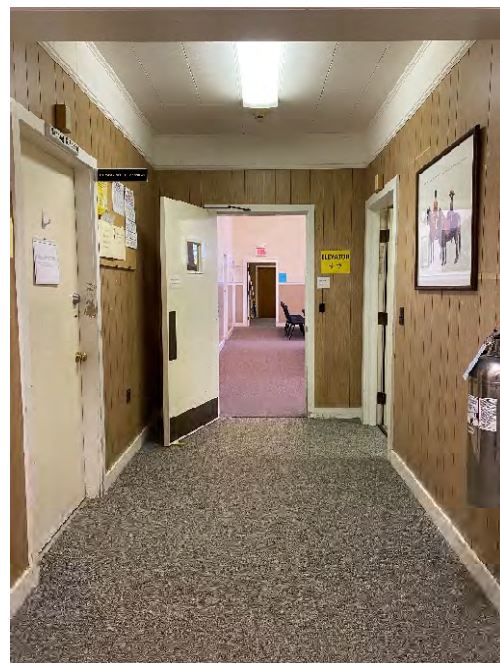
Figure 70. Second floor, hallway and conference room: paint loss on door frame and baseboards; dated finishes.

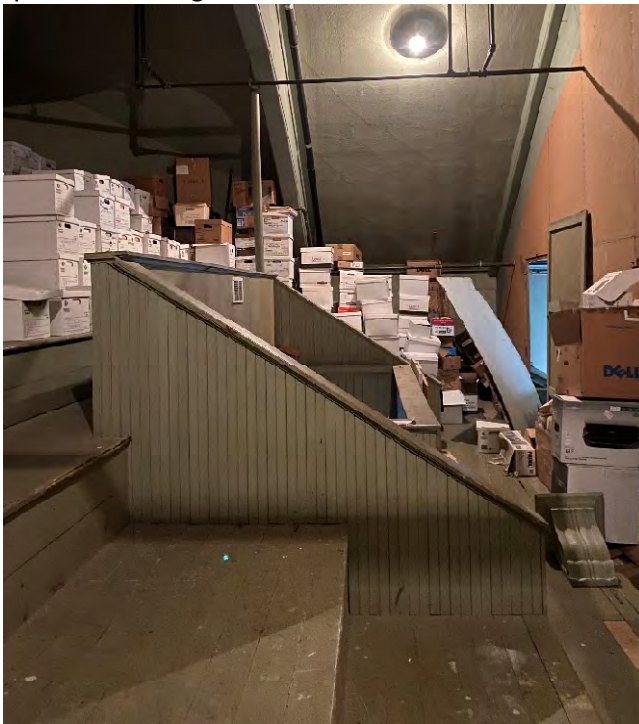
Figure 72. Attic stair: minor wood deterioration and paint loss on wood beadboard and wood seating.

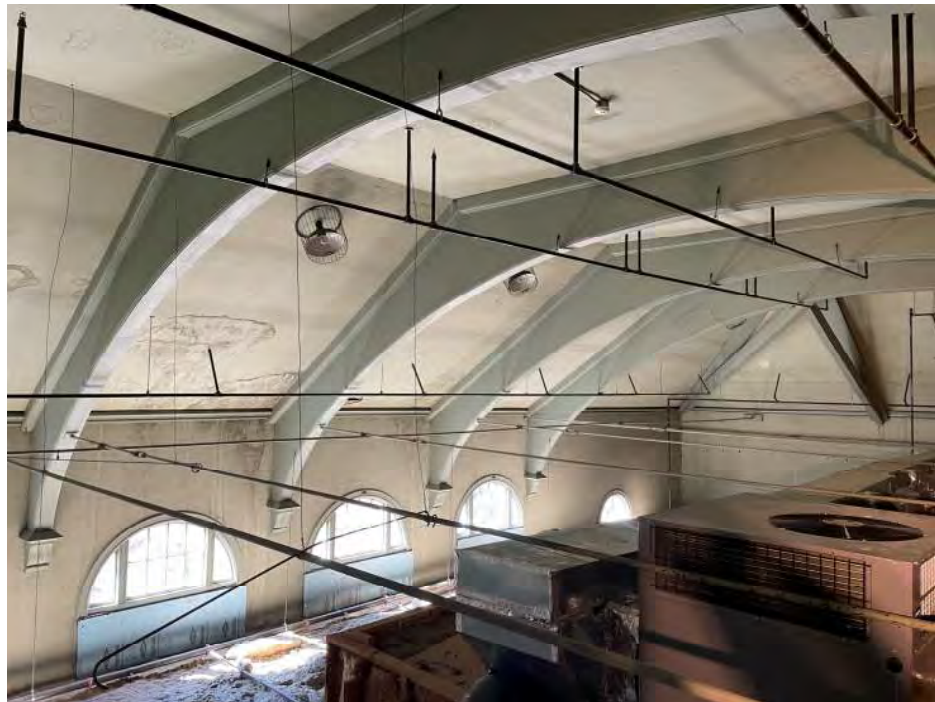
Photo 2: Repair tie-rods at roof trusses

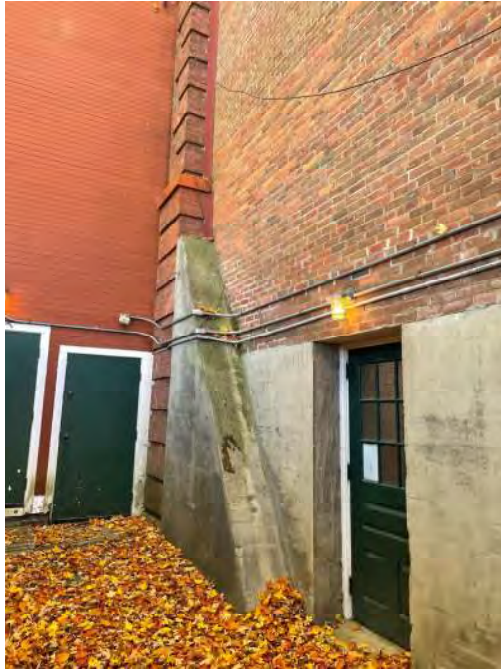
Photo 3: Repair concrete buttress at northeast side of existing structure.

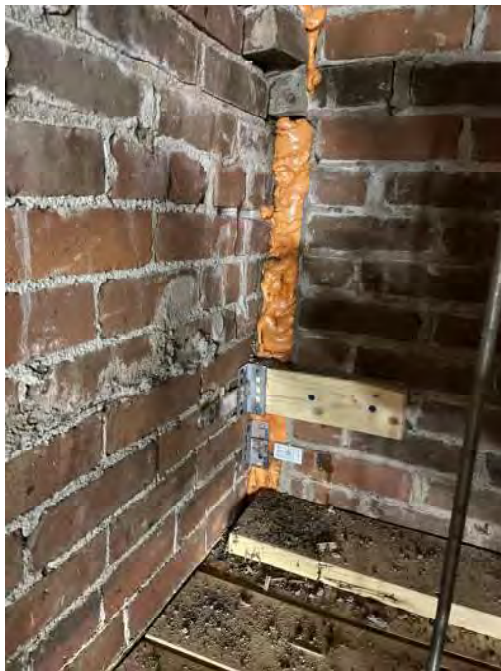
Photo 4: Crack gauge within fly loft.

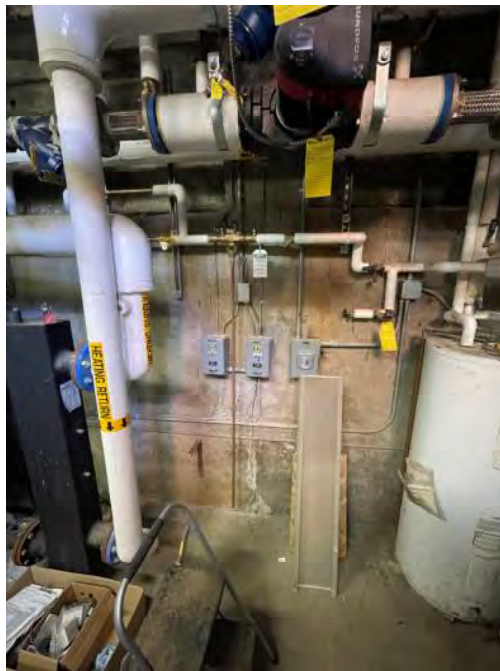
- A vertical crack in the wall plaster within the green room was observed. On the other side of this wall, a vertical crack in the east foundation wall within the mechanical room below the stage was observed to be propagating from the re-entrant corner of an existing opening (Photo 6). This crack is most likely the result of the settlement of the northern most foundation walls of the stage addition. LeMessurier recommends a flexible pressure injected grout full depth of the foundation wall as a repair.

Photo 6: East mechanical room foundation wall with vertical crack.

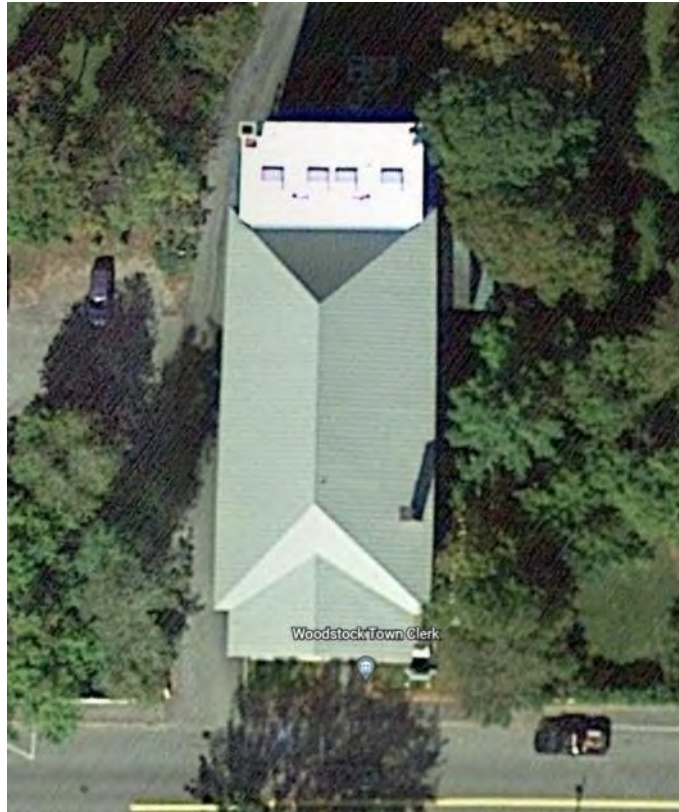
Previous repairs to the roof and enclosure were observed, such as the installation of standing seam metal roofing over the original and portico portions of the building - which appear to be in very good condition (Photo 7), mismatched mortar repairs at the brick exterior (Photo 8), patched terra-cotta water table (Photo 9). General exterior masonry observations include migrating cracks in brick mortar joints (Photo 10), cracking within the brick assembly (Photo 11), deteriorated mortar joints at brick walls and granite foundation (Photos 12, 13), organic growth on brick surface (Photo 14), environmental staining on brick surface (Photos 15, 16), heaved or settled granite steps and brick pavers at the portico entrance (Photo 17,18).

Photo 7: Aerial view of existing roof (courtesy Google Earth)

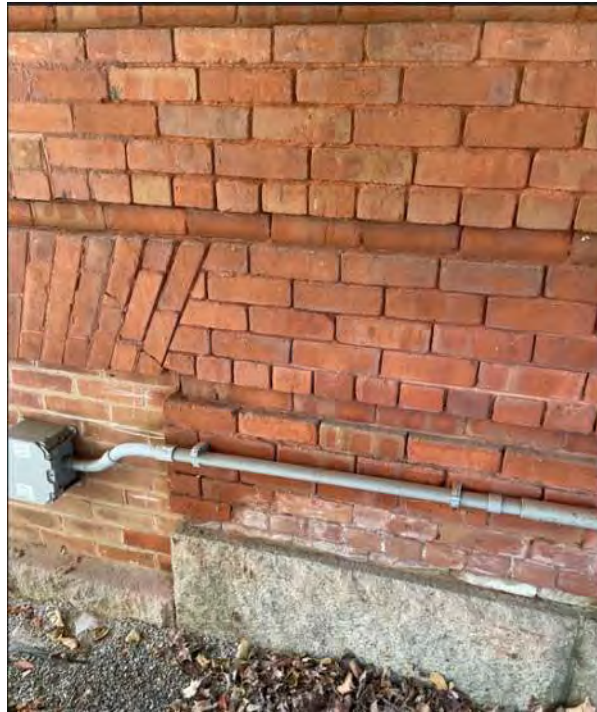
Photo 12: Deteriorated mortar joints at brick

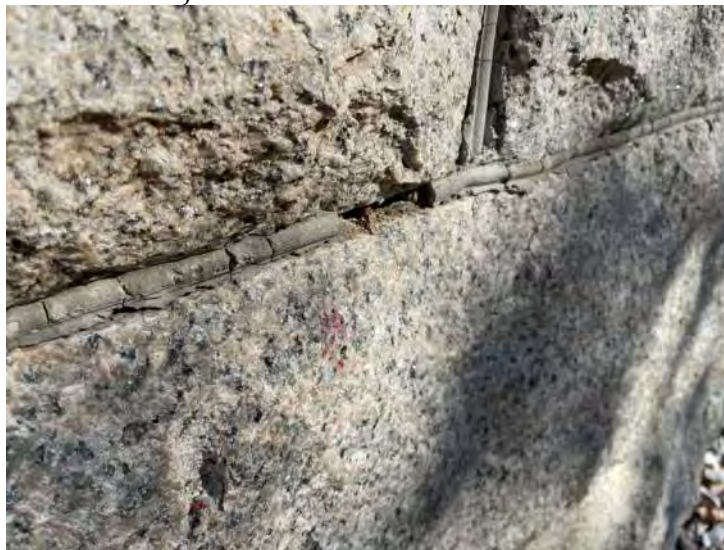
Photo 13: Deteriorated mortar joint at granite foundation

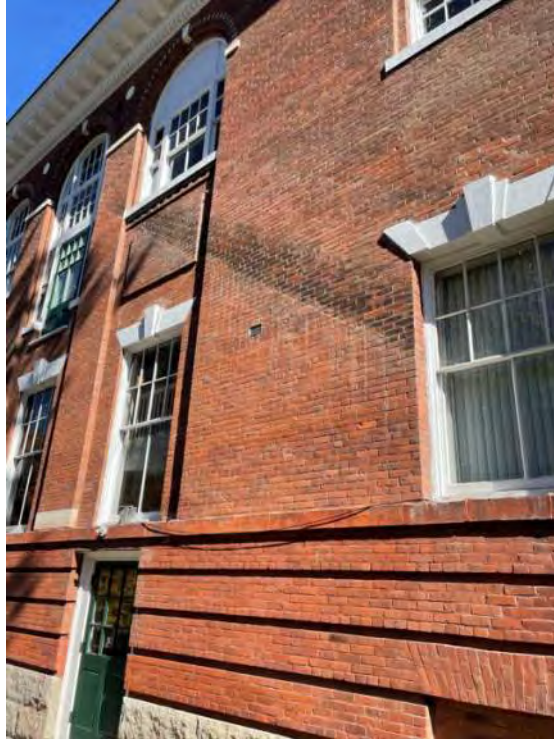
Photo 15: Environmental staining on brick at previous staircase

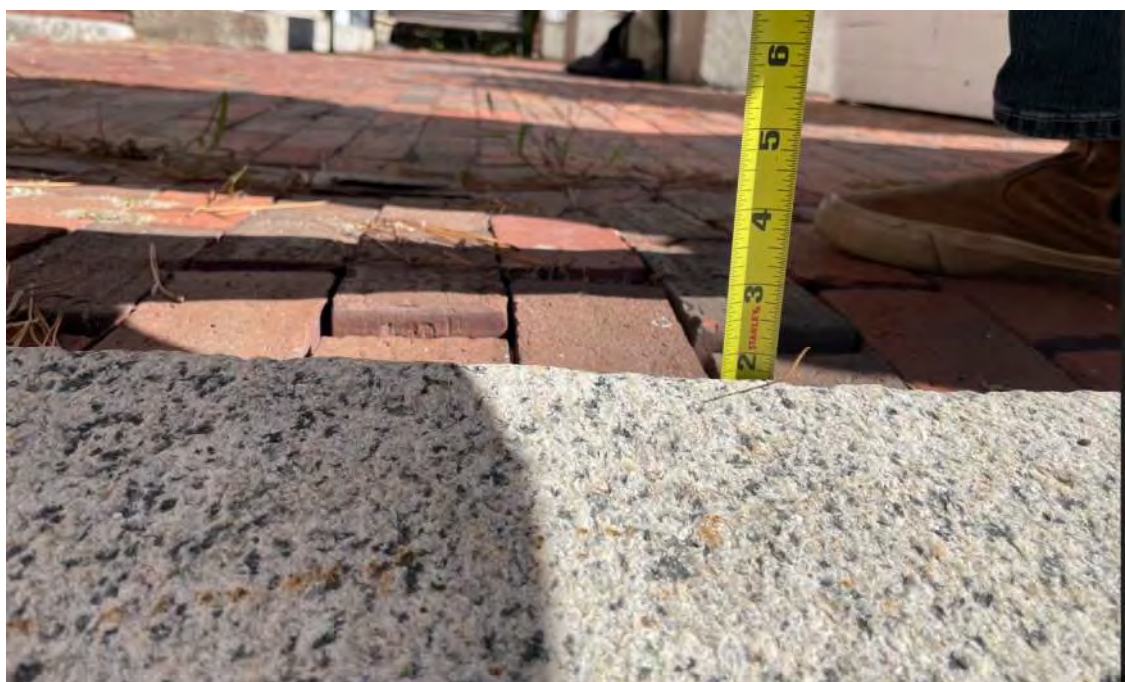
Photo 18: Settled or heaved granite steps and brick pavers at portico entrance

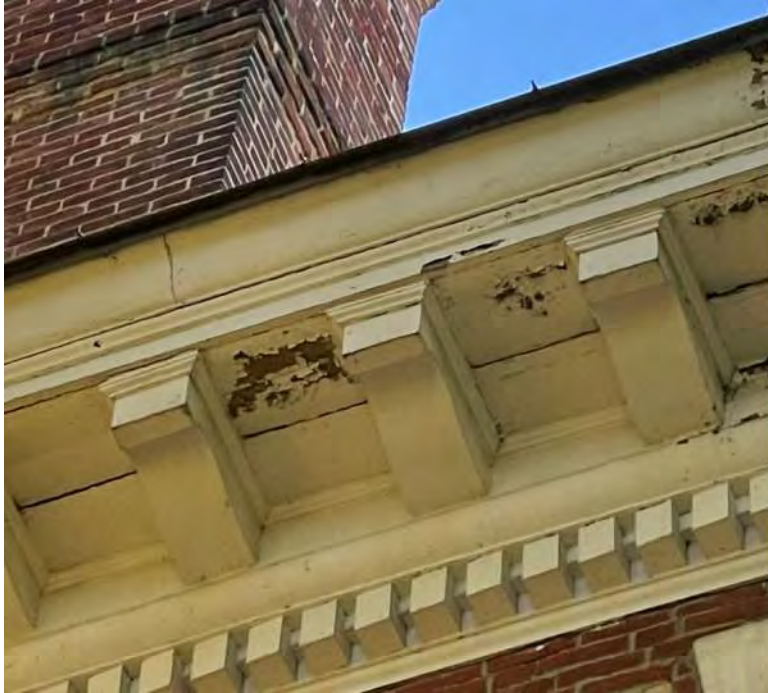
- Mortar joints of the brick chimney in the boiler room are badly deteriorated (Photo 19).
- Steel lintels above the windows and door along the rear of the building are rusty and beginning to show signs of delamination and rust jacking (Photo 20).
- Wooden trim is rotted at the east stairway structure (Photo 21).
- Wooden cornice has areas of peeled paint and exposed wood (Photo 22).
- Low sloped roof over the east side covered walkway has accumulated organic debris (Photo 23).

Photo 22: Peeling paint and exposed wood at cornice

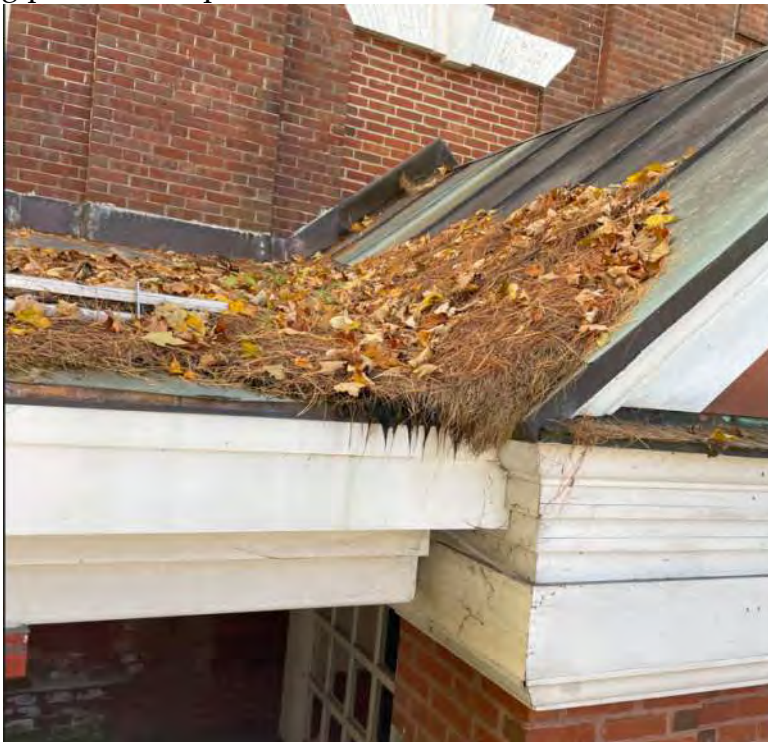
Photo 23: Accumulated organic debris over covered walkway
